January 9, 2024

**Report for AHERA 6-Month Surveillance**  
**2407 S. Broad Street and Playground at 1338-42 Ritner Street**  
**Philadelphia, PA 19148**  
*Synertech Environmental LLC Project No. 603-026*

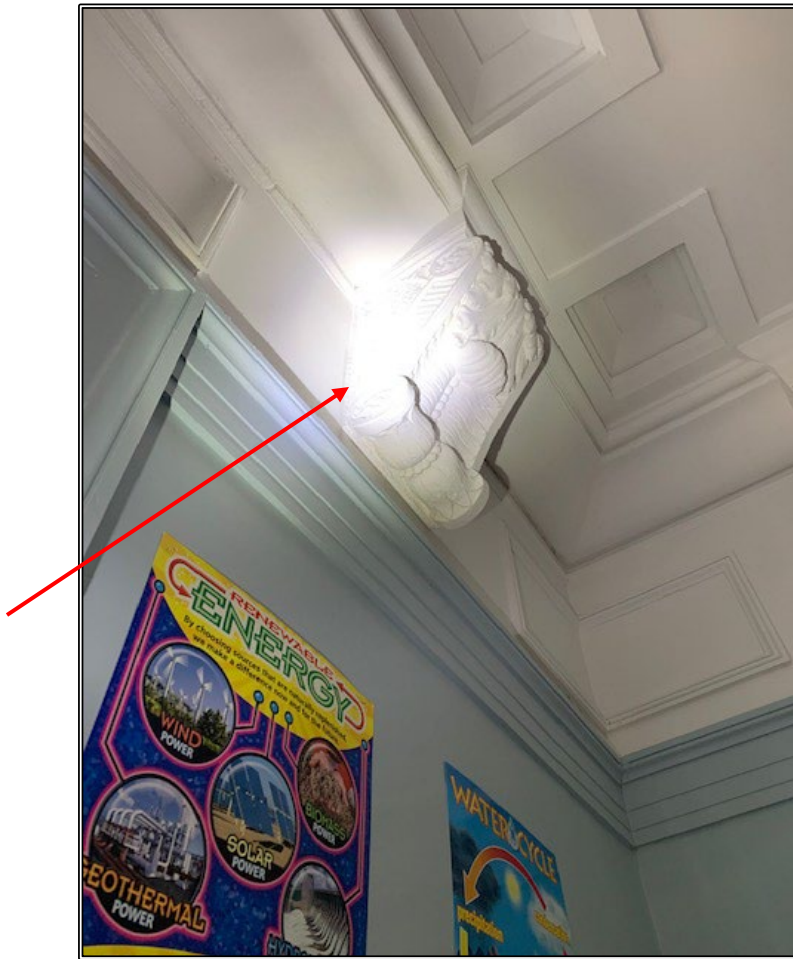
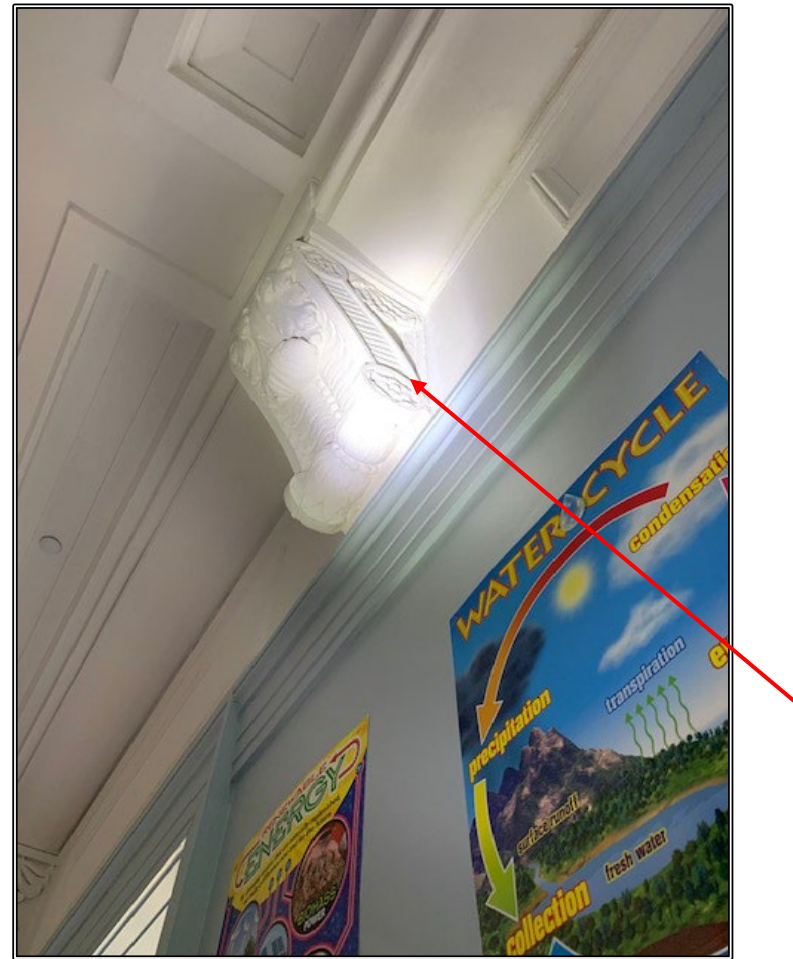
**Photos 1 & 2**

Flaking Paint applied to Decorative Ceiling Plaster in the Science Room

Lead–Based Painted Components and Recommendations				
Location	Wall	Component	Condition	Recommended
<b>2<sup>nd</sup> Floor</b>				
Science Lab	N/A	Decorative Plaster associated with Ceiling	Flaking (Approx. 2 SF)	WS/LS
		Paint applied to Ceiling	3 SF	
Hallway outside Science Lab	N/A	Paint applied to Ceiling	Flaking (Approx. 2 SF)	WS/LS
		Wall above Door	Flaking (Approx. 1 SF)	
Classroom 205	N/A	Paint applied to Ceiling & Decorative Plaster associated with Ceiling	Flaking (Approx. 2 SF)	WS/LS
	C, D	Cracking around Window Frames	Cracking (4 Windows)	Caulk around Perimeter of Window Frame
Music Room	N/A	Paint applied to Ceiling	Flaking (Approx. 4 SF)	WS/LS

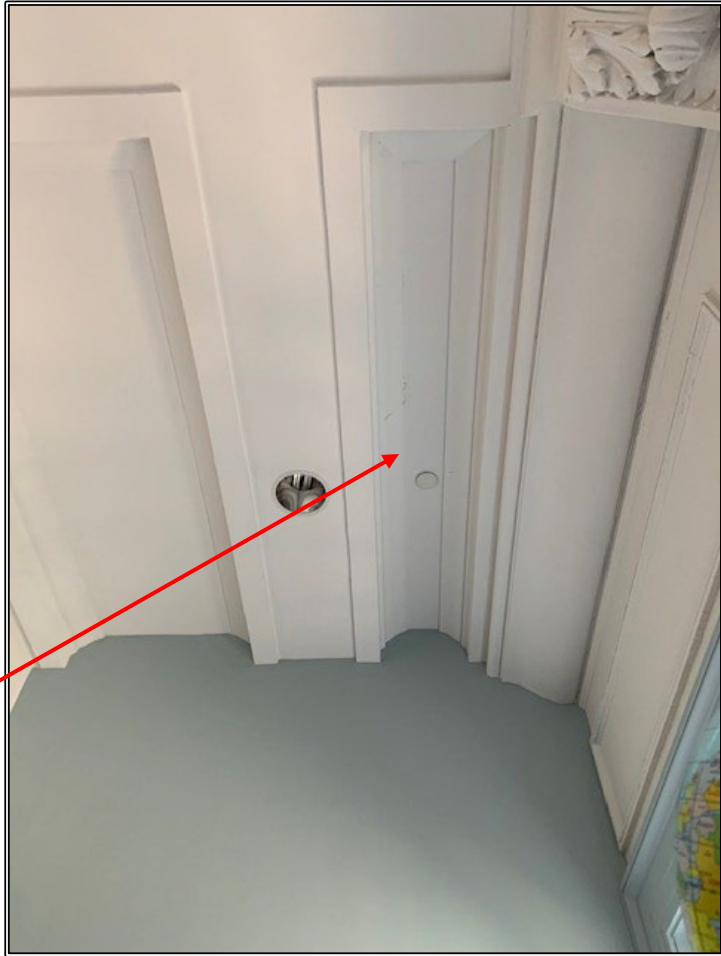
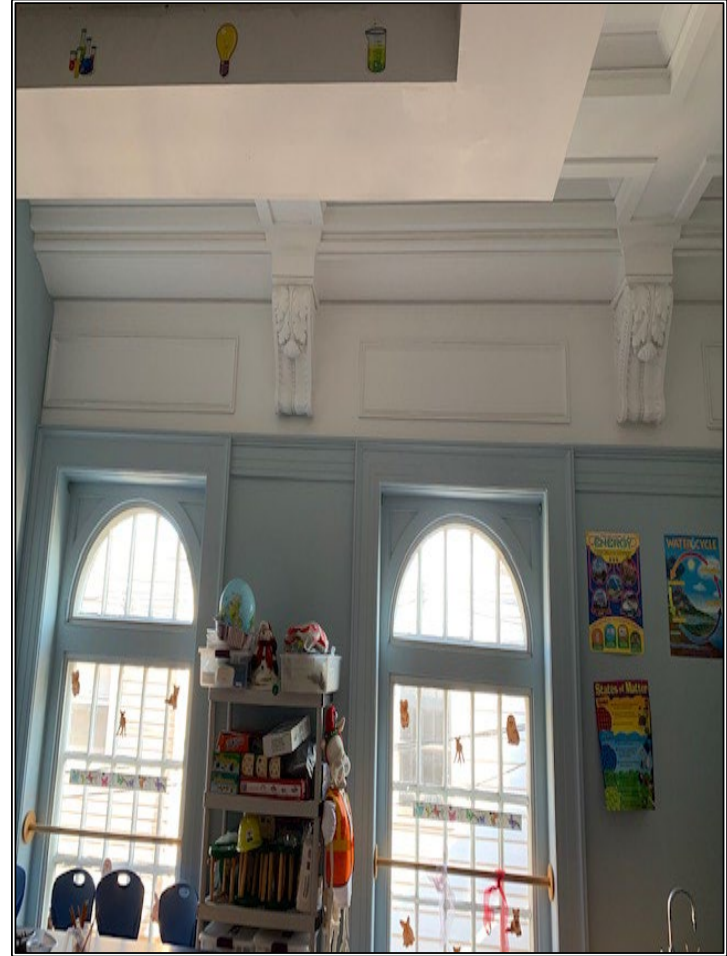
**Photos 3 & 4**  
Flaking Paint applied to Decorative Ceiling Plaster in the Science Room

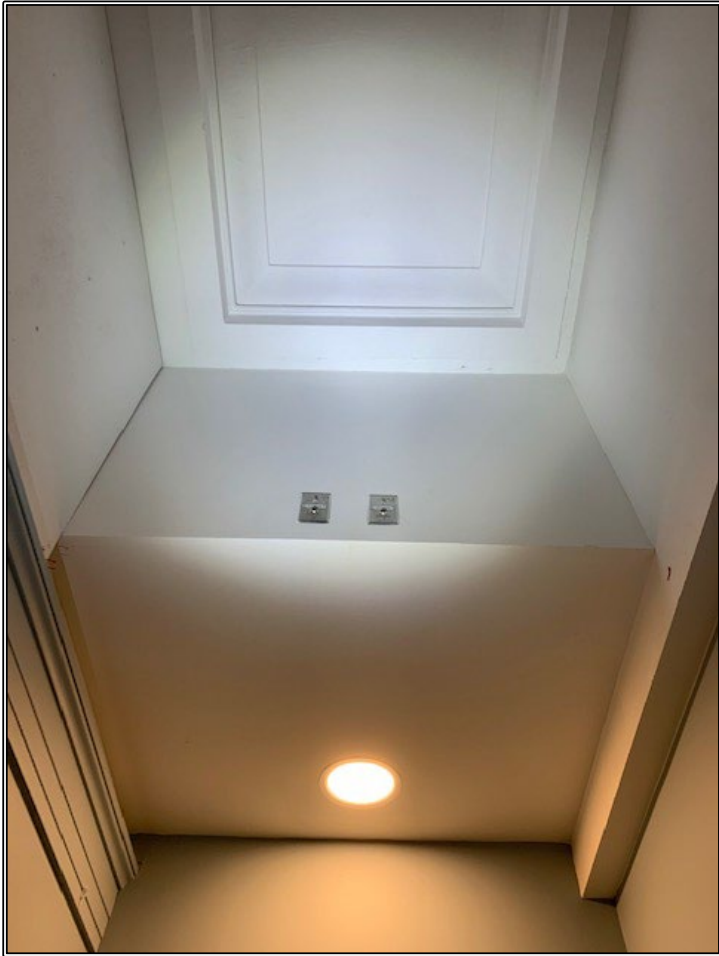
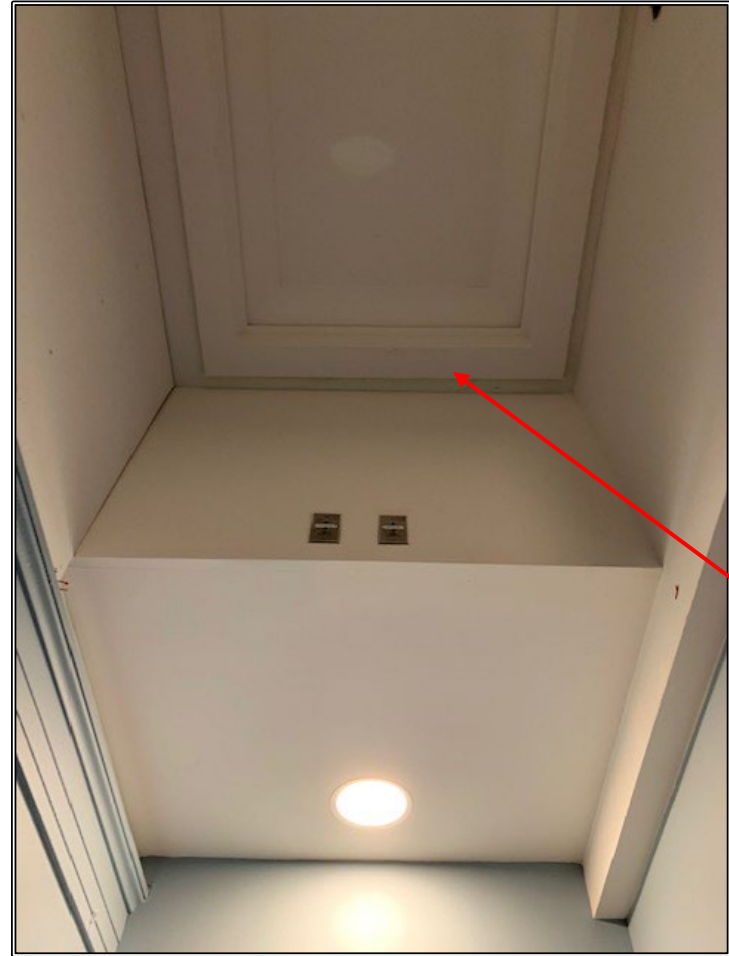
**Photos 5 & 6**  
Flaking Paint applied to the Ceiling in the 2<sup>nd</sup> Floor Hallway outside of the Science Room

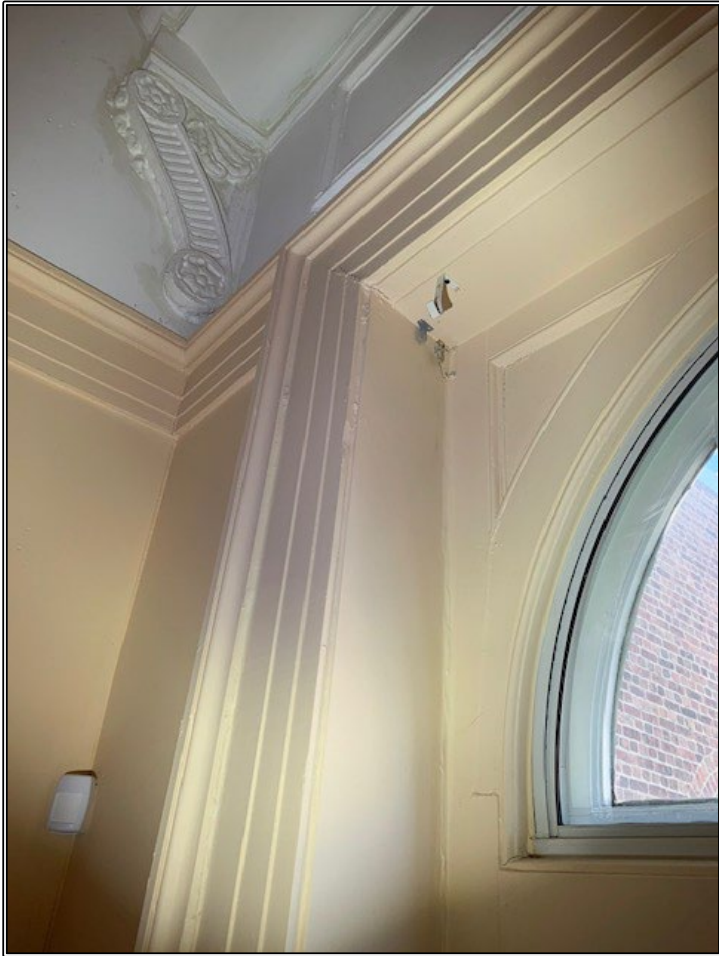
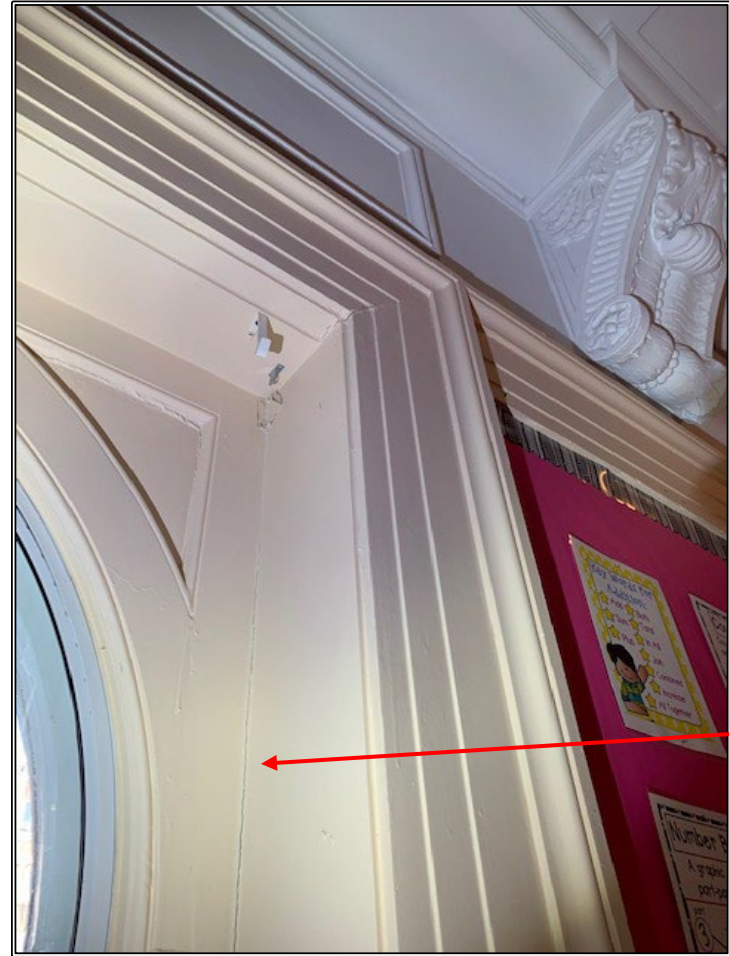
**Photos 7 & 8**  
Cracking Paint associated with Window Frames in Room 205

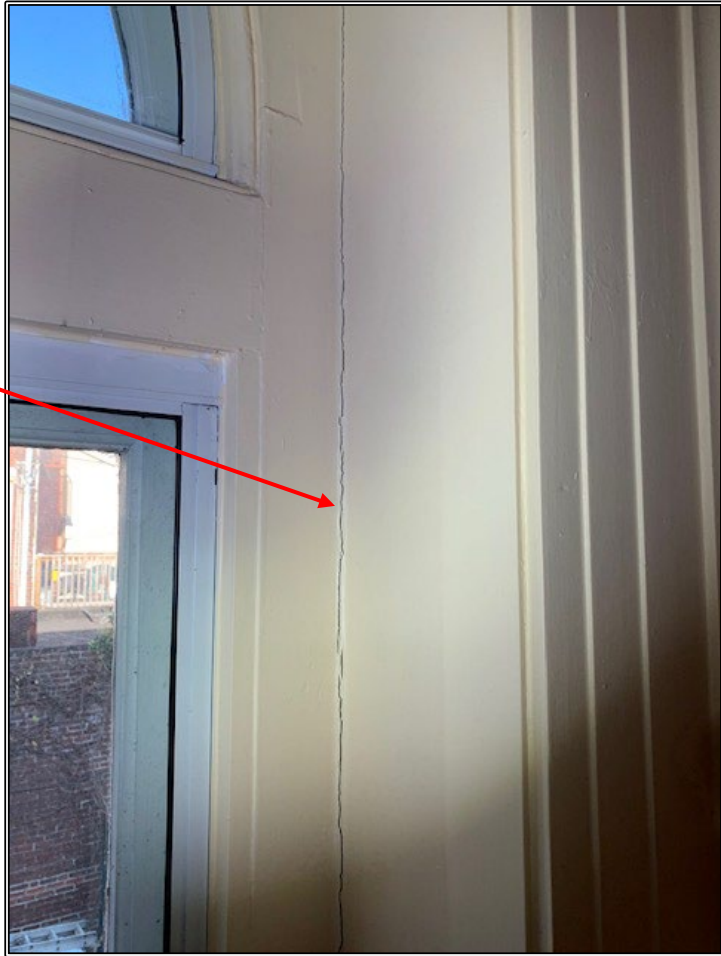
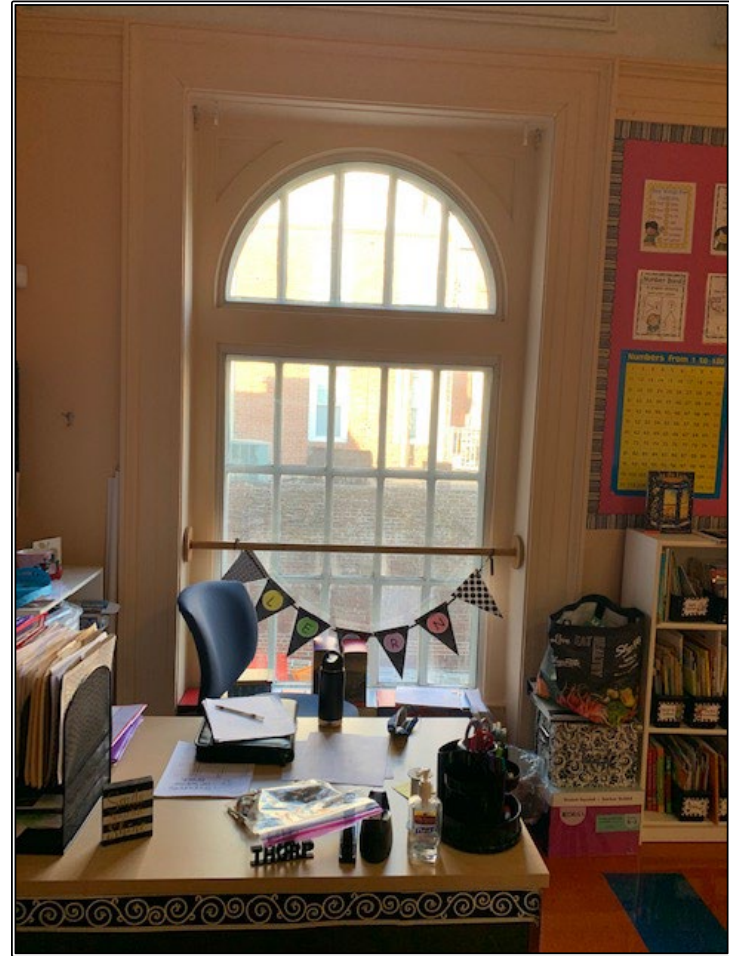
**Photos 9 & 10**  
Cracking Paint associated with Window Frames in Room 205

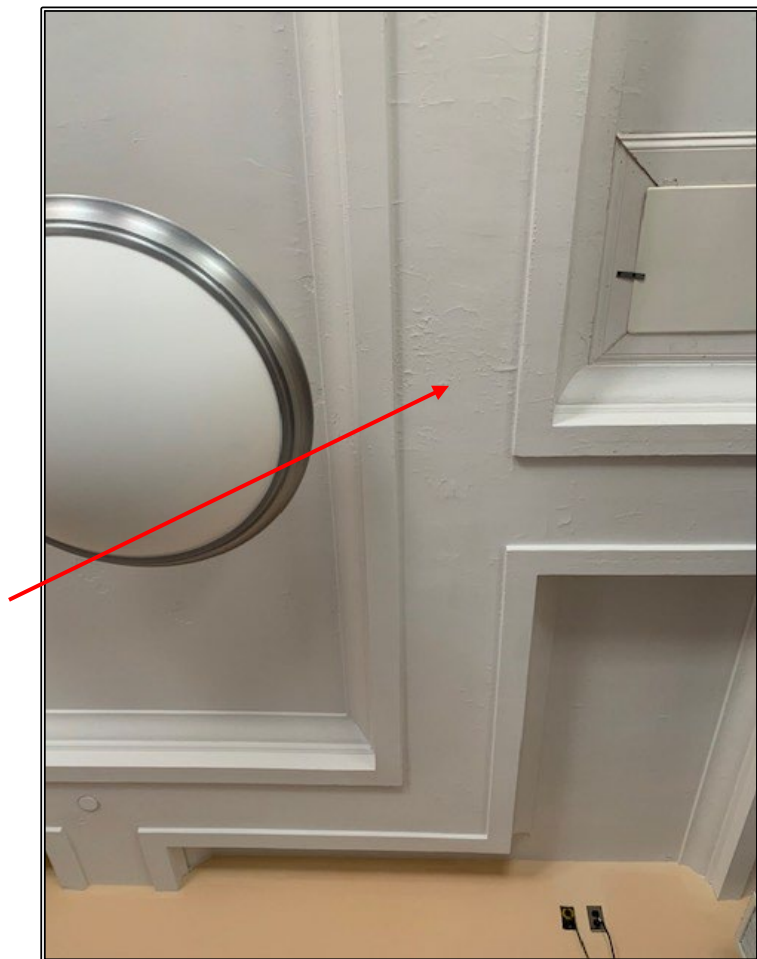
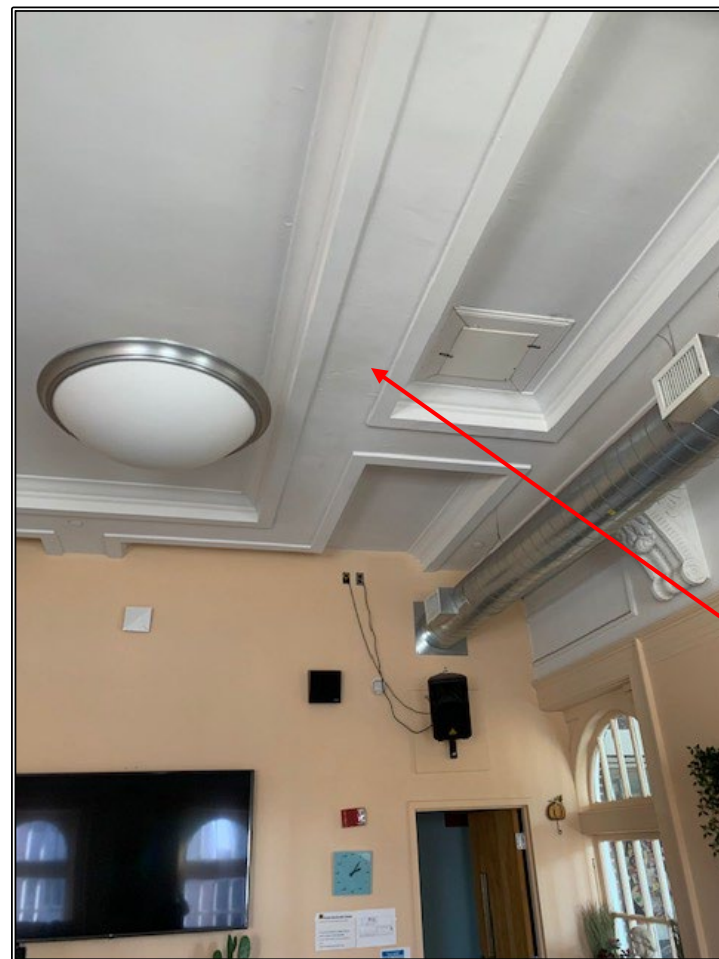
**Photos 11 & 12**  
Flaking Ceiling Paint in the Music Room

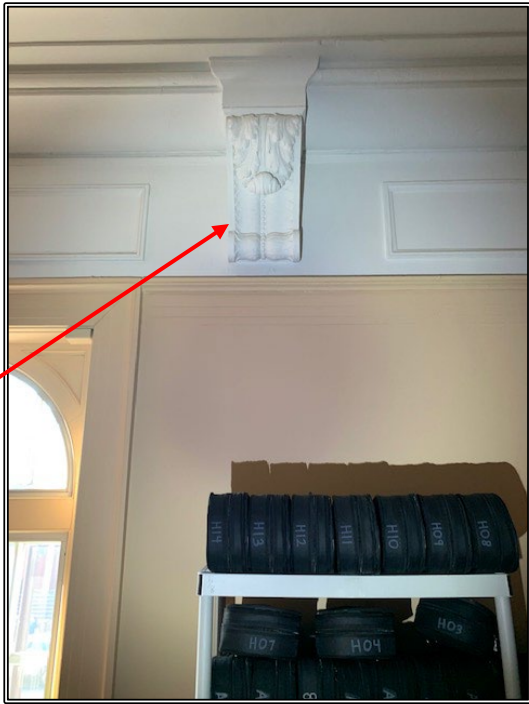
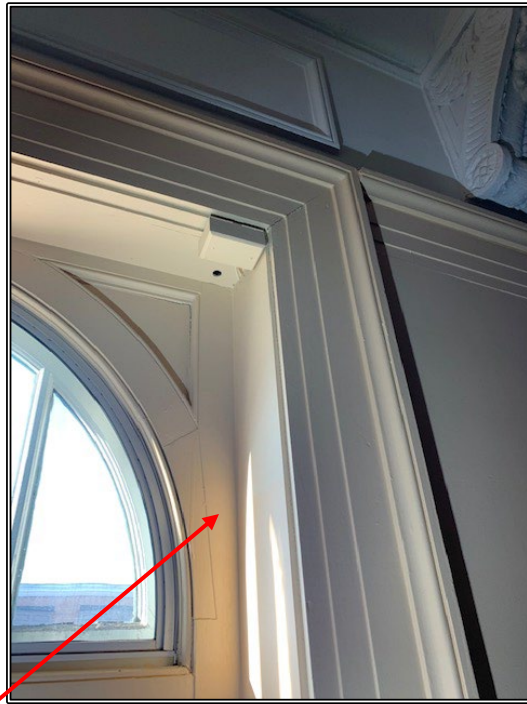
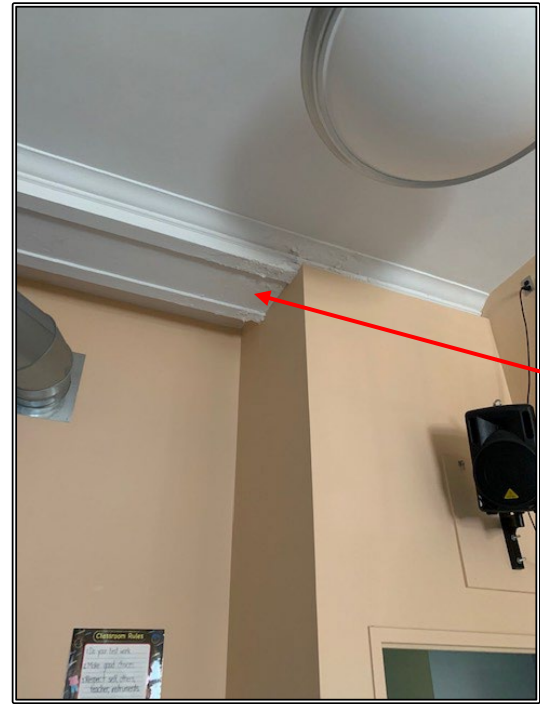
**Photos 13-15**

Damaged Paint applied to Decorative Ceiling Plaster & Cracked Paint associated with Window Frames in the Instrumental Room

Lead-Based Painted Components and Recommendations				
Location	Wall	Component	Condition	Recommended
<b>2<sup>nd</sup> Floor</b>				
Instrumental Studio	N/A	Decorative Plaster associated with Ceiling	Flaking (Approx. 5 SF)	WS/LS
	C	Cracking around Window Frames	Cracking (1 Window)	Caulk around Perimeter of Window Frame
Ballet Studio	N/A	Decorative Plaster associated with Ceiling	Flaking (Approx. 4 SF)	WS/LS
	B, C, D	Cracking around Window Frames	Cracking (8 Windows)	Caulk around Perimeter of Window Frame
	C	Flaking Paint associated with Window Sash (Missing Windowpane)	Flaking (Approx. 4 SF)	WS/LS or Replace Missing Windowpane

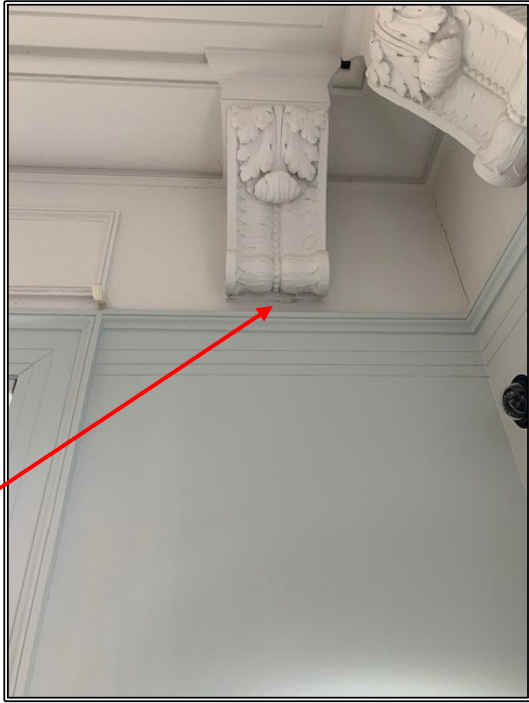
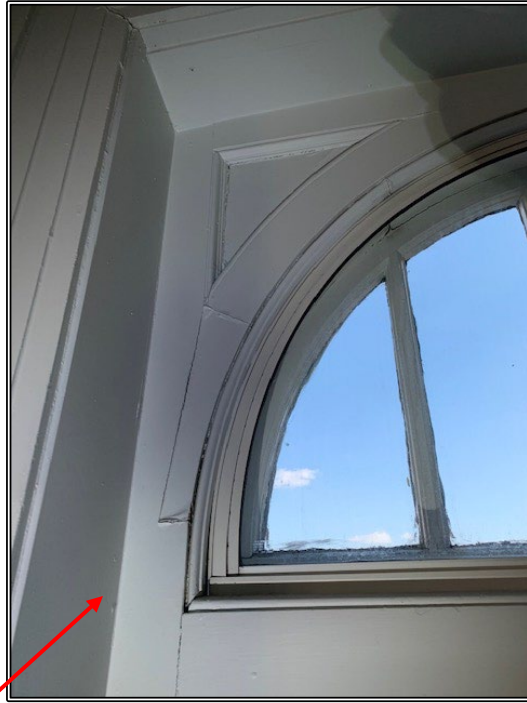
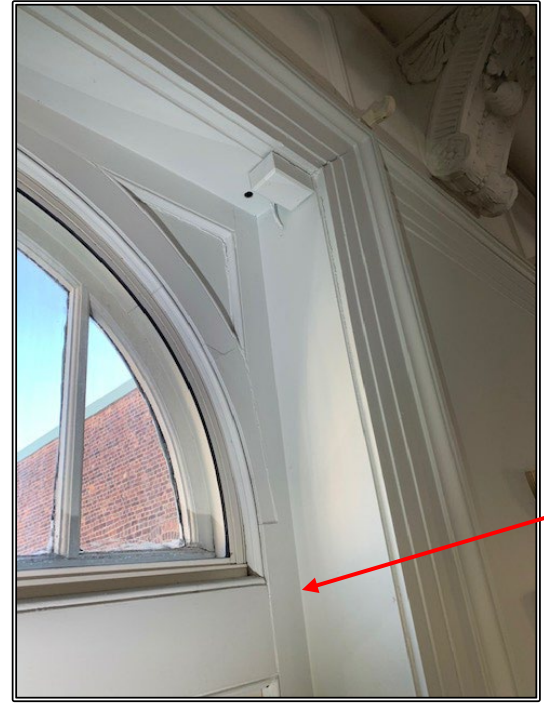
**Photos 16-18**

Damaged Paint applied to Decorative Ceiling Plaster & Cracked Paint associated with Window Frames in the Instrumental Room

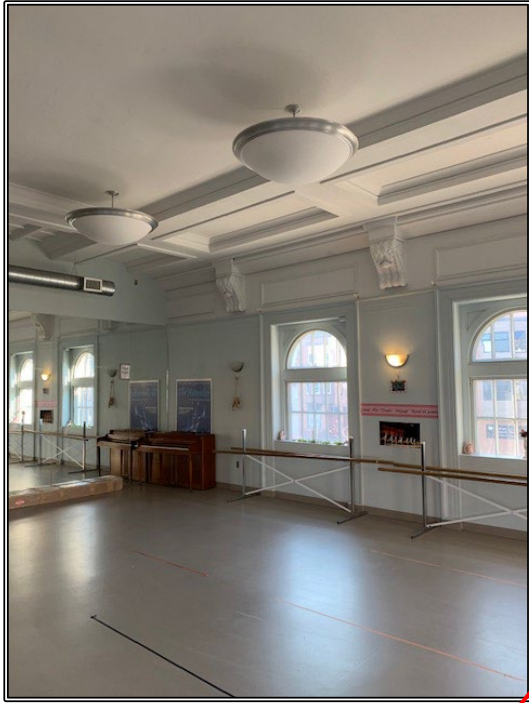
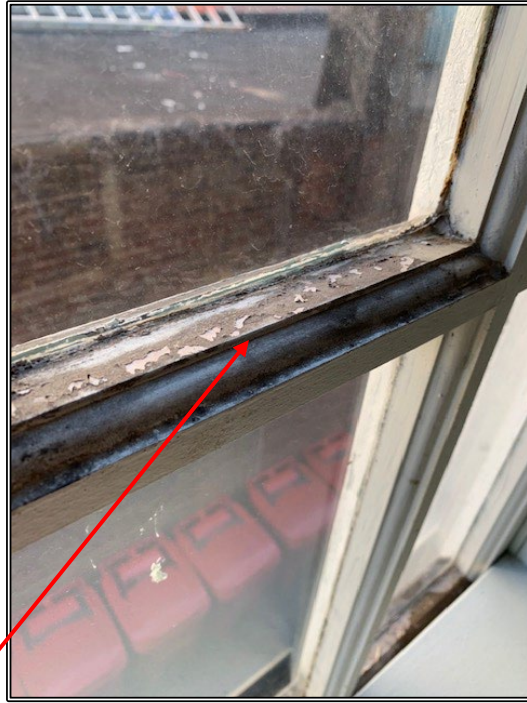
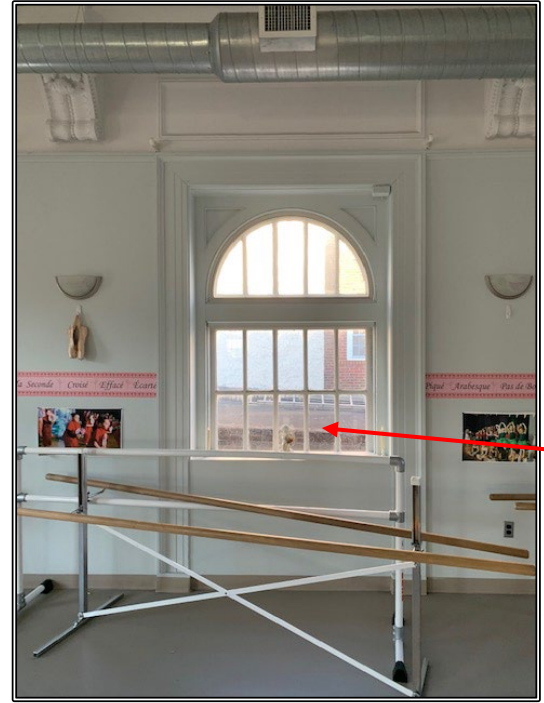
**Photos 19-21**  
Damaged Paint associated with Window Sash and Missing Windowpane
