Report for AHERA 6-Month Surveillance

2600 S. Broad Street

Synertech Environmental LLC Project No. 603-025

Project Name: Philadelphia Performing Arts Charter School: 2600 S. Broad Street

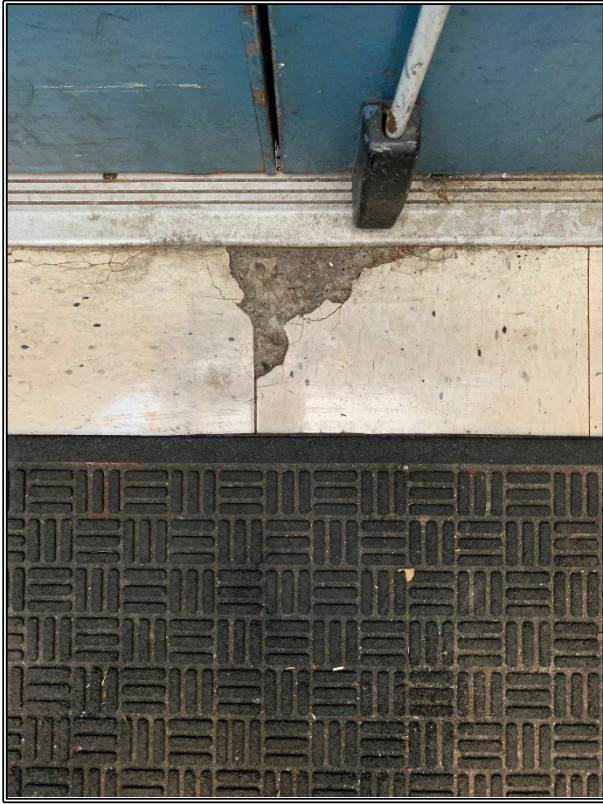
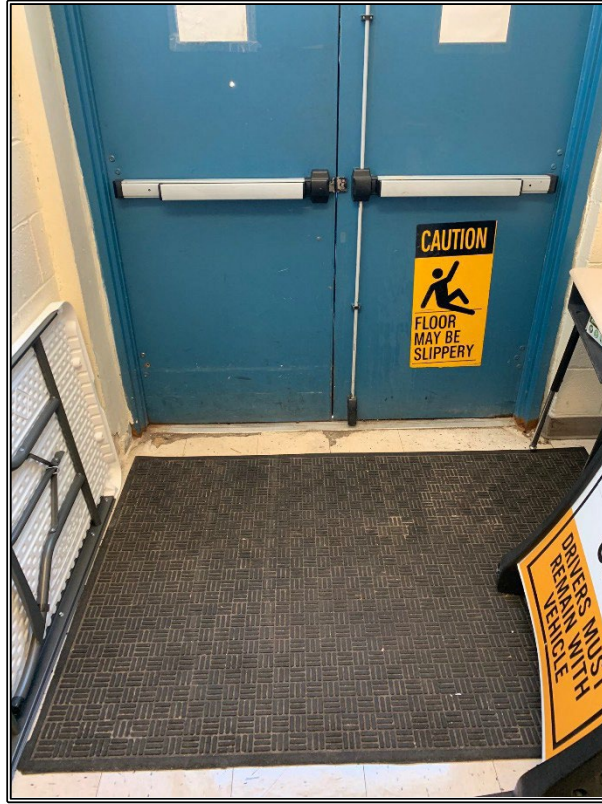
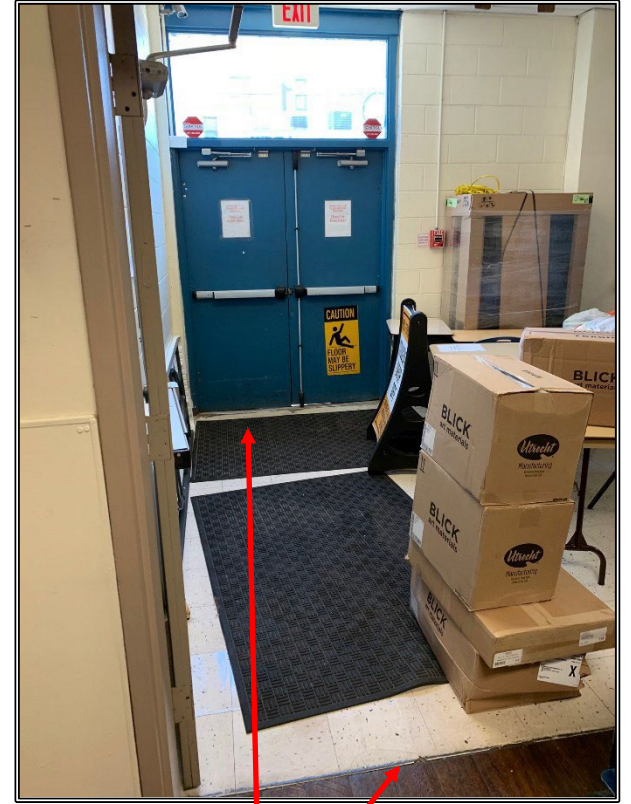
Photos 1-3
Damaged Vinyl Asbestos Floor Tile (VAT) in the North Stairwell by Elevator

The following table lists damaged ACM’s observed during this 6-Month Surveillance. *Synertech Environmental LLC* recommends the removal of the following ACM’s followed by their replacement with non- asbestos substitutes.

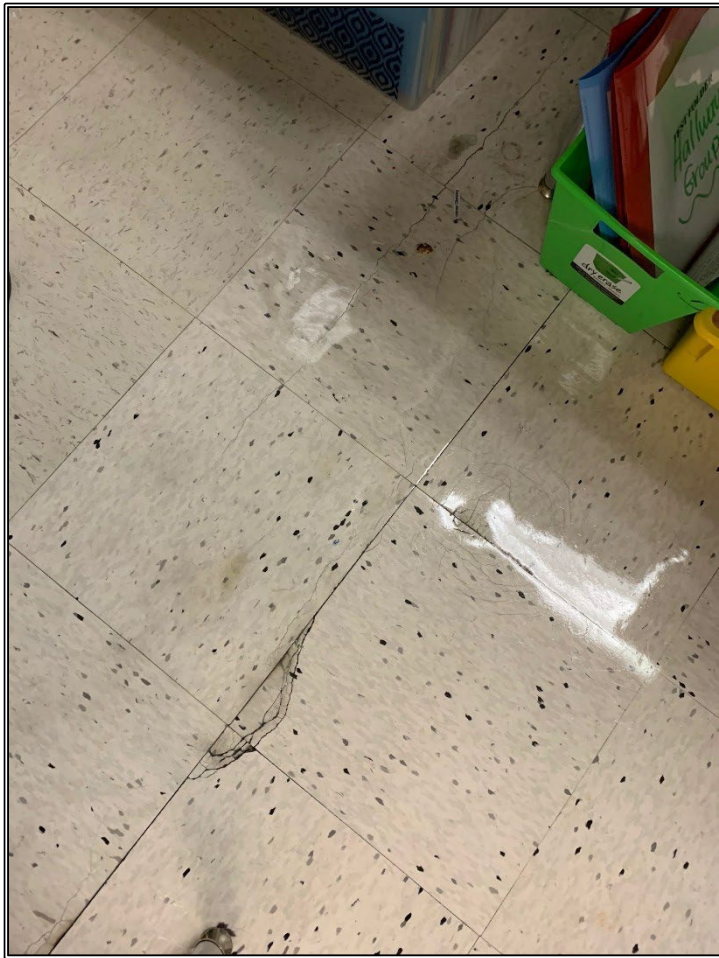
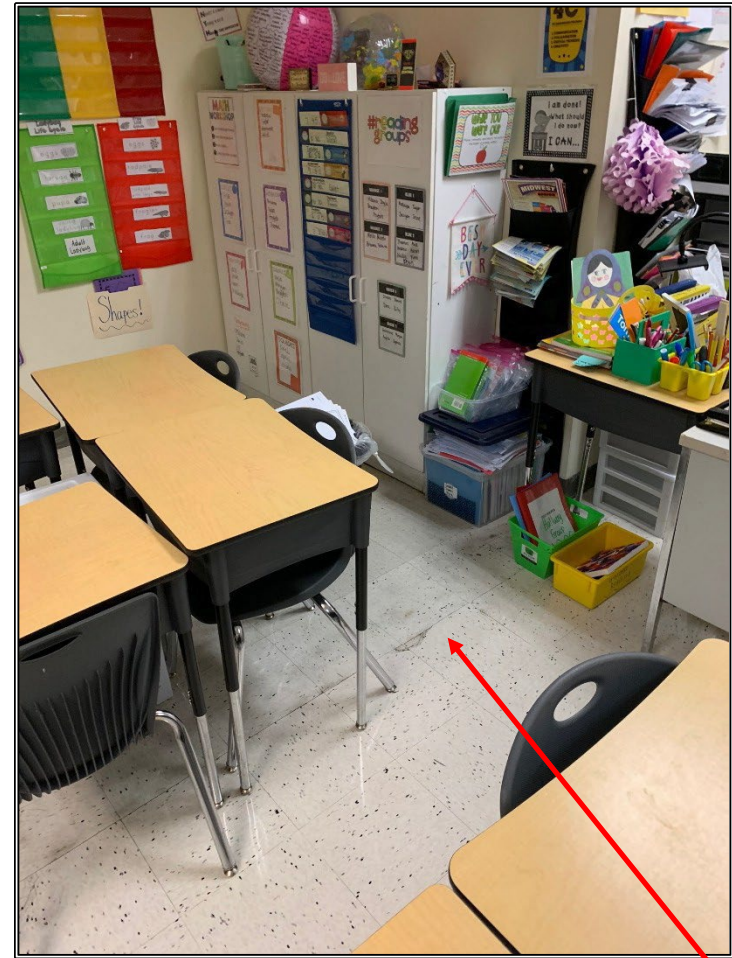
Photos 4 & 5
Damaged VAT in Classroom 102

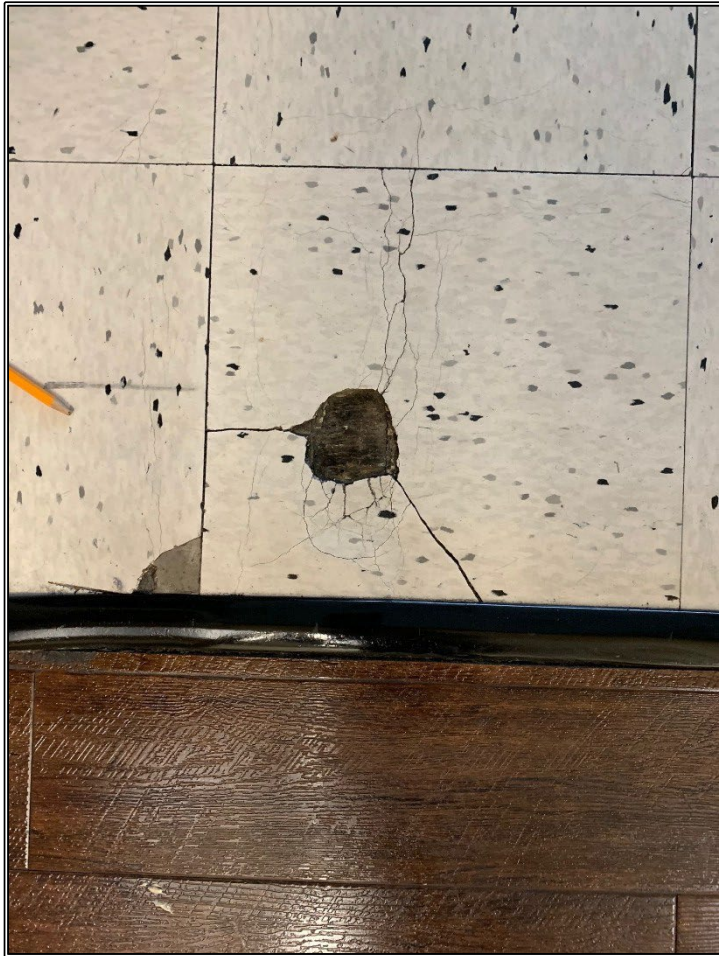
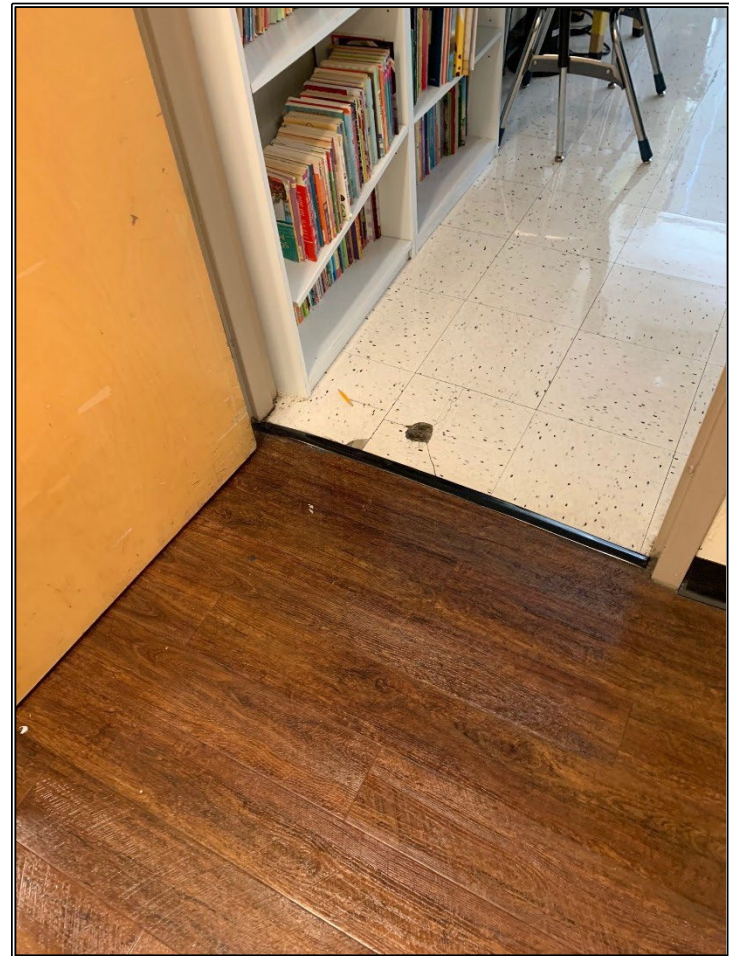
Photos 6 & 7
Damaged VAT in Classroom 106

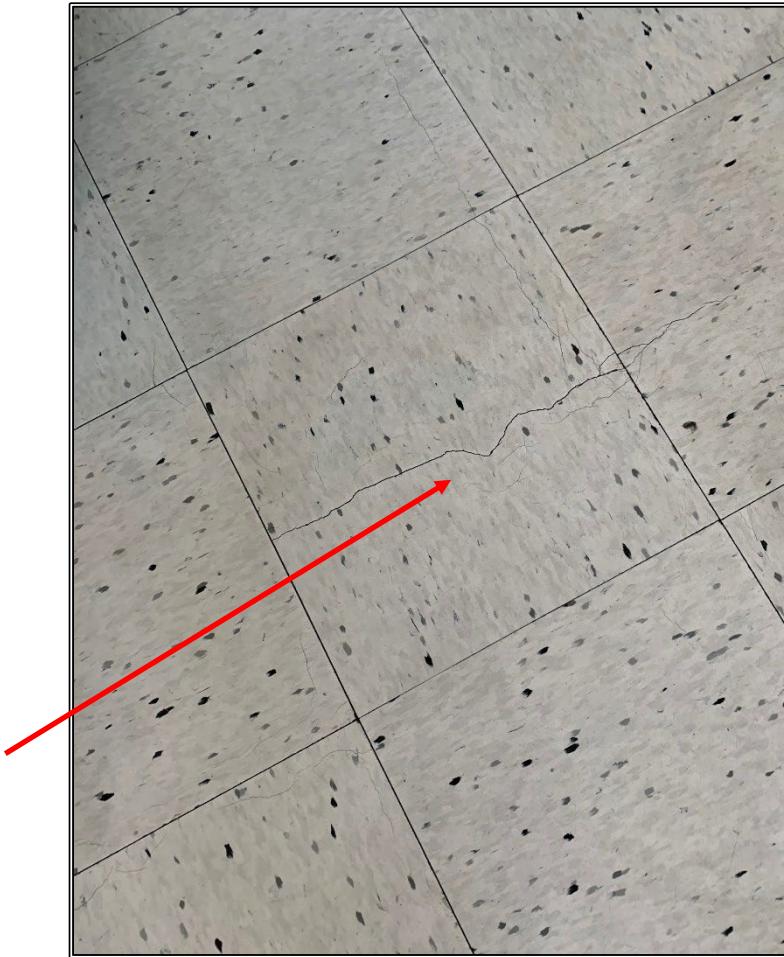
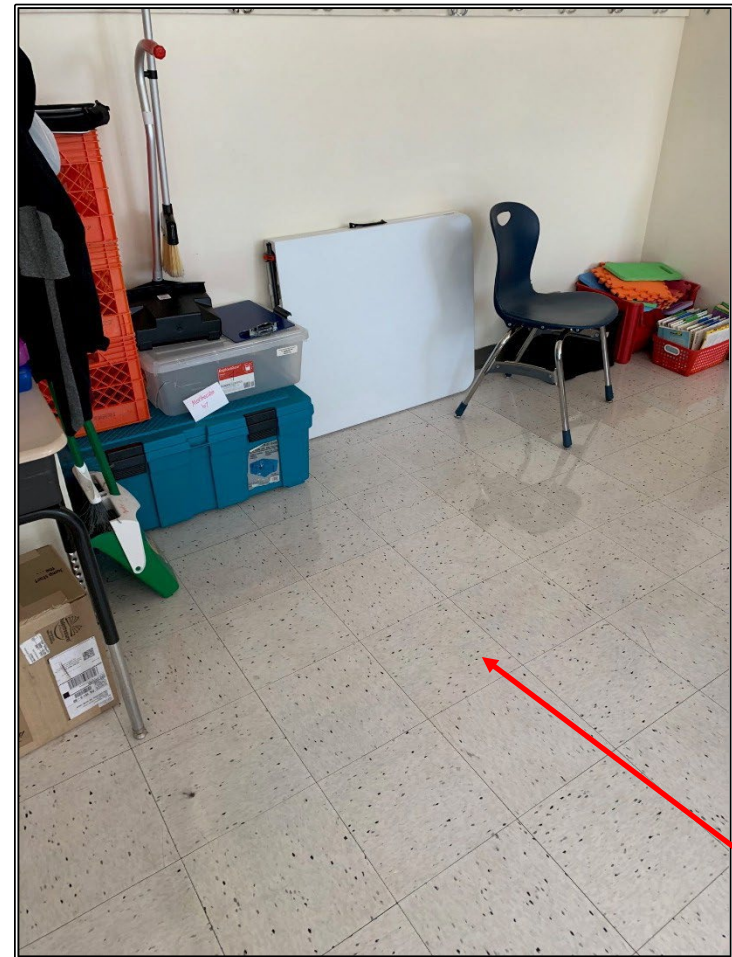
Photos 8 & 9
Damaged VAT in Classroom 107

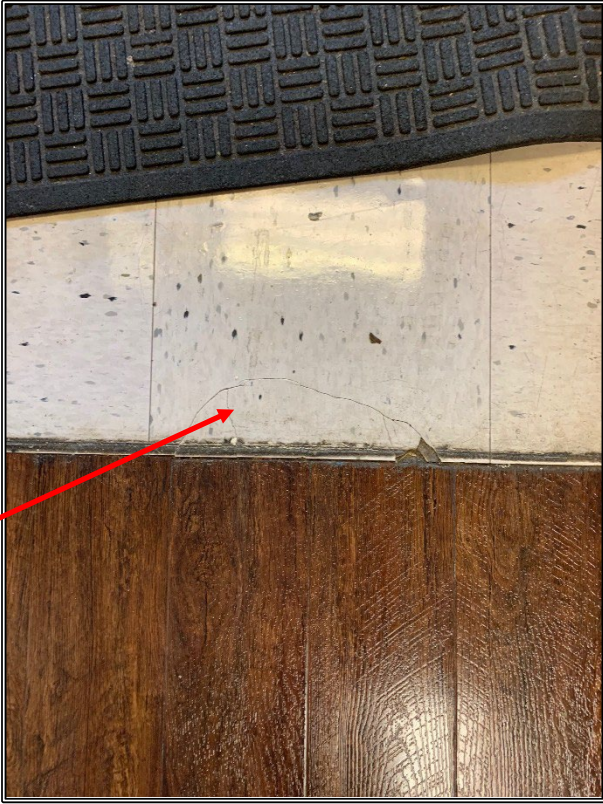
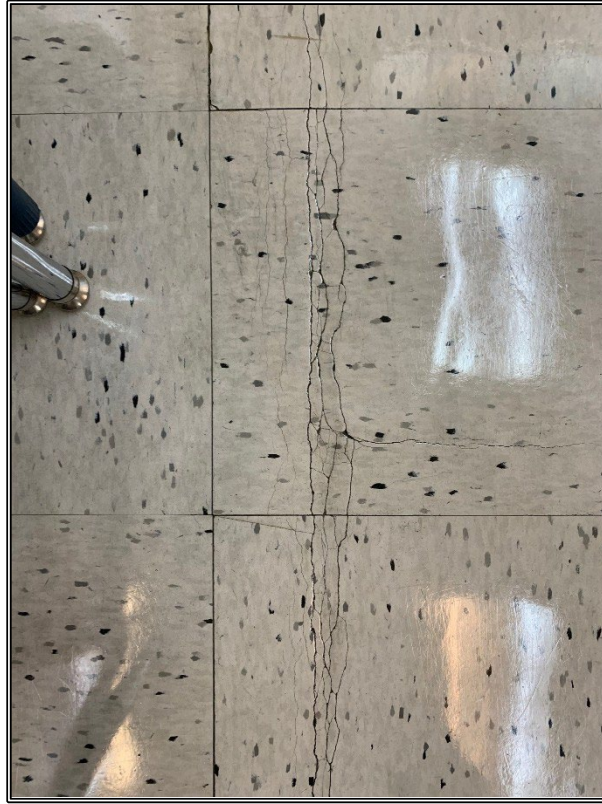
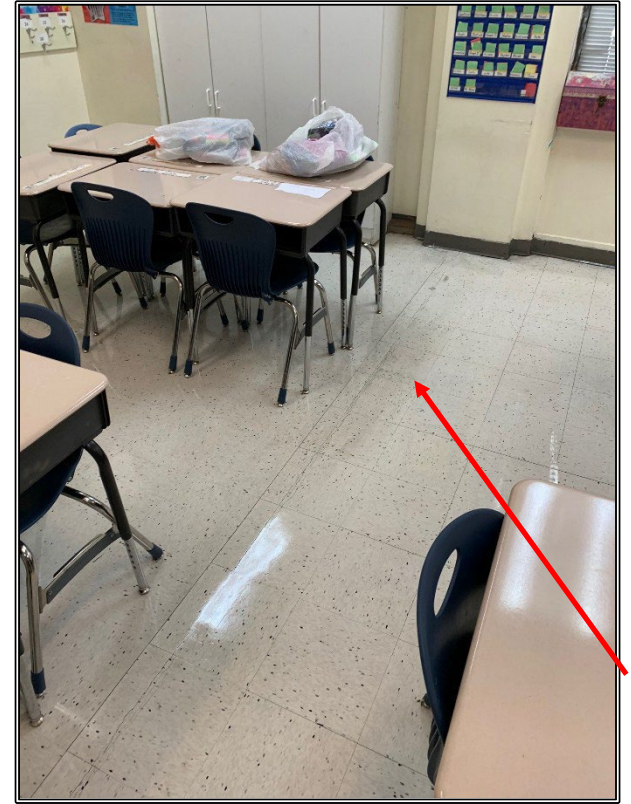
Photos 10-12
Damaged VAT in Classroom 108

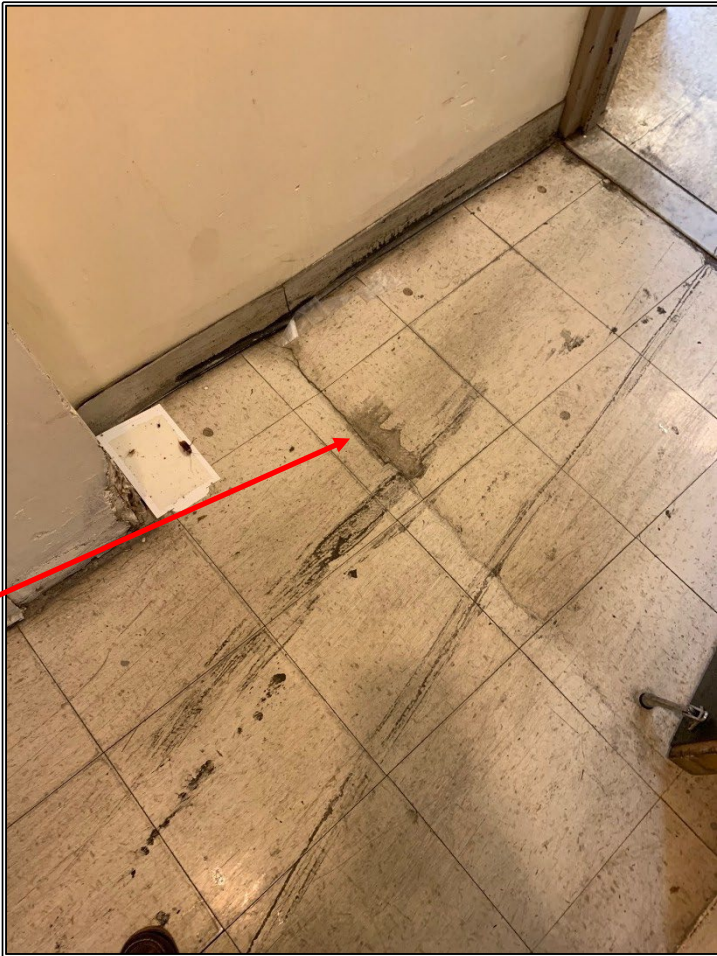
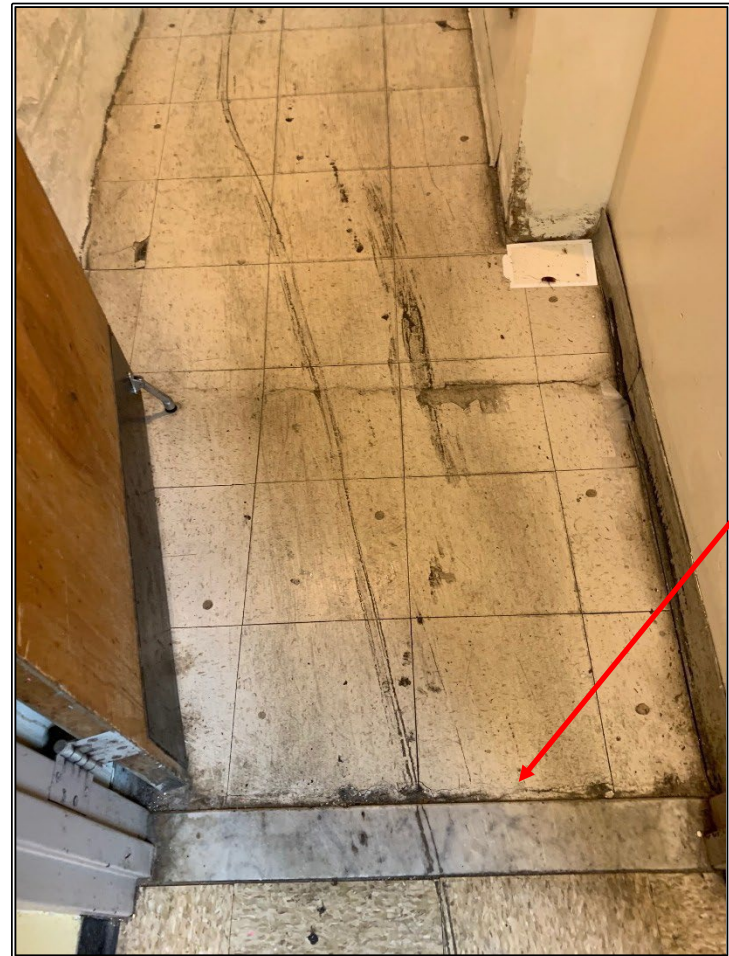
Photos 13 & 14
Damaged VAT in the Hallway to Exit behind Kitchen

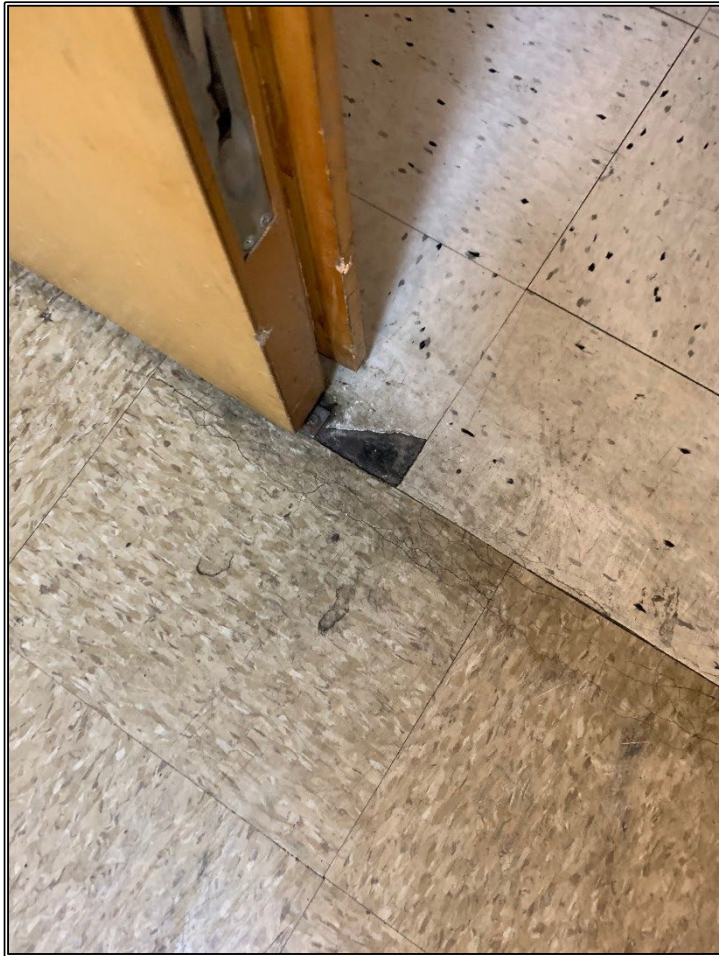
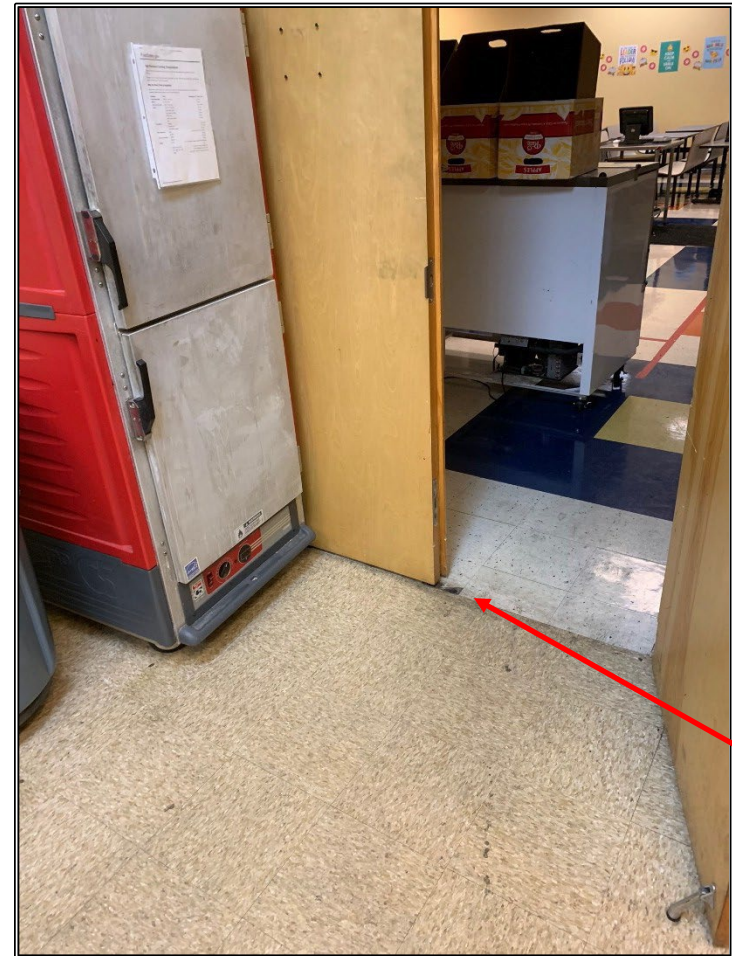
Photos 15 & 16
Damaged VAT in the Cafeteria

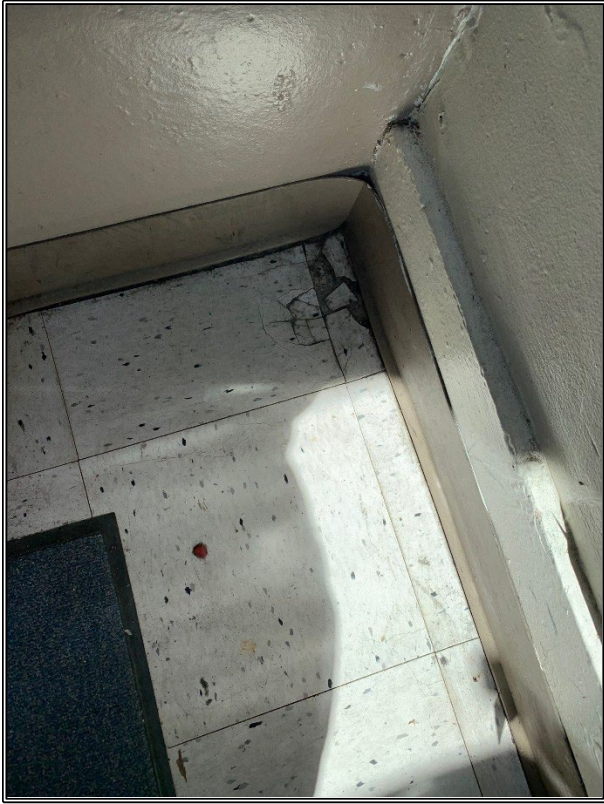
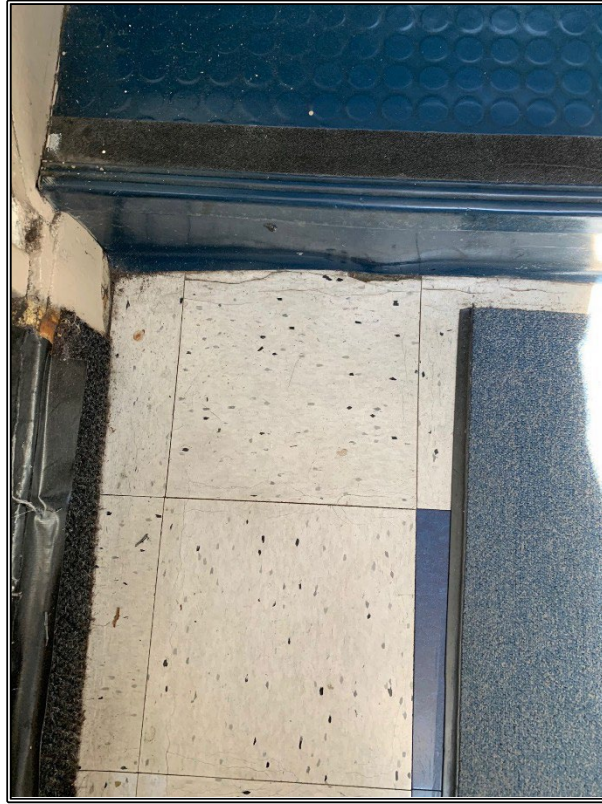
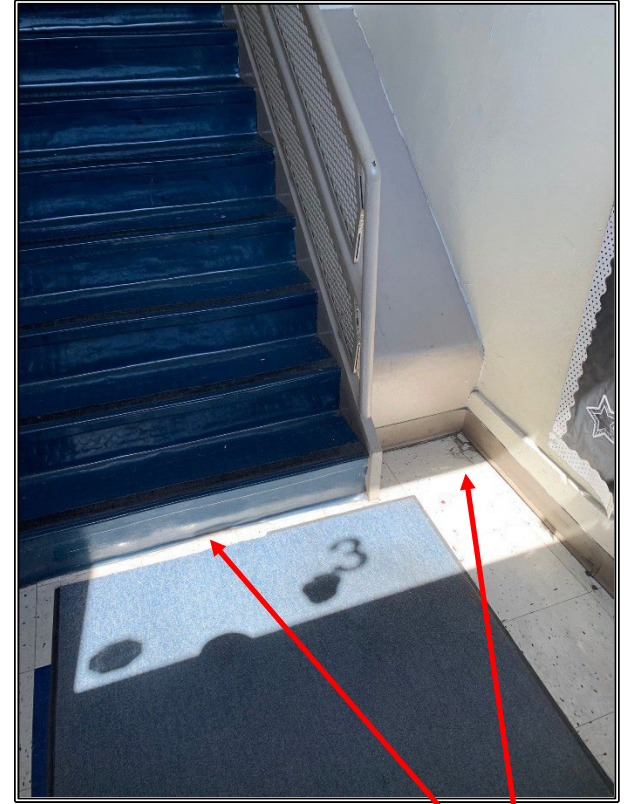
Photos 17-19
Damaged VAT in the Center Stairwell by Main Entrance (1st Floor)

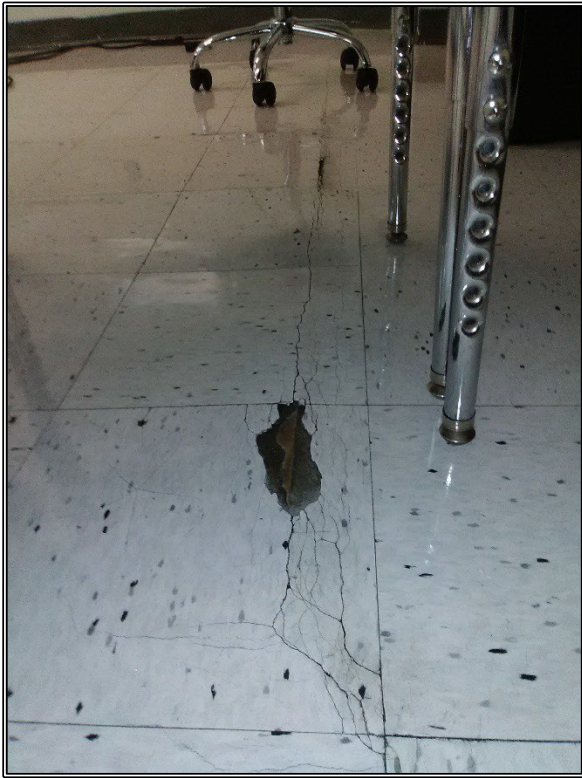
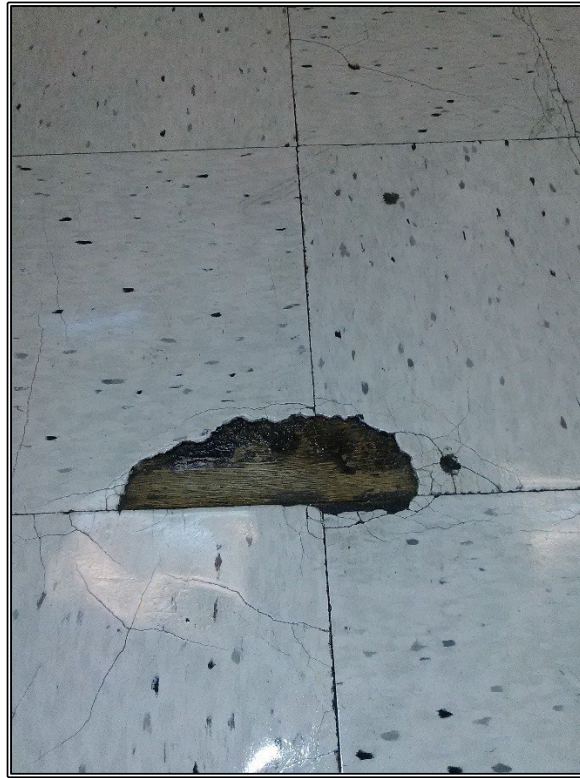
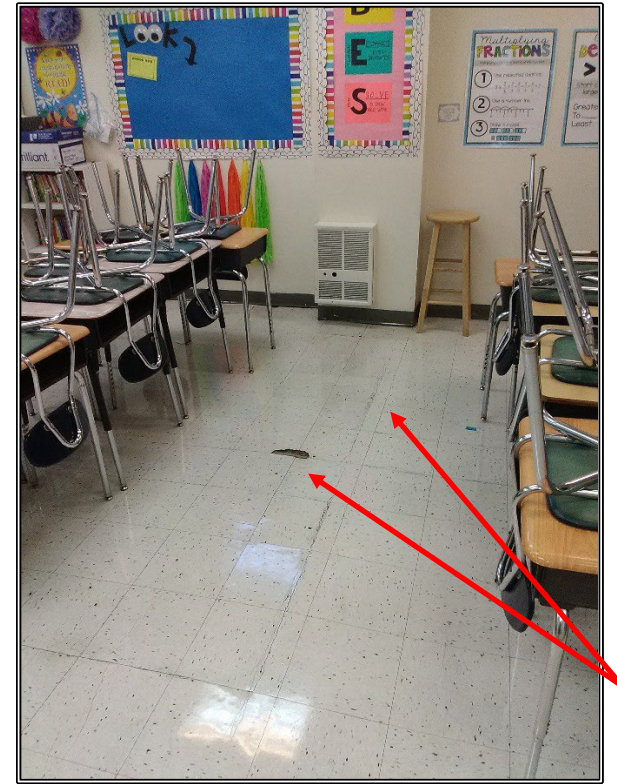
- 2) Floor Tiles in Classrooms 201 & 202 were observed to have widespread damage throughout with additional damage to the wood substrate. While the tiles are currently waxed over and are intact, they possess the potential to become friable with additional damage over time. Full removal of all floor tiles in these areas is recommended and can only be done in a friable manor.

Photos 20-22
Damaged VAT in Classroom 201

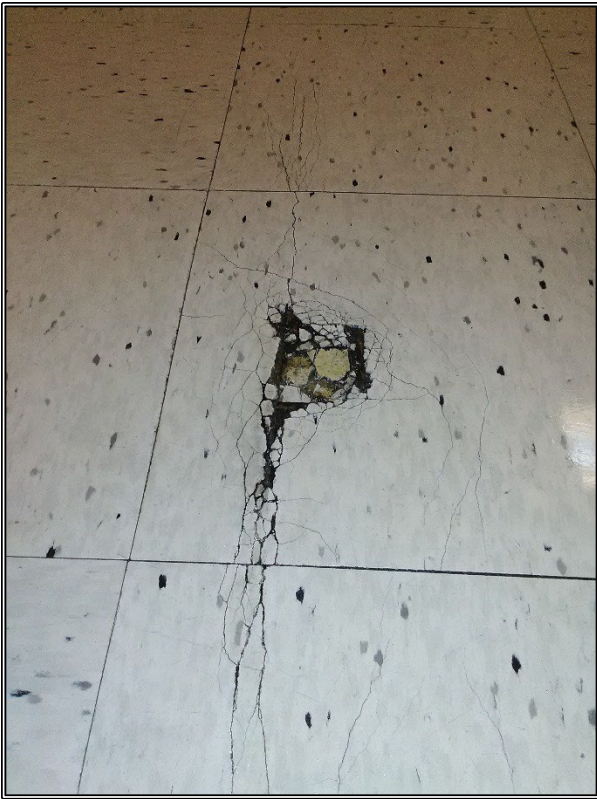
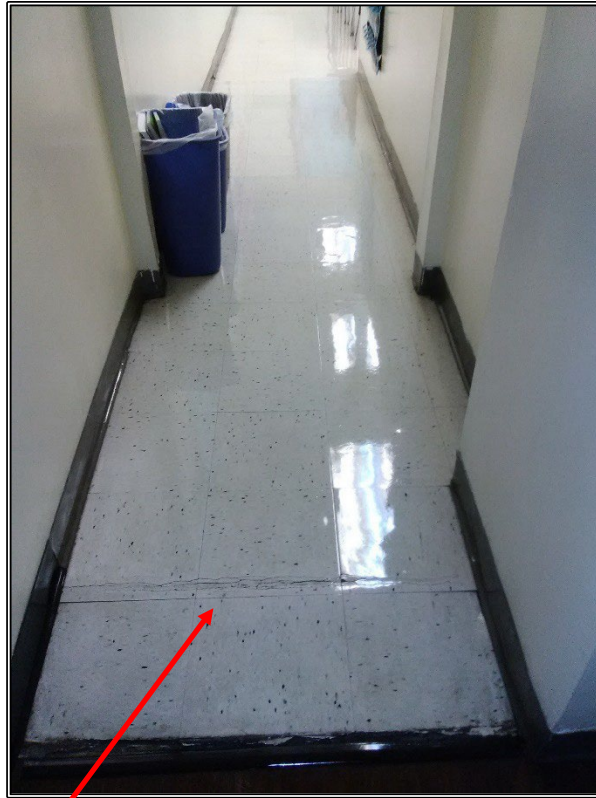
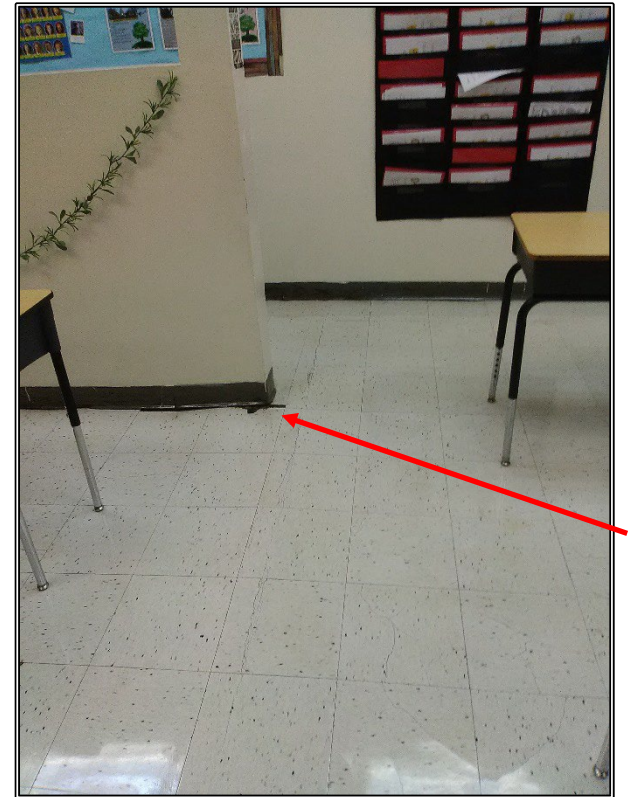
Photos 23-25

Damaged VAT in Classroom 202

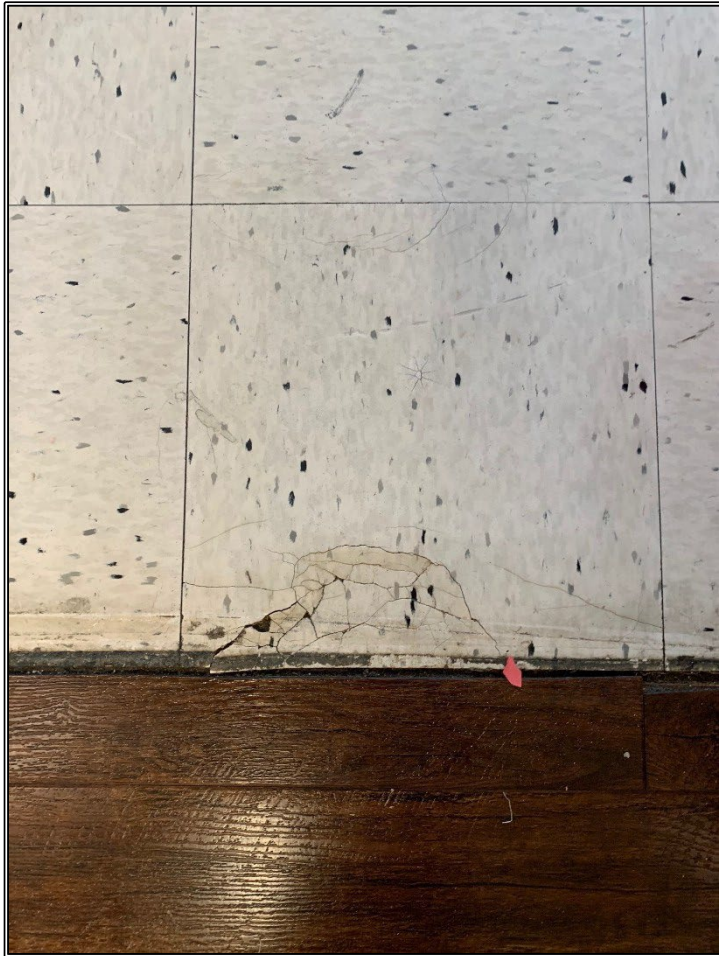
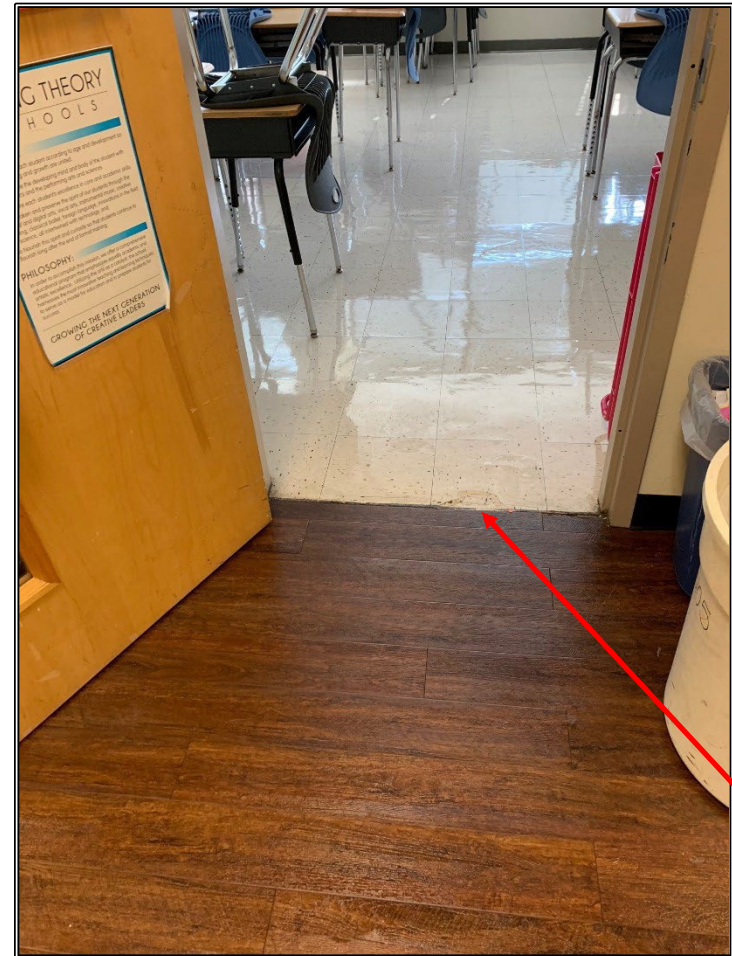
Photos 26 & 27
Damaged VAT in Classroom 205

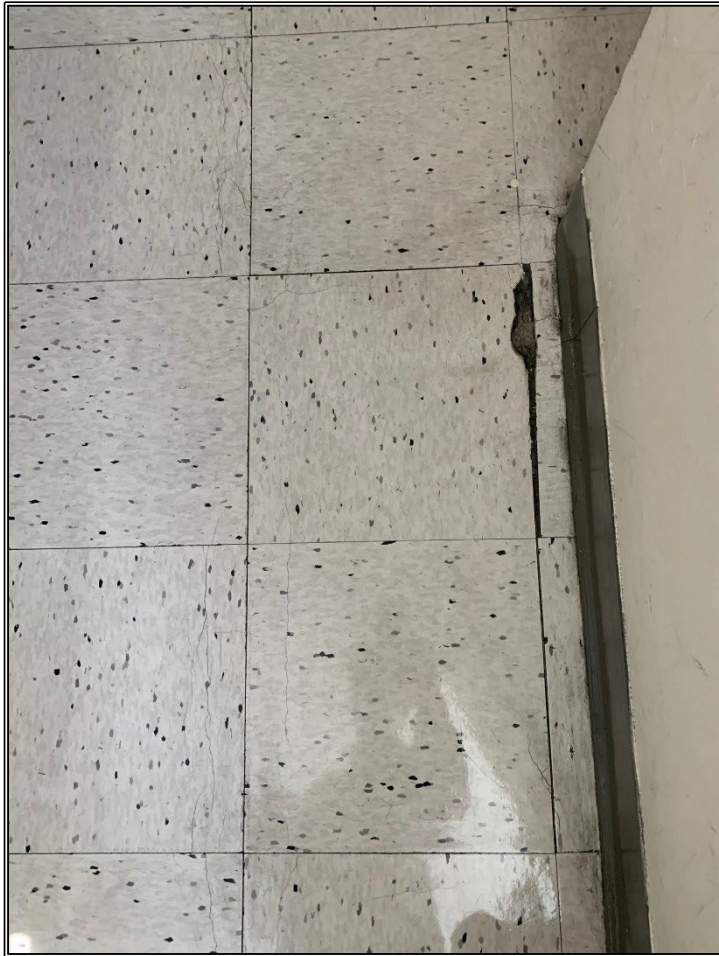
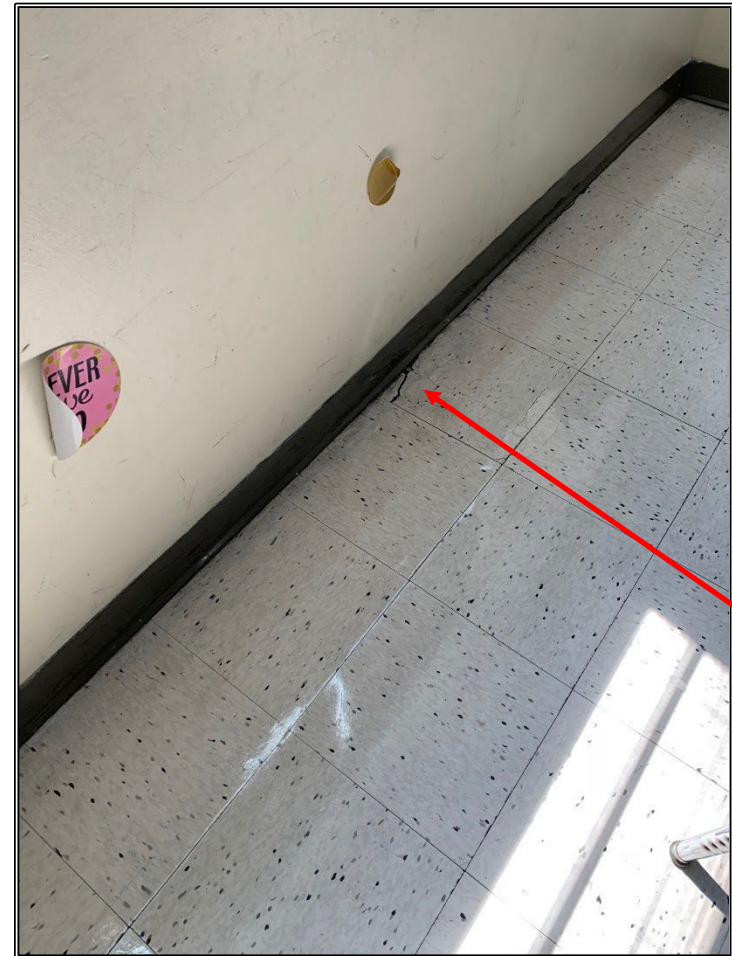
Photos 28 & 29
Damaged VAT in Classroom 207

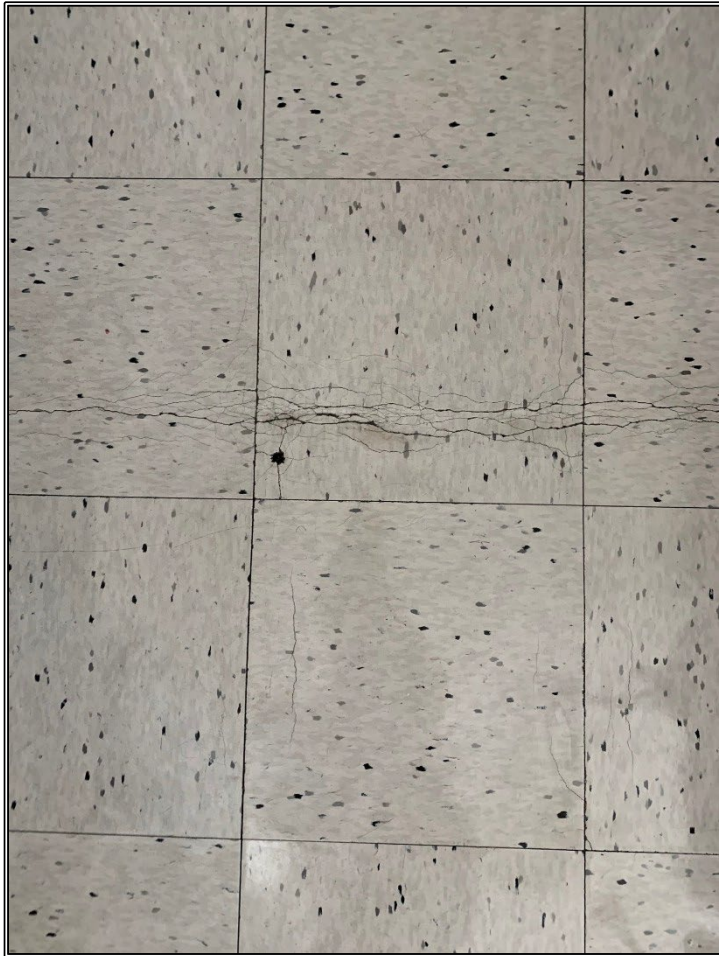
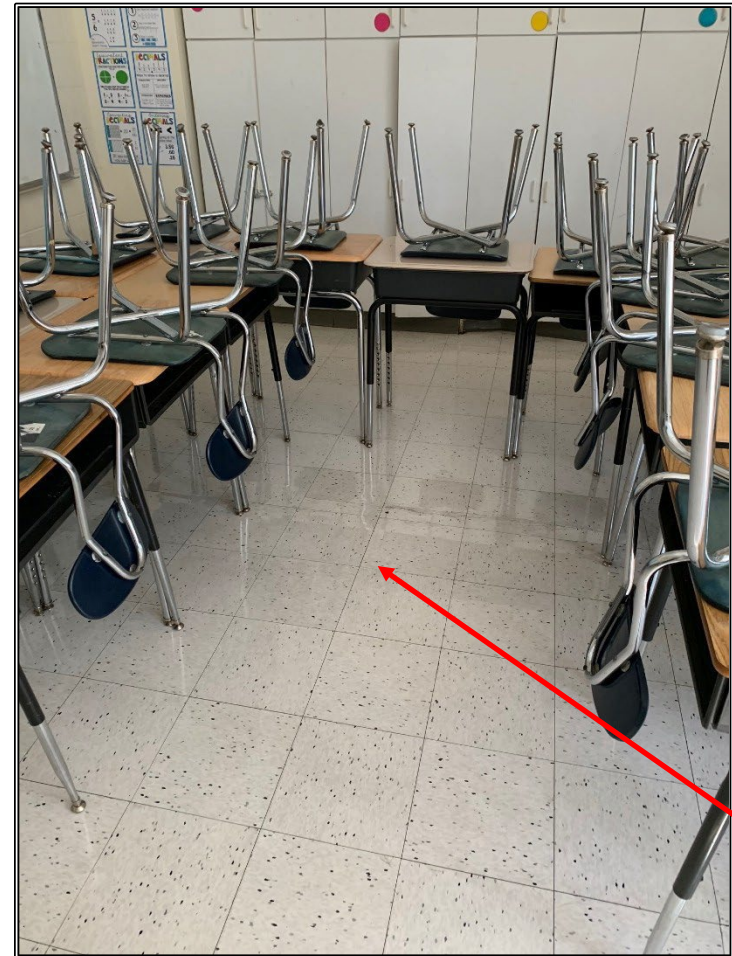
Photos 30 & 31
Damaged VAT in Classroom 207

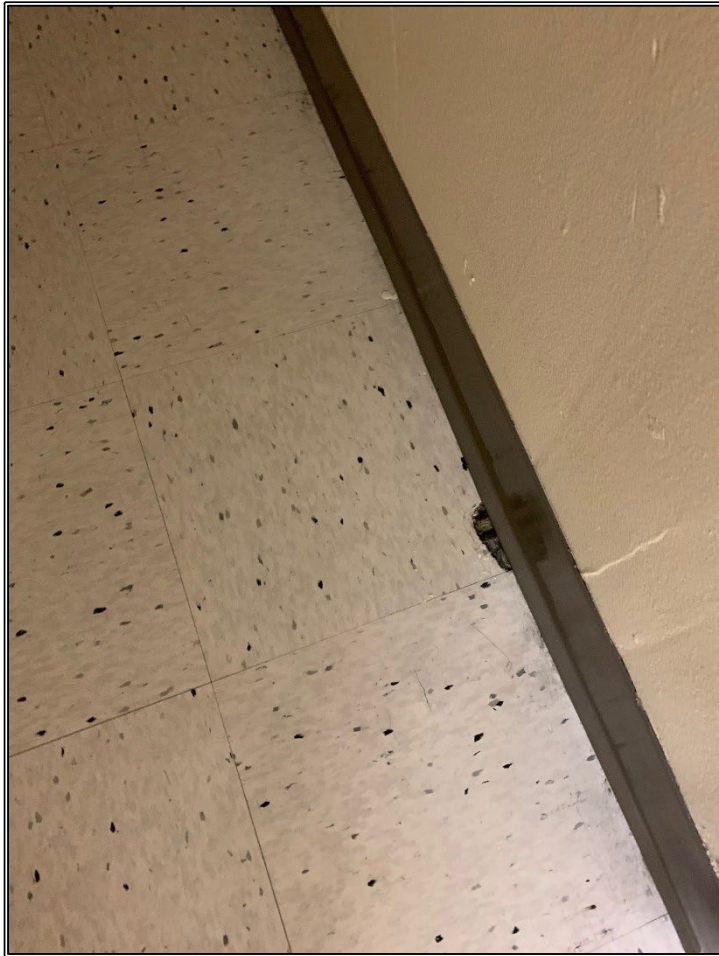
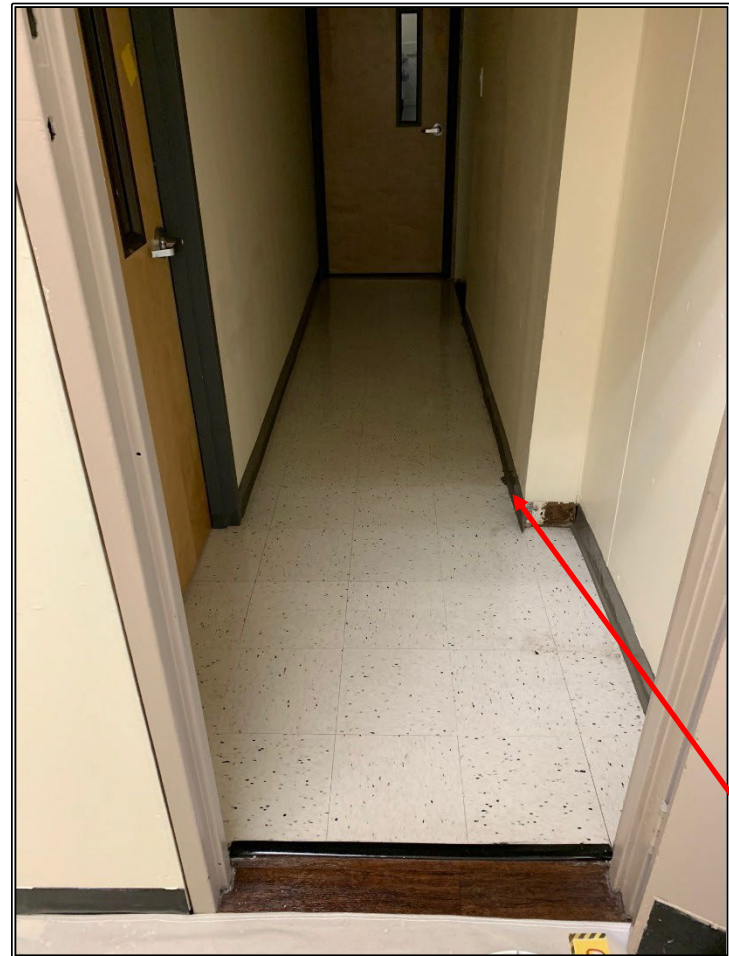
Photos 32 & 33
Damaged VAT in the Hallway in Room 209

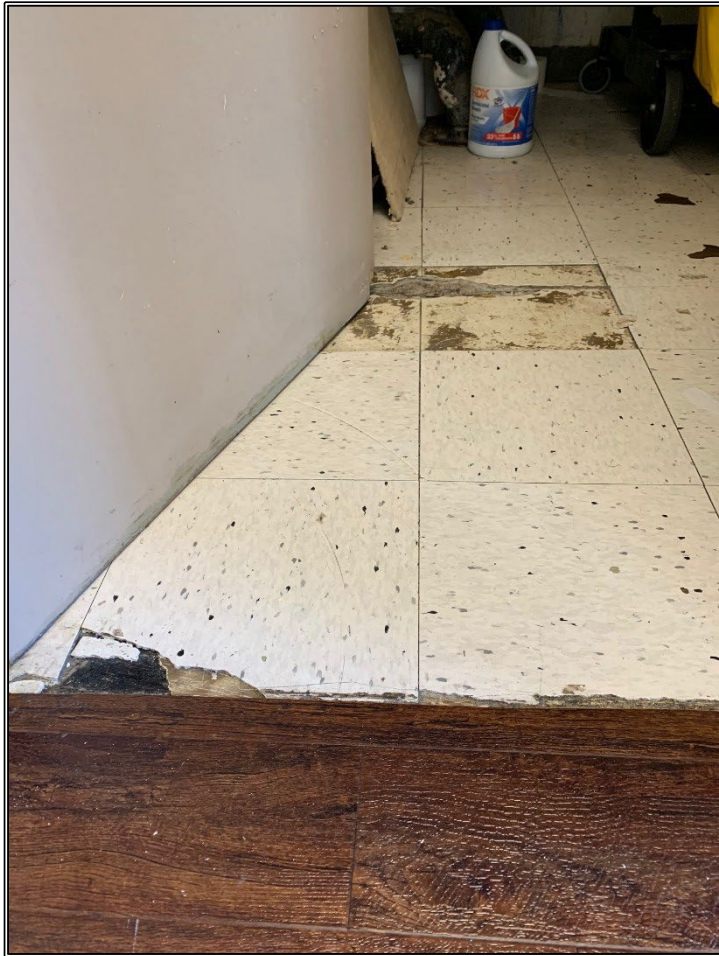
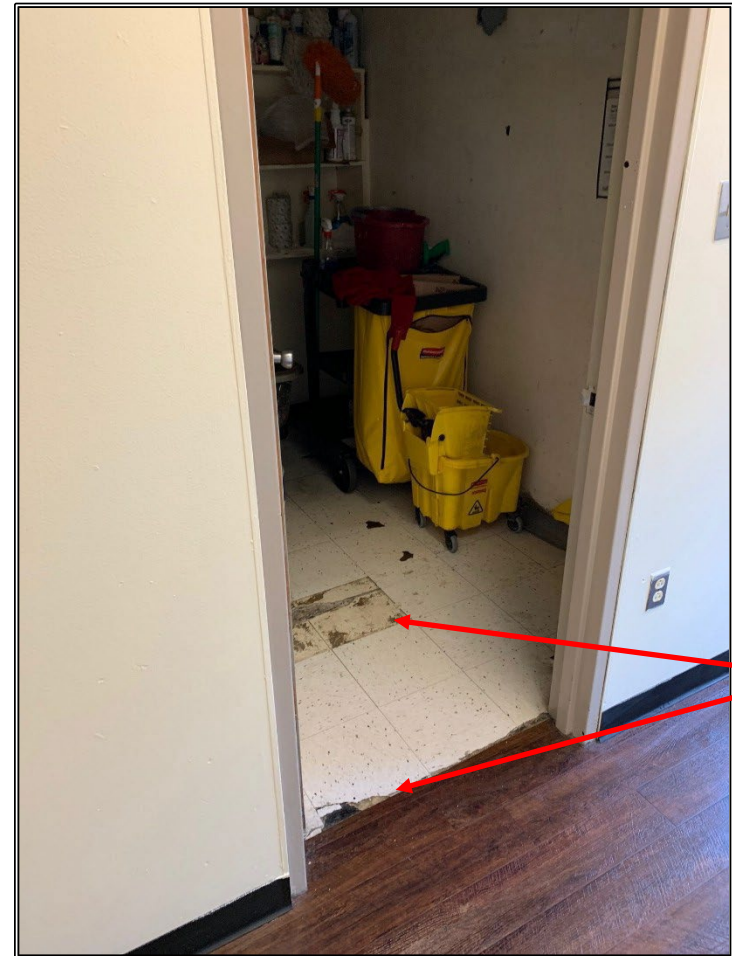
Custodial Closet adjacent to Classroom 208	6 SF	D	M	4	5

Photos 34 & 35
Damaged VAT in the Custodial Closet adjacent to Classroom 208

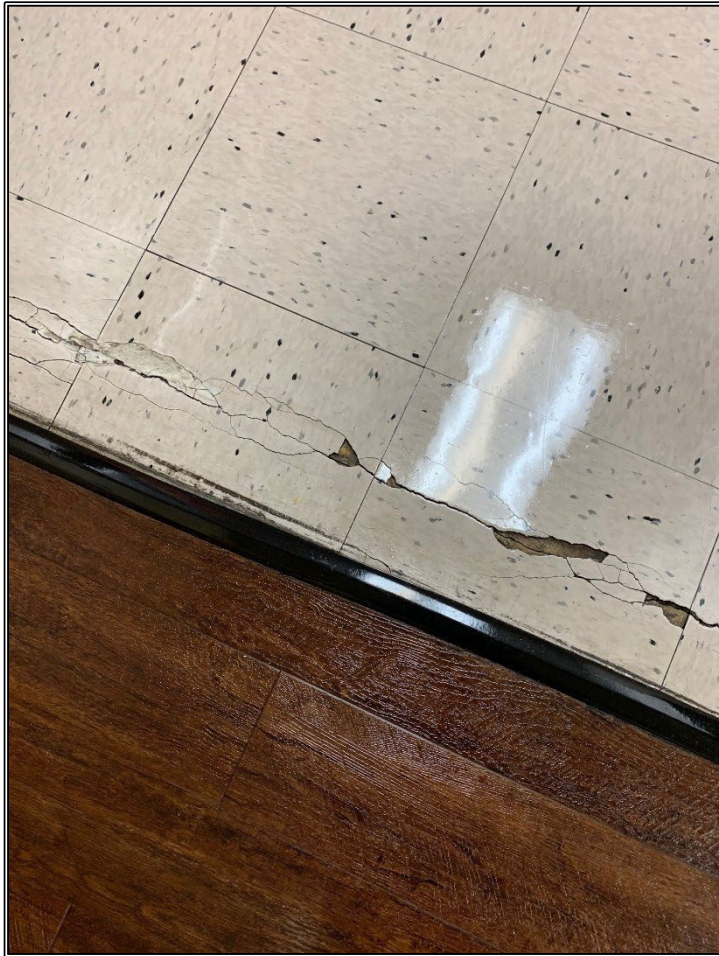
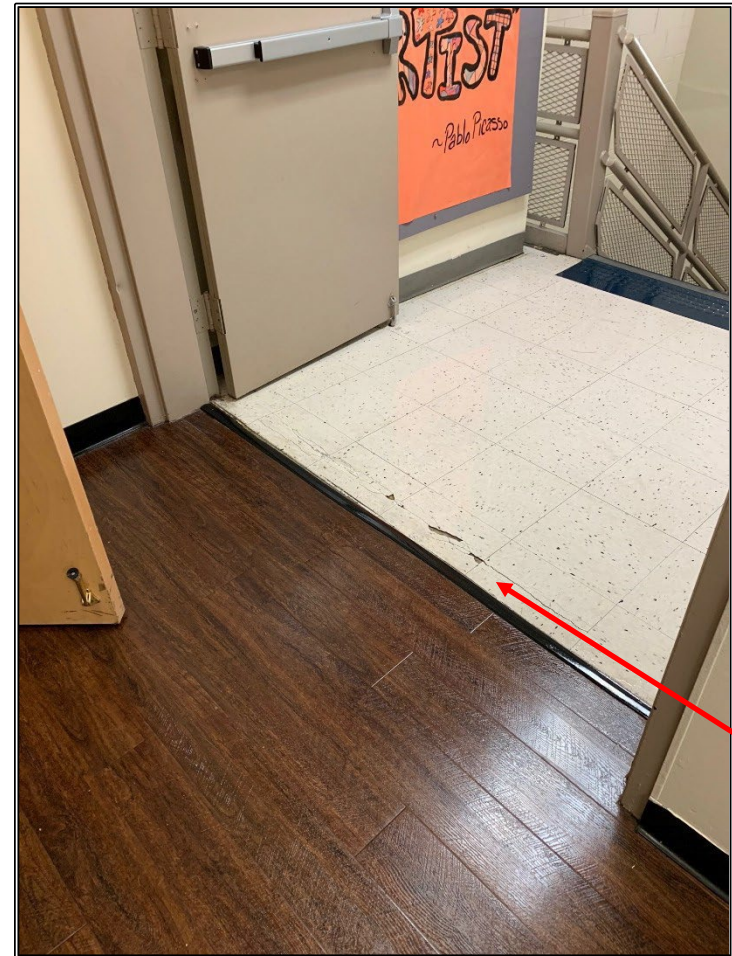
Photos 36 & 37
Damaged VAT in the North Stairwell by Elevator (2nd Floor)
