Report for AHERA 6-Month Surveillance

2600 S. Broad Street

Synertech Environmental LLC Project No. 603-025

Project Name: Philadelphia Performing Arts Charter School: 2600 S. Broad Street

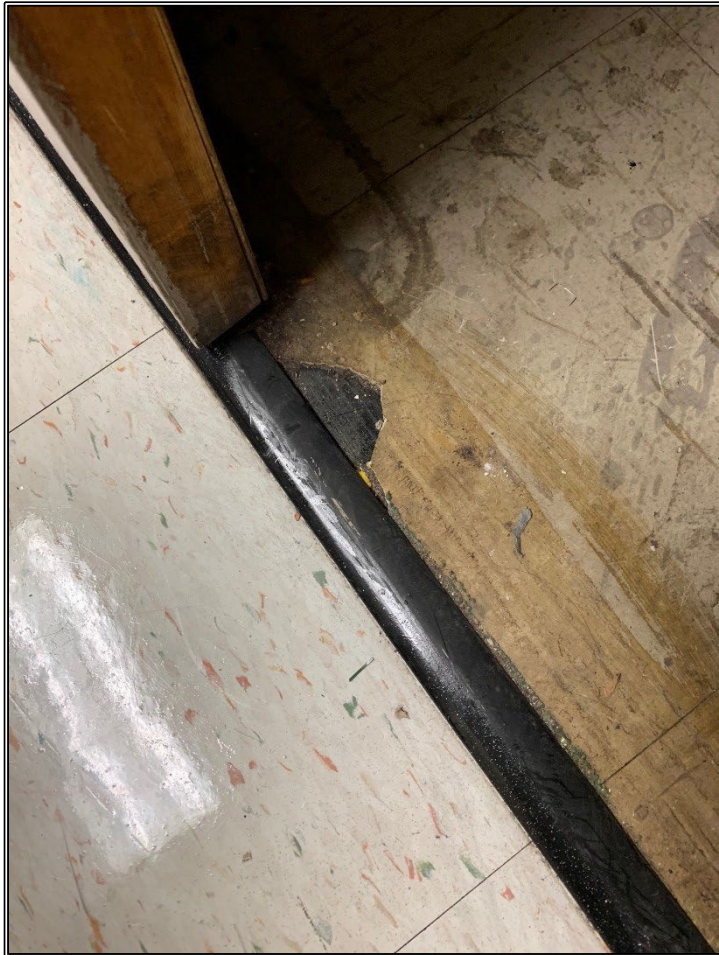
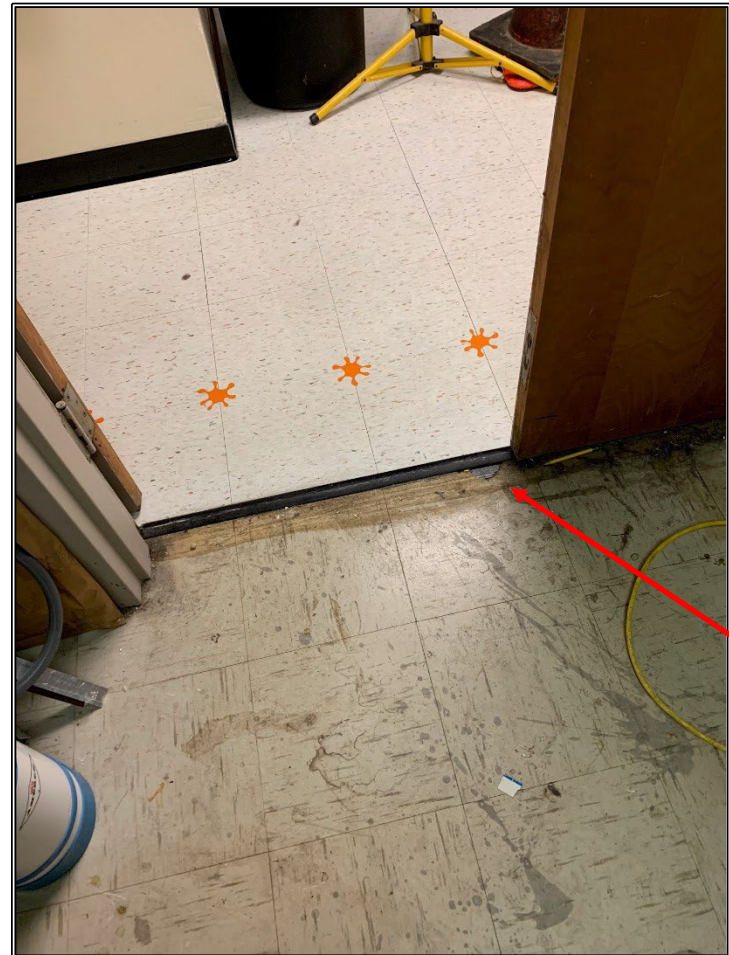
Photos 38 & 39
Damaged VAT in the Basement Electrical Closet

The following table lists damaged ACM’s observed during this 6-Month Surveillance. *Synertech Environmental LLC* recommends the removal of the following ACM’s followed by their replacement with non- asbestos substitutes.

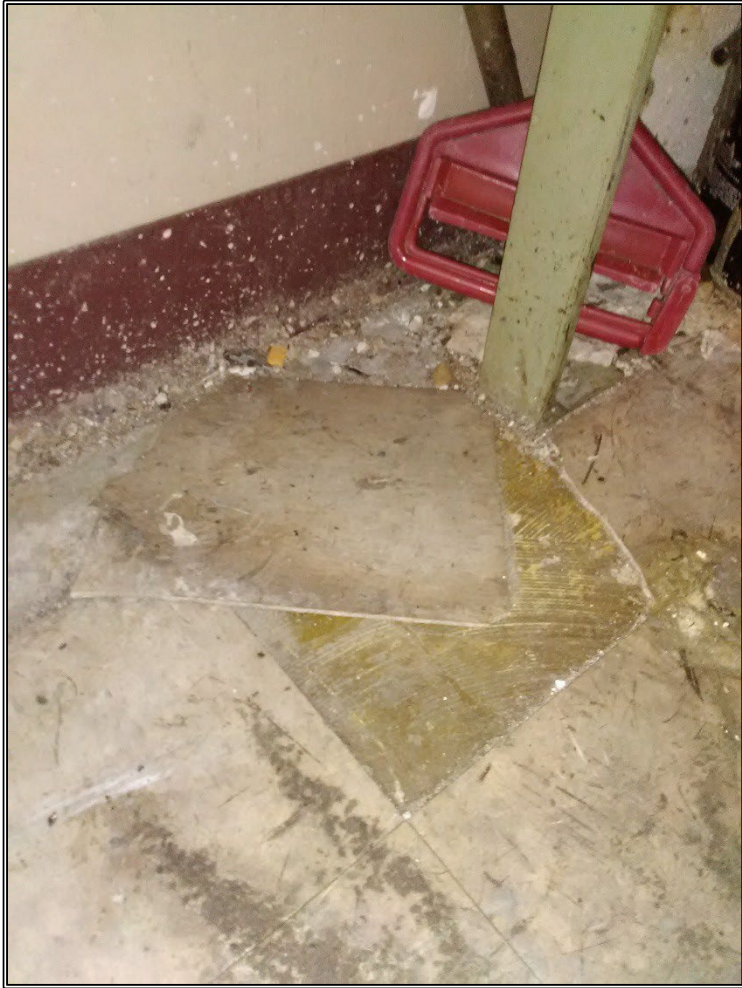
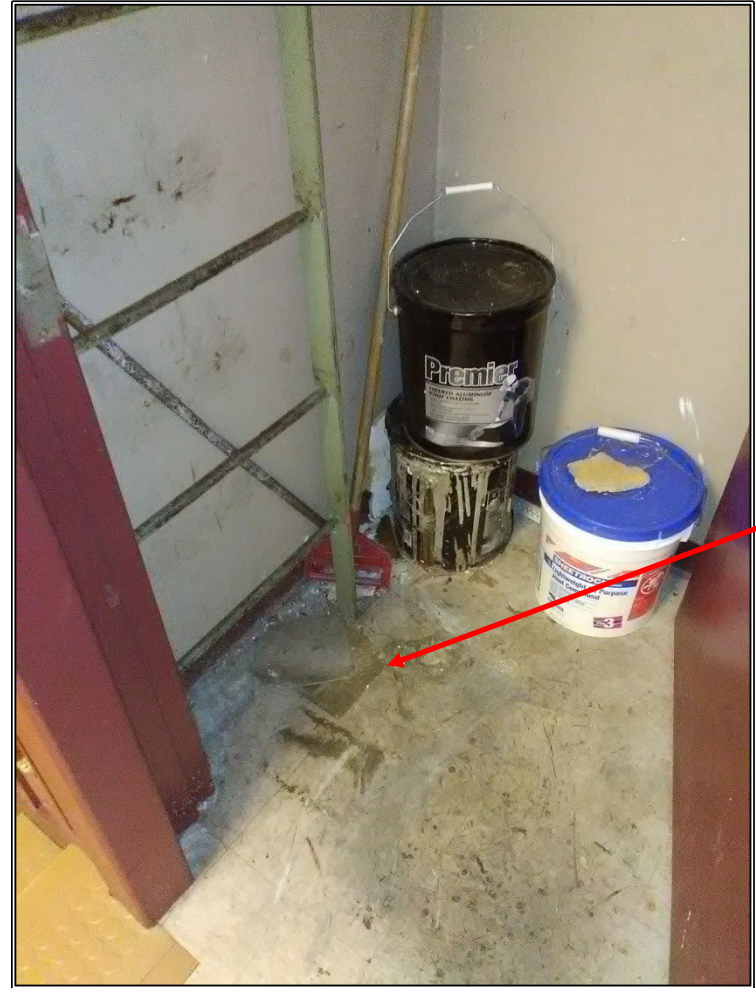
Photos 40 & 41
Damaged VAT at the Roof Access

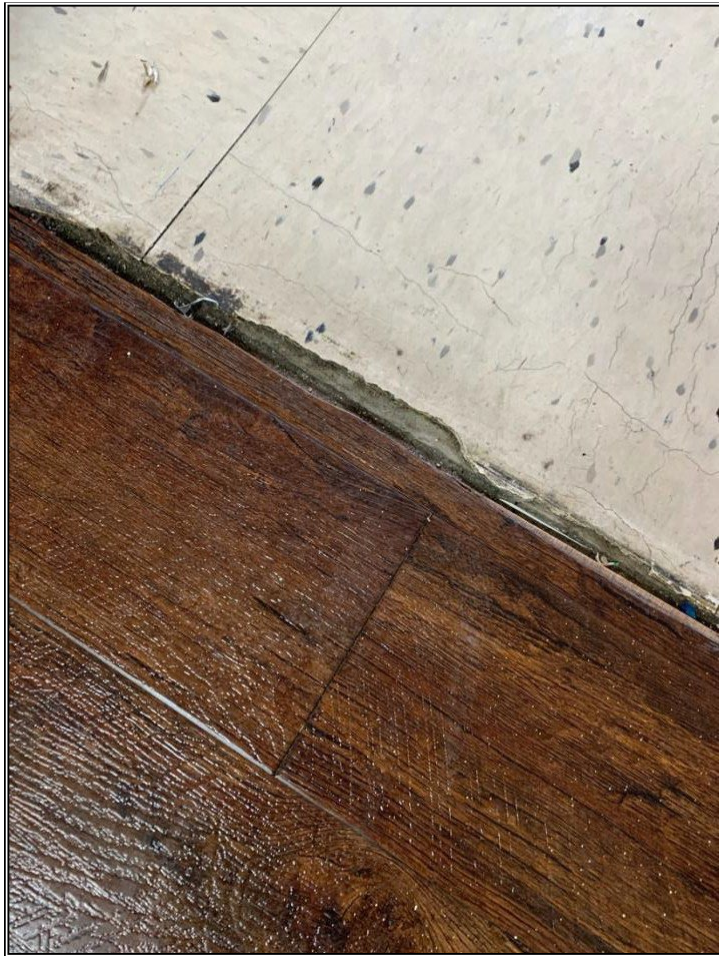
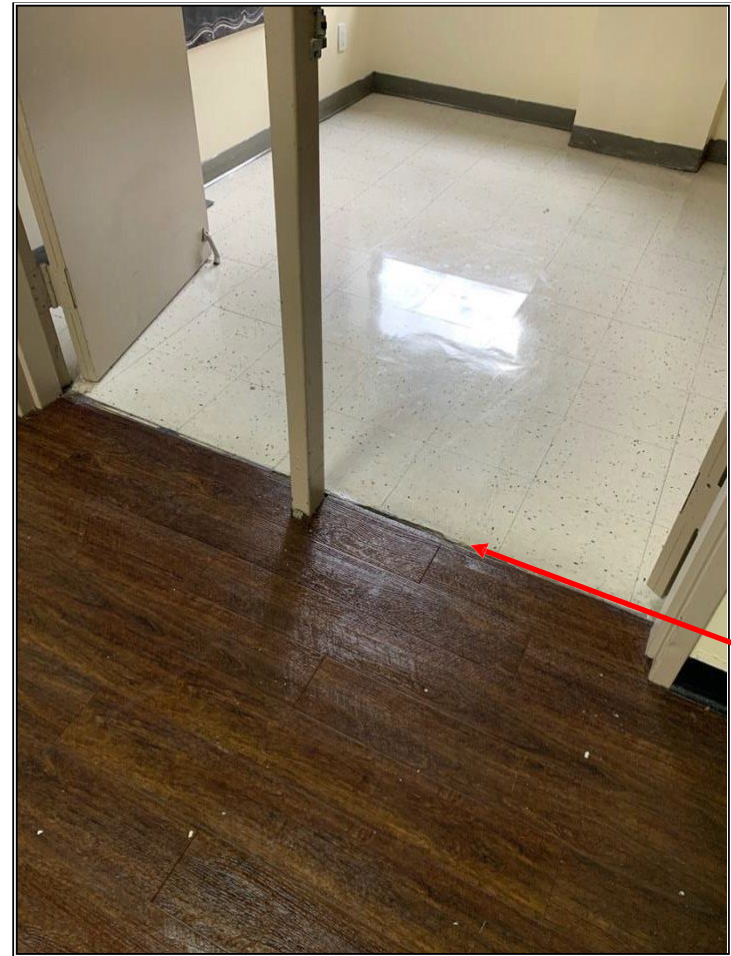
Photos 42 & 43
Damaged 12" x 12" Floor Tile in the 2nd Floor Center Stairwell

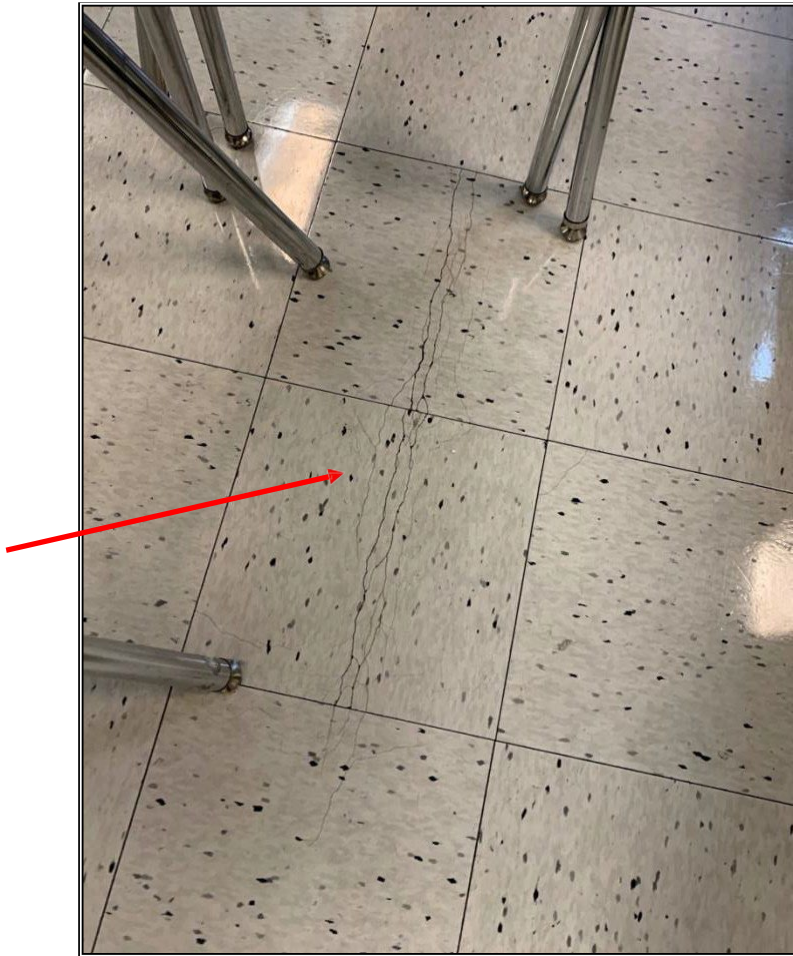
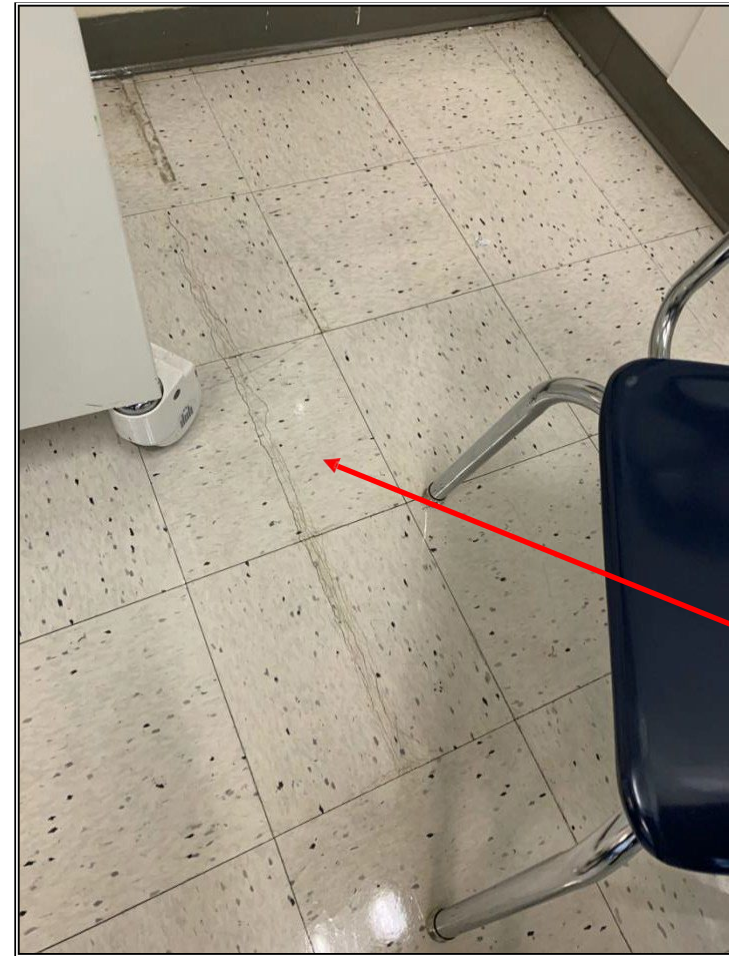
Photos 44 & 45
Damaged Floor Tile in Classroom 204
