RE: Jones Park Playground Safety Inspection

Jones Park Playground Inspection Asheville, NC

Jones Park Playground
544 Kimberly Ave
Asheville, NC 28804

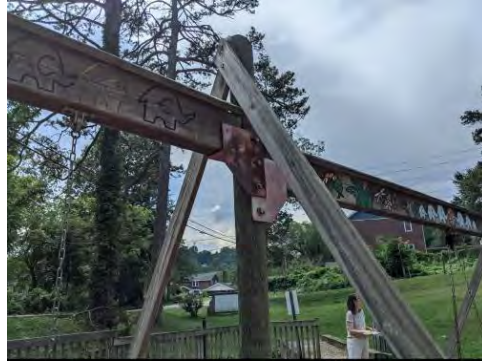
(18)

Comments _____
[Rusting Brackets](#)

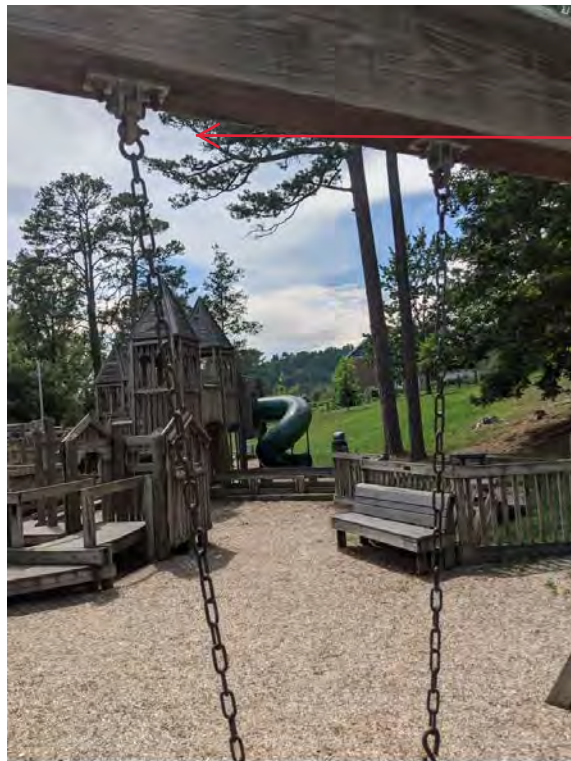
(48)

Rusting Bracket

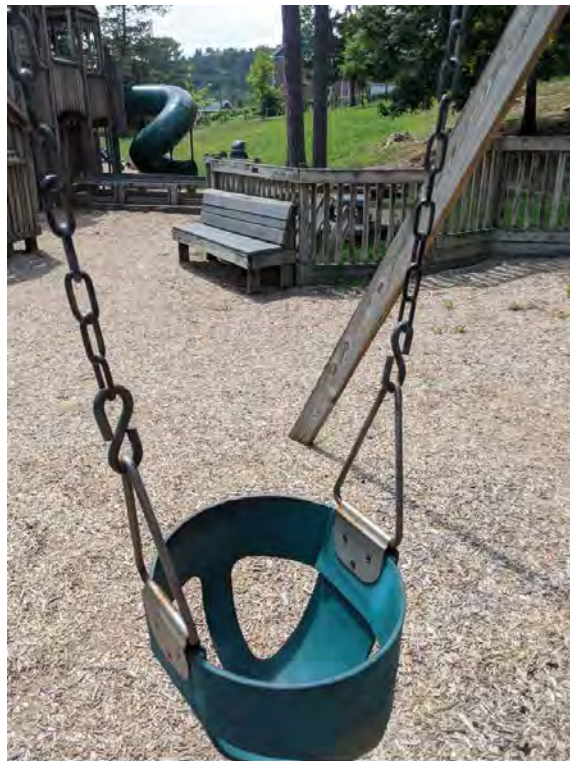
(50)

Tot Swing Chains Are Rusting

Open S-Hooks

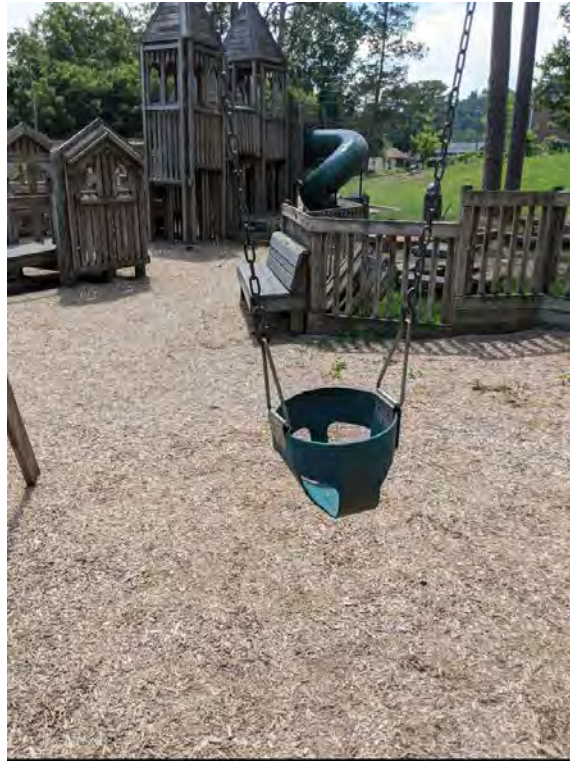
(53)

Rusting Hardware

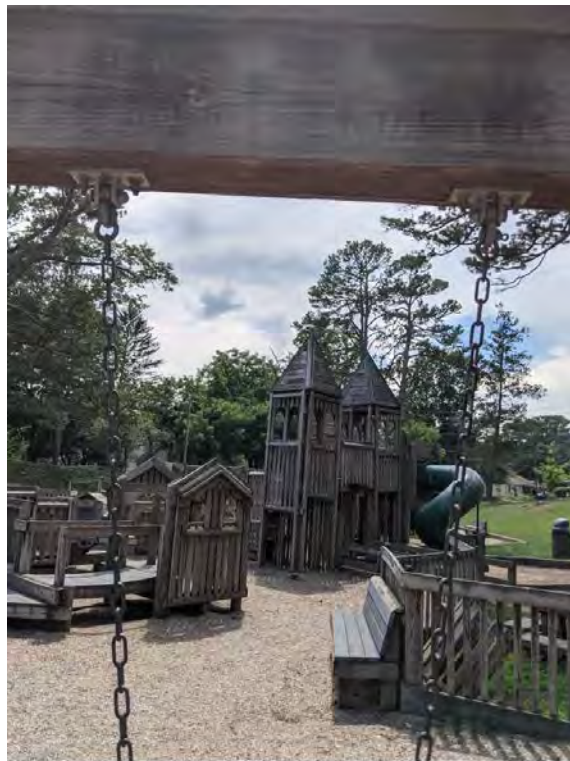
(54)

**Tot Swing Has Rusting Chains
and Open S-Hooks**

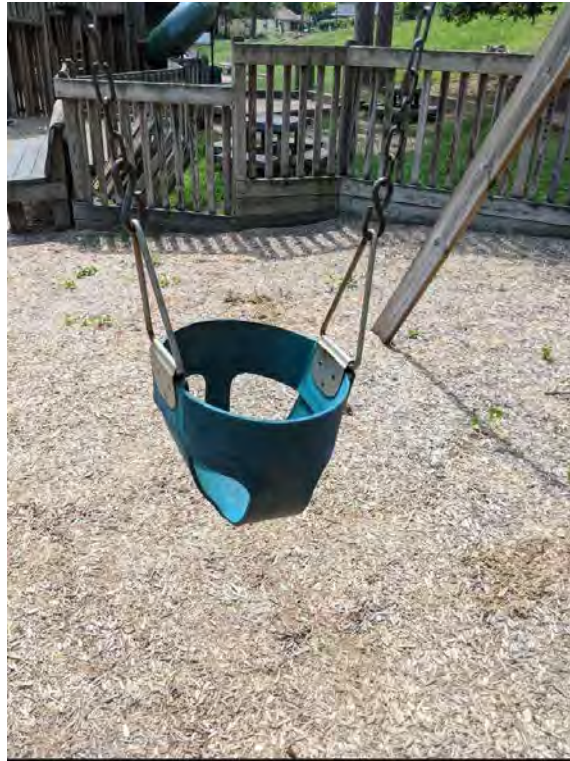
(55)

**Tot Swing Has Rusting Chains
and Open S-Hooks**

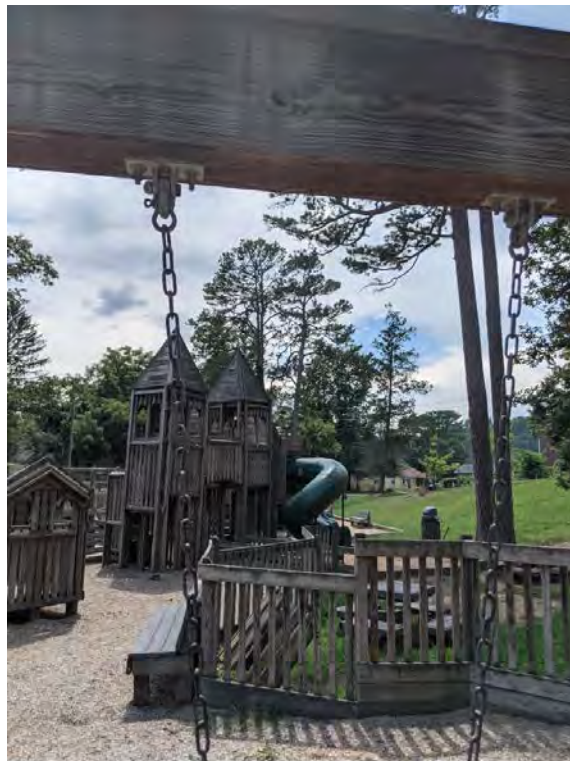
(56)

**Tot Swing Has Rusting Chains
and Open S-Hooks**

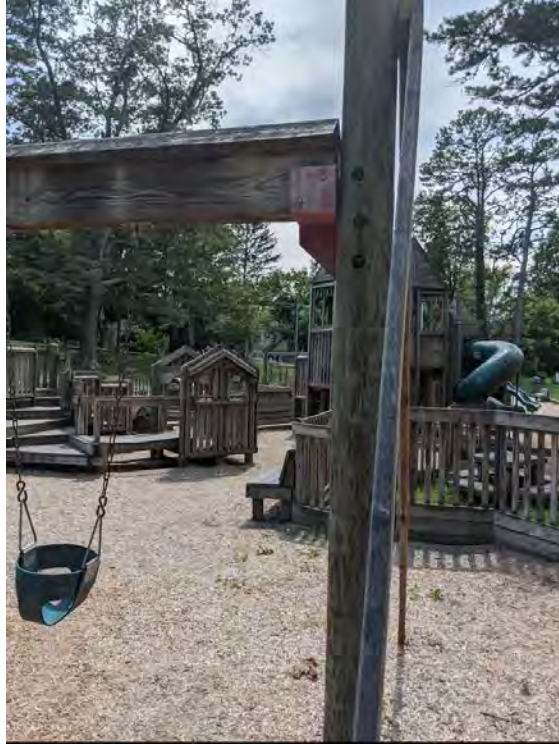
(57)

**Tot Swing Has Rusting Chains
and Open S-Hooks**

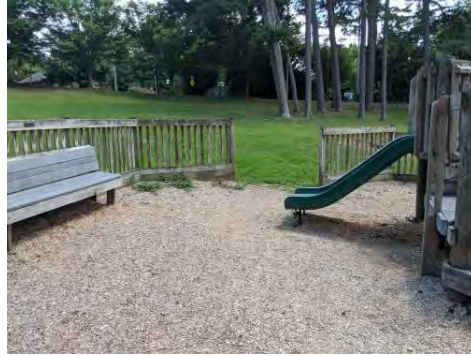
(64)

Bench Has Cracks

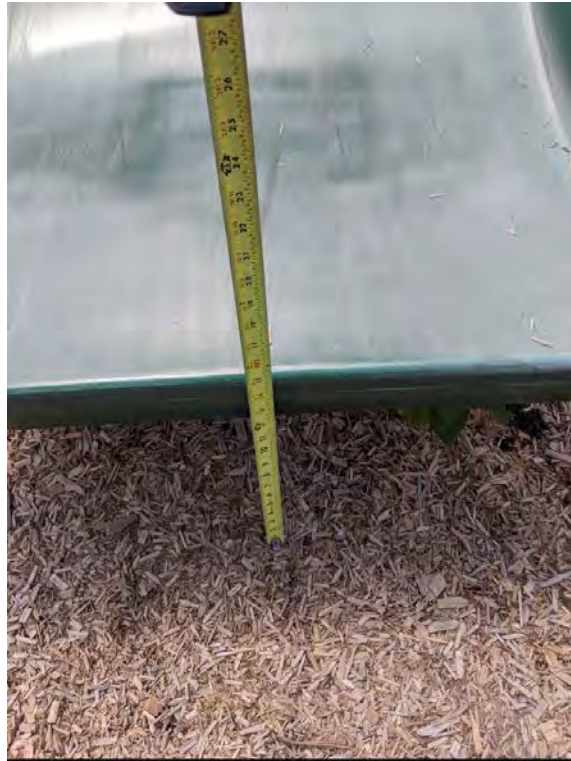
(67)

Straight Slide Is Fading

Shows Signs of UV Failure

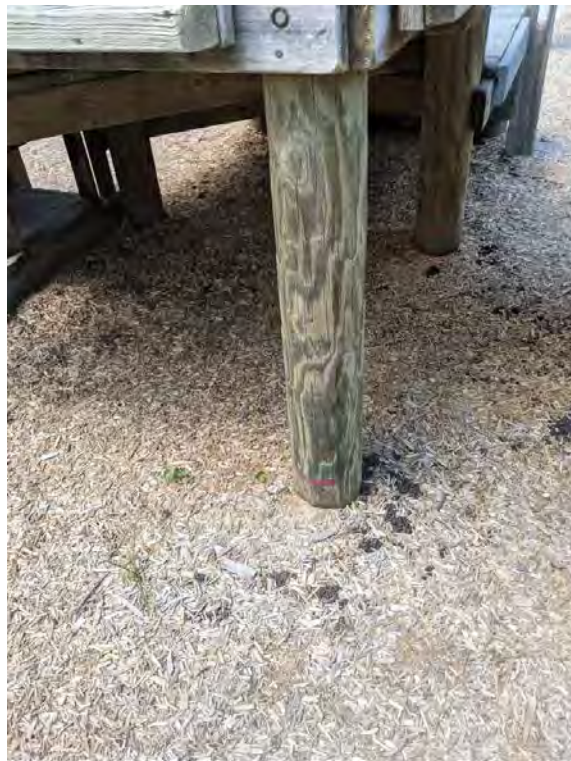
(70)

Comments Multiple Cracks in Wood

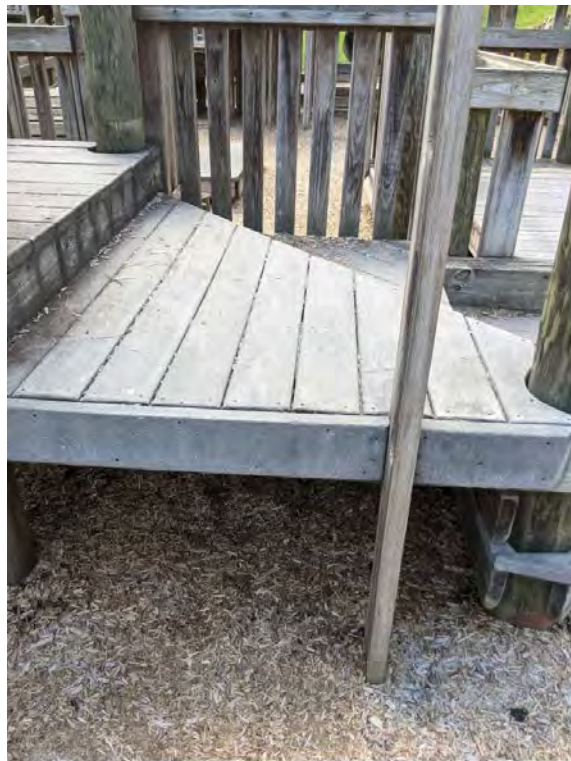
(74)

Connecting Bridge

Multiple Cracks

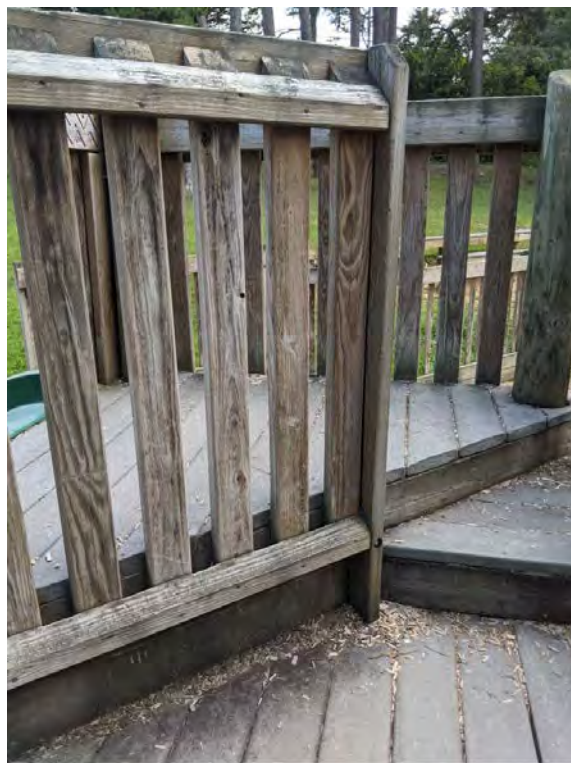
(82)

[Post Has Cracks](#)

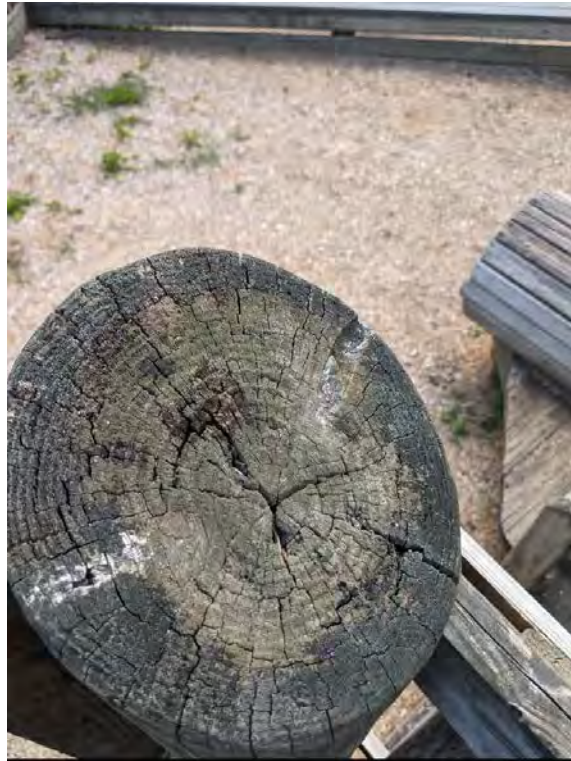
(83)

[More Cracks in Wood](#)

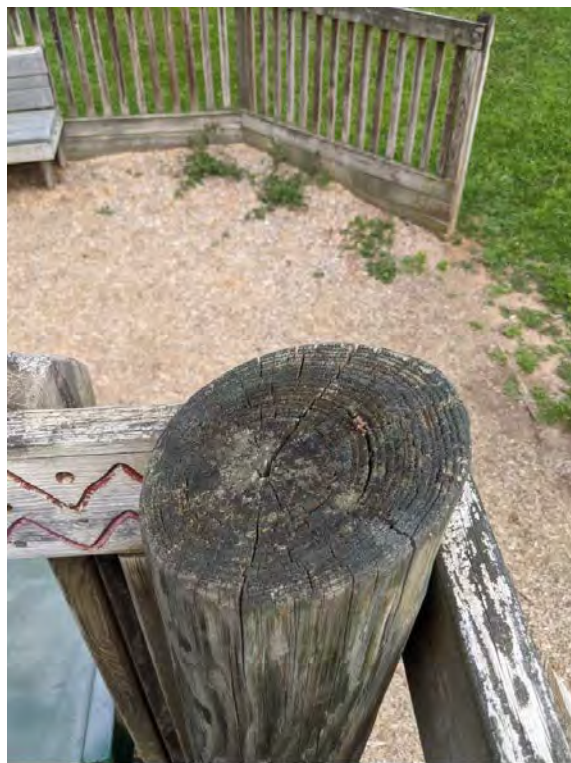
(84)

Post Has Top Rot and Splits

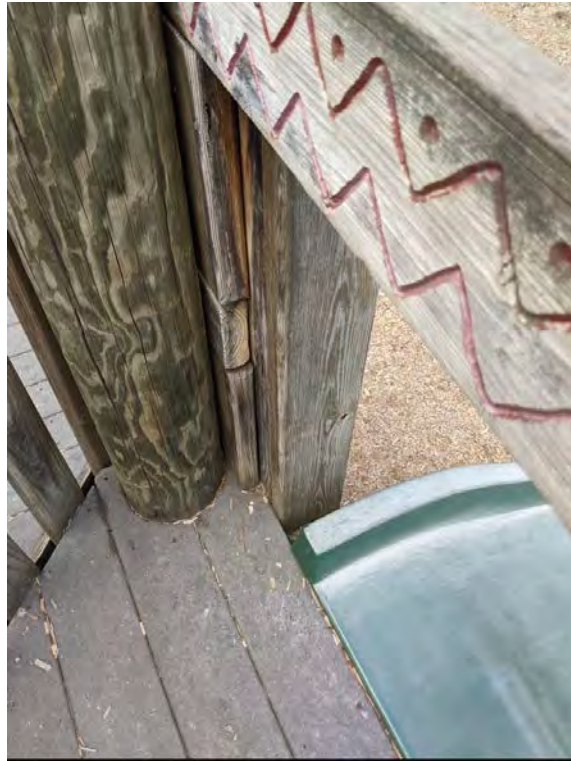
(87)

Post Has Top Rot and Splits

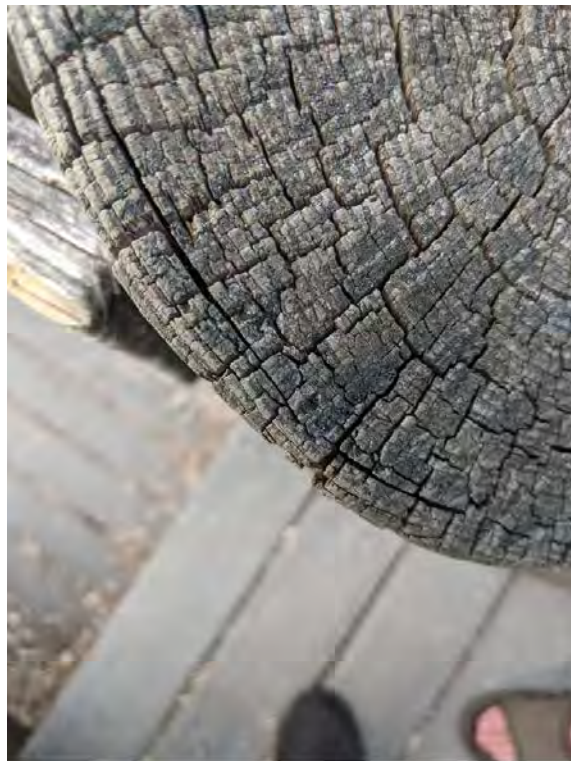
(88)

Cracks in Posts

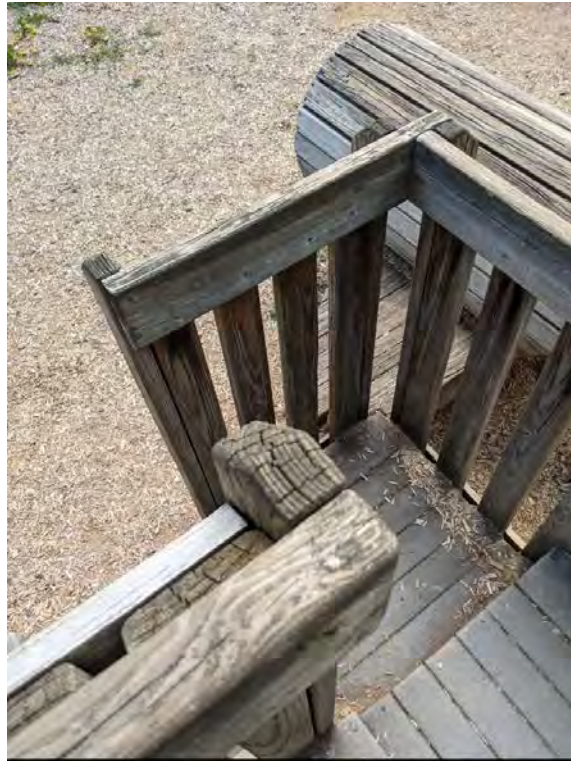
(89)

Multiple Cracks in Post

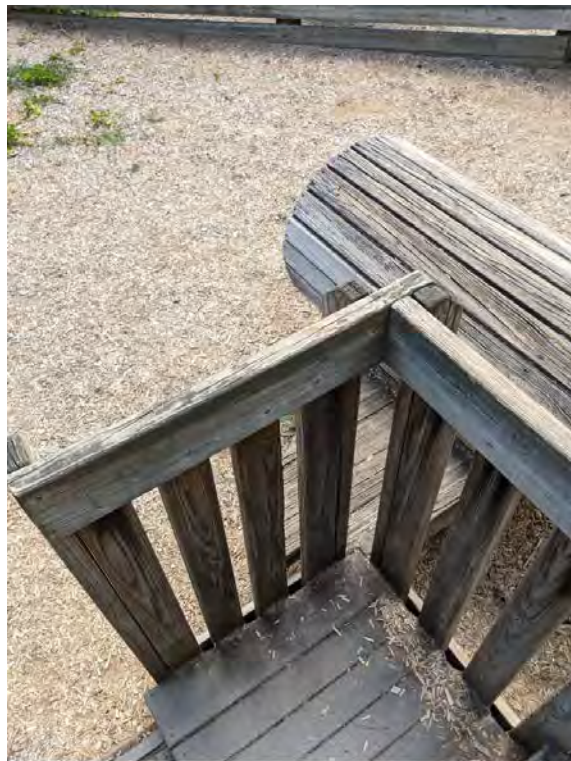
(90)

Comments Multiple Cracks in Wood

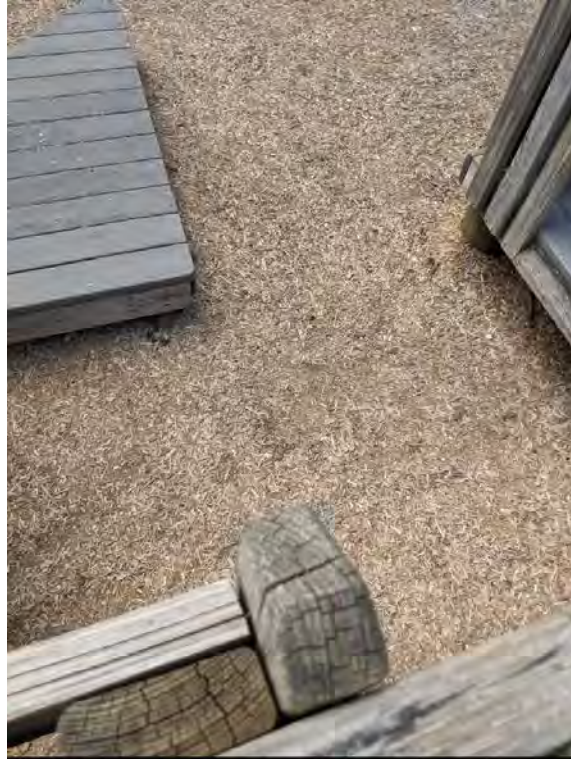
(91)

Comments Multiple Cracks in Wood

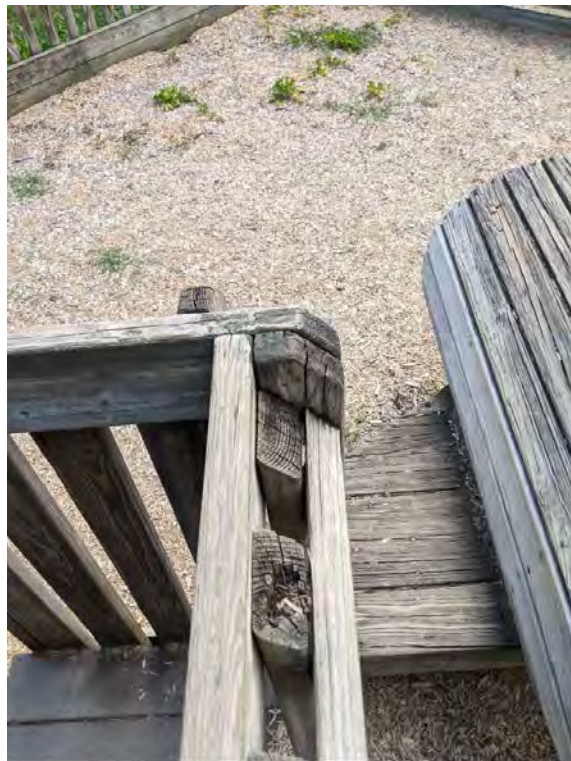
(92)

Multiple Cracks in Wood

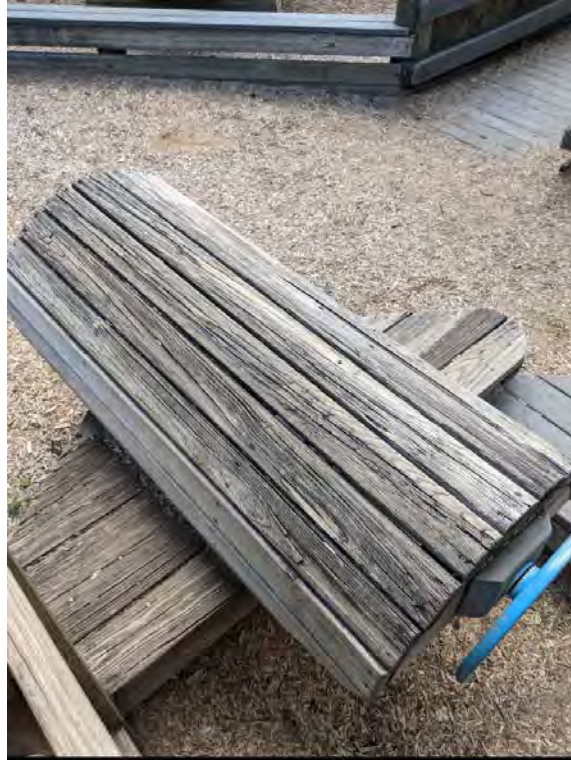
(93)

Multiple Cracks in Wood

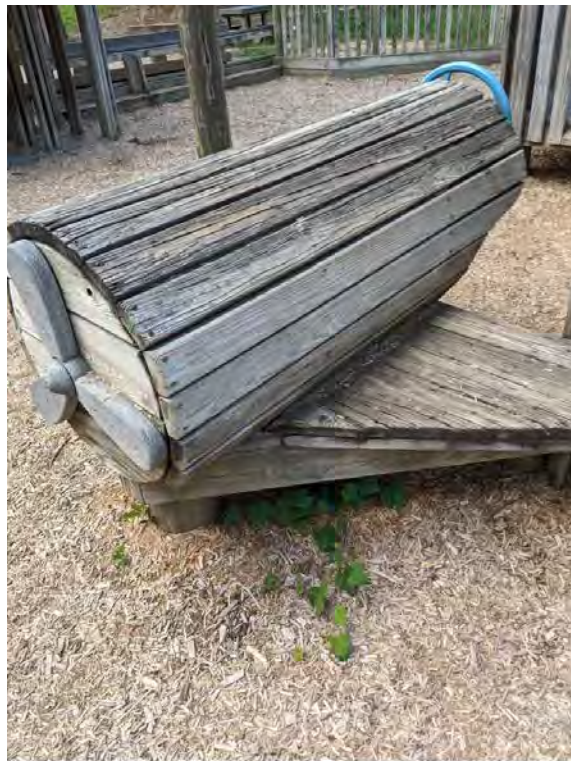
(94)

[Multiple Cracks in Wood](#)

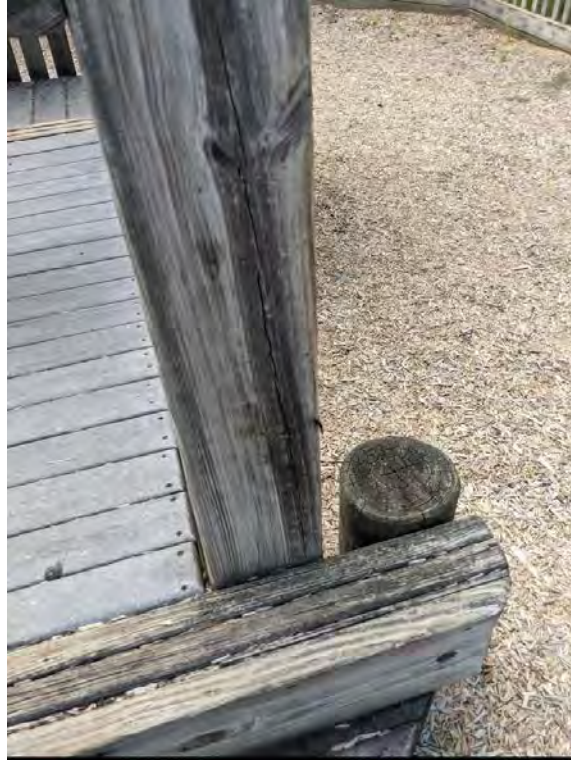
(95)

[Multiple Cracks in Wood](#)

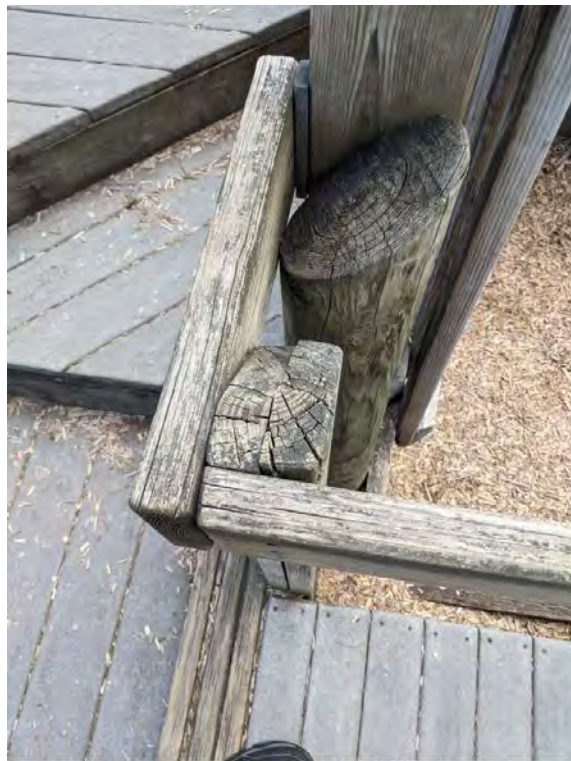
(96)

Multiple Cracks in Wood

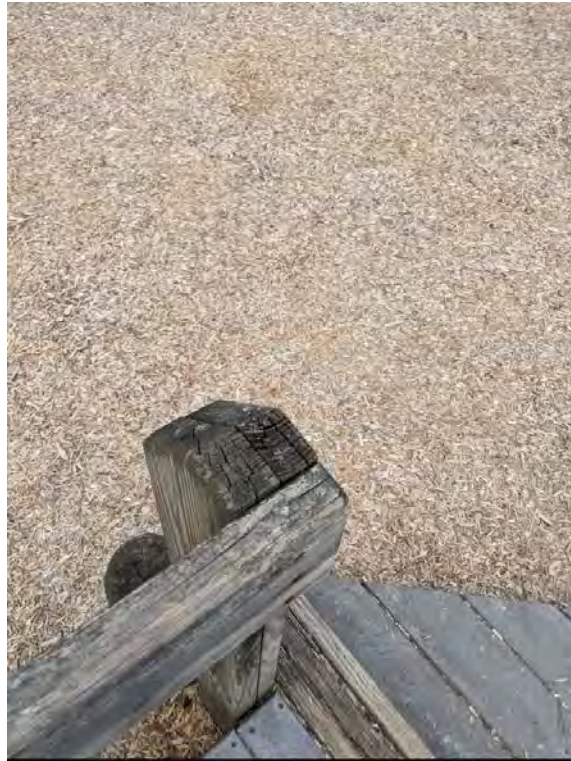
(99)

Multiple Cracks in Wood

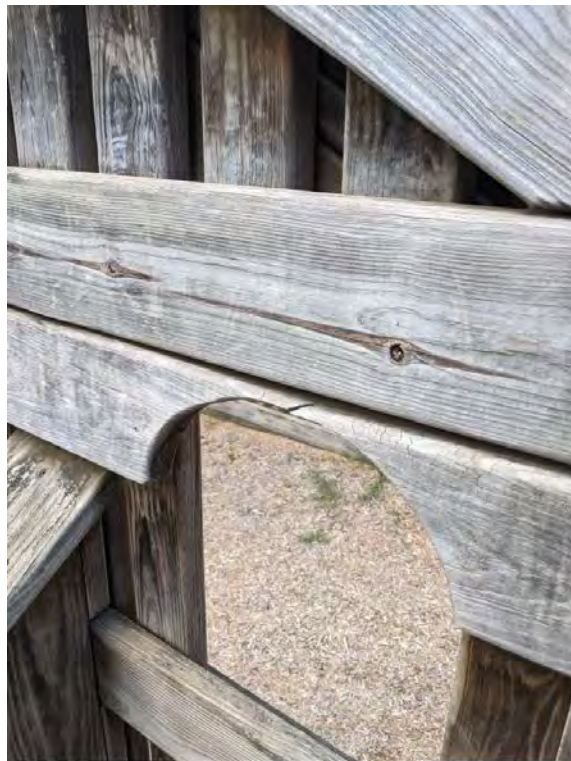
(100)

Multiple Cracks in Wood

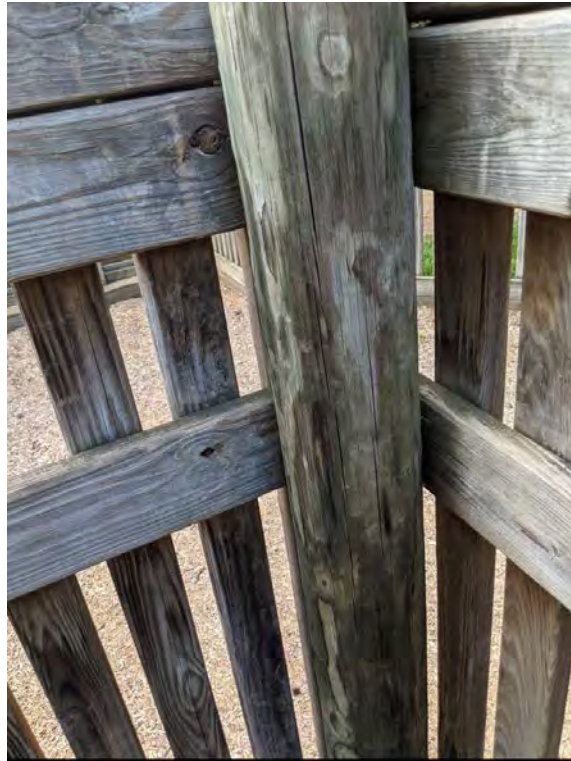
(103)

Multiple Cracks in Wood

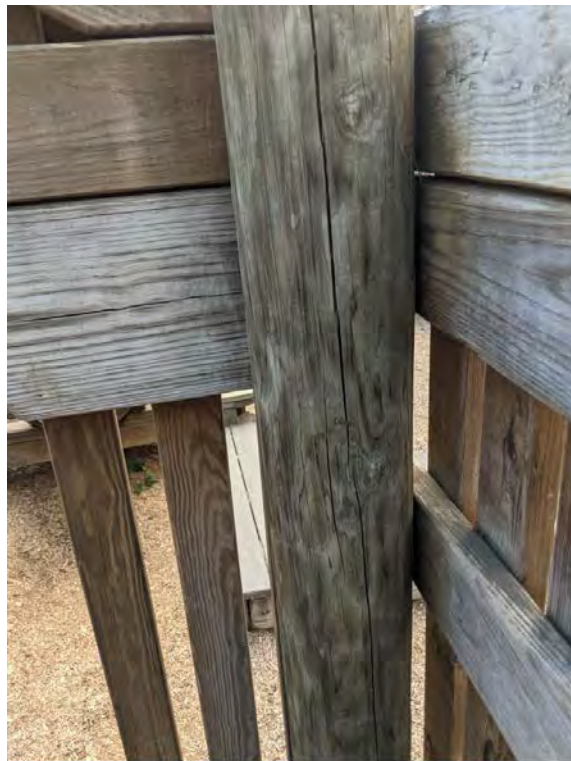
(104)

Multiple Cracks in Post

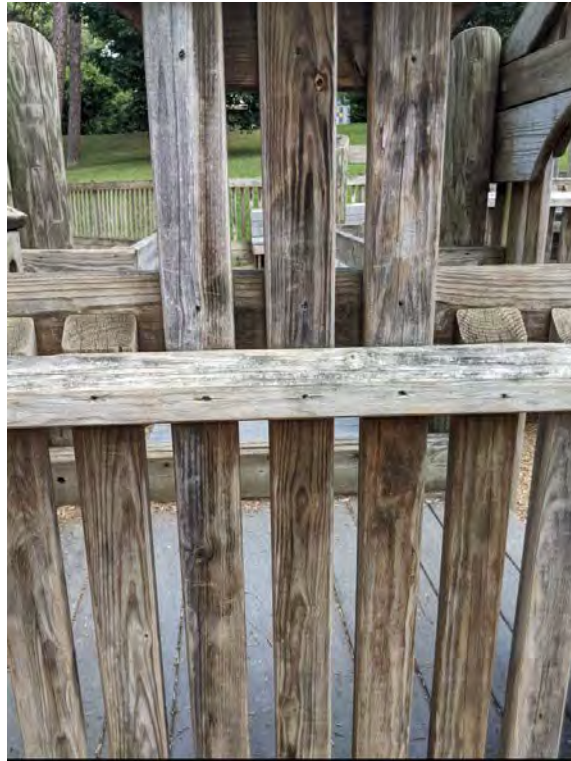
(105)

Multiple Cracks in Post

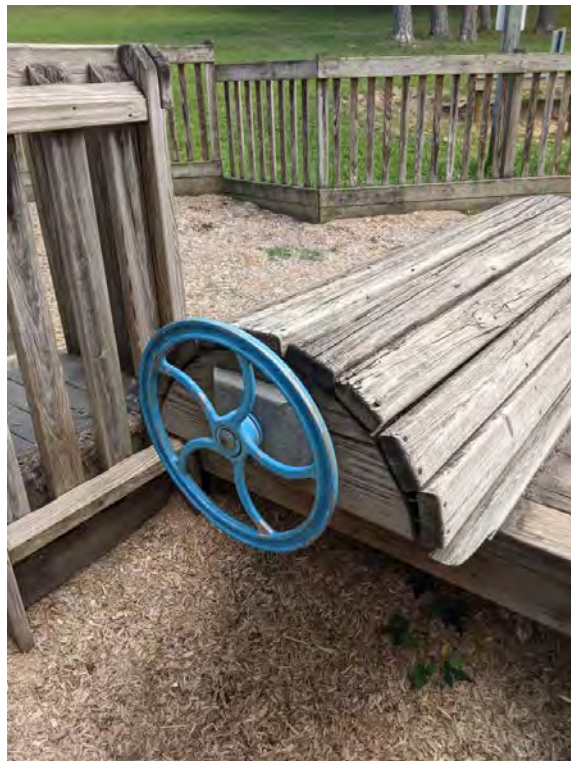
(106)

Multiple Cracks in Wood

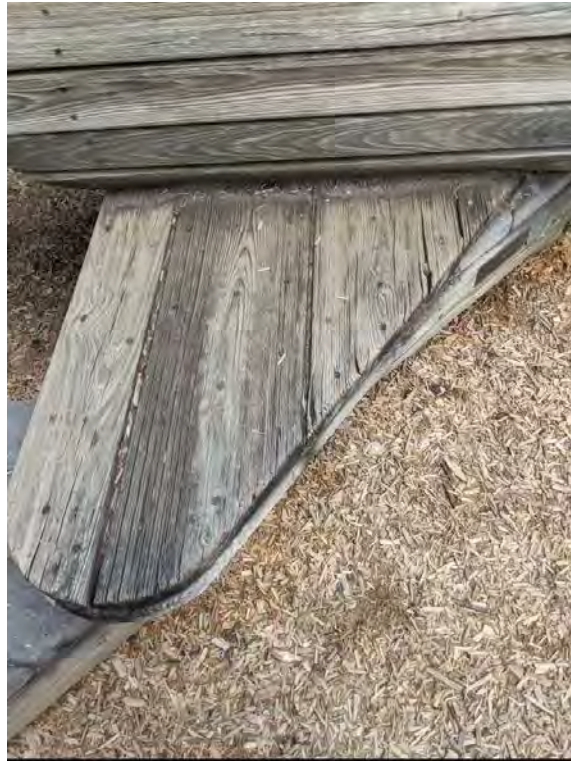
(113)

Comments Cracks In Wood

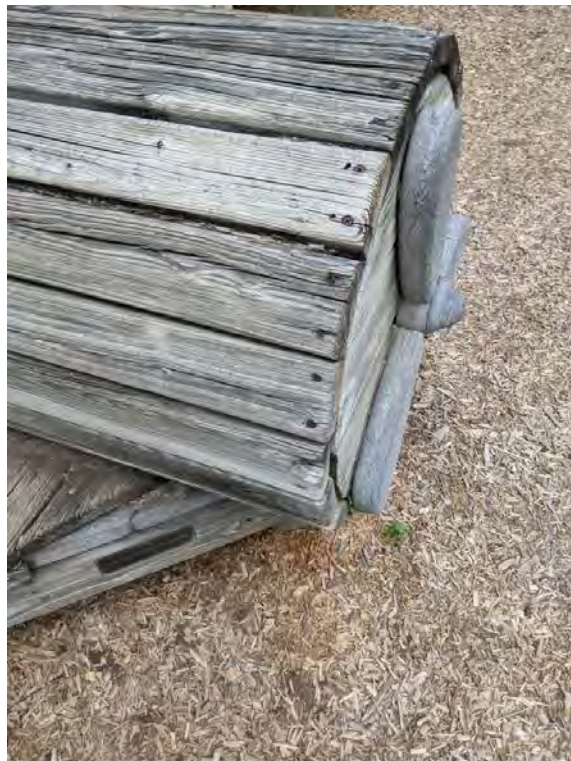
(114)

Comments Cracks in Wood

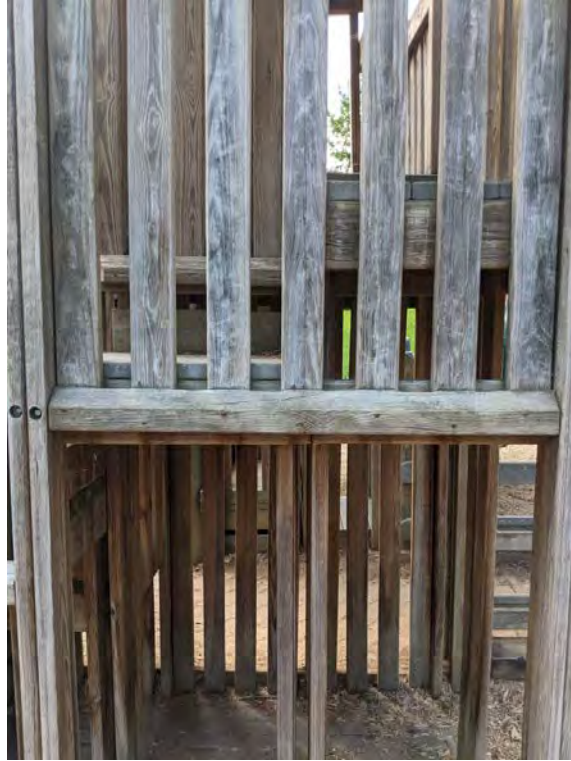
(119)

Cracks in Wood

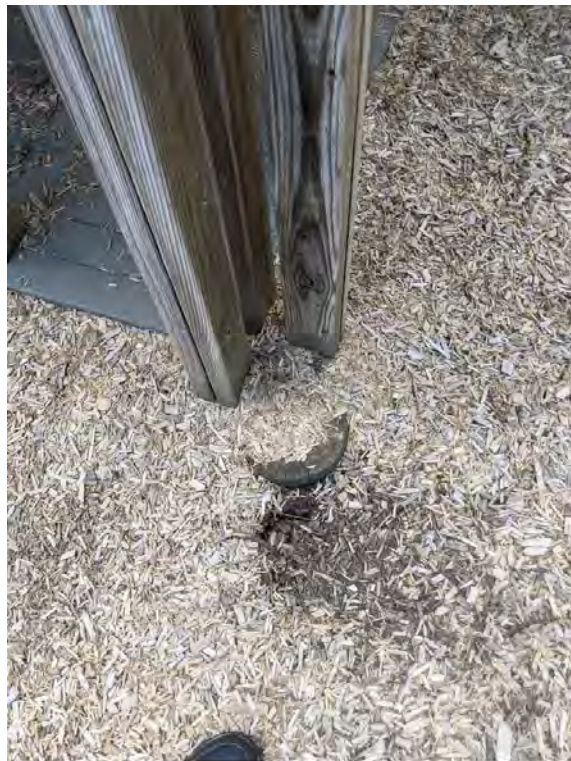
(120)

Cracks in Wood

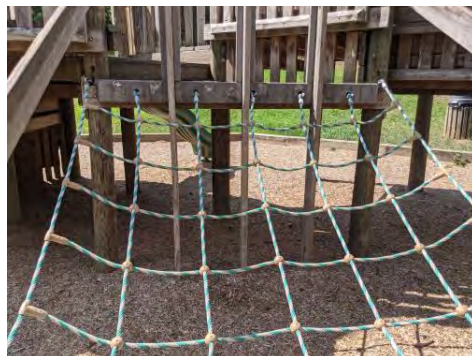
(3)

Comments [Net Climber](#)
[Connections and Ropes Are Deteriorating](#)

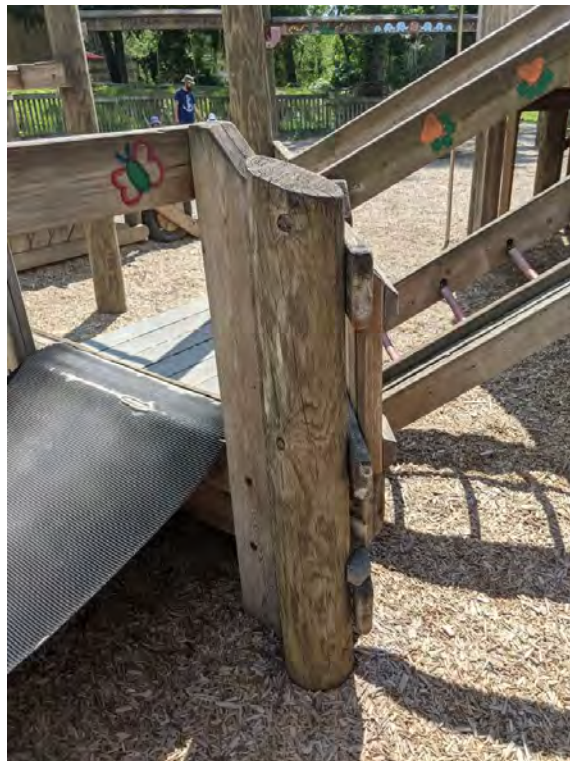
(17)

Cracks and Splinters

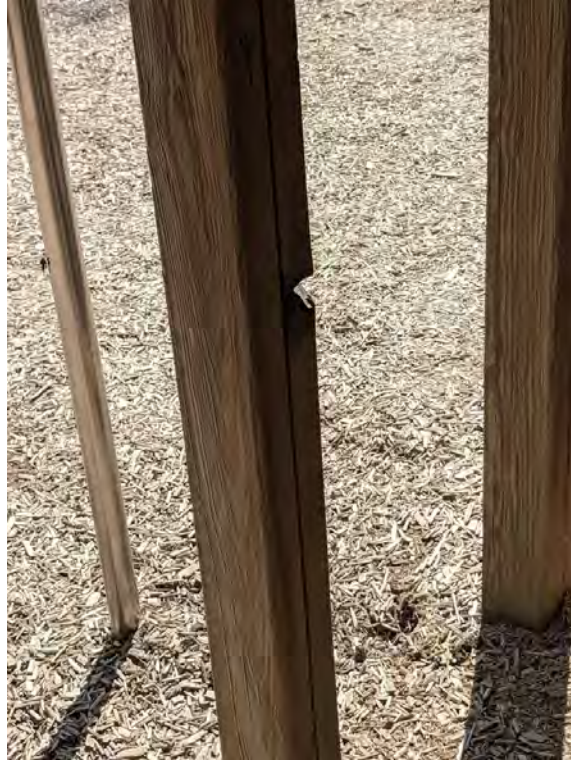
(20)

Cracks

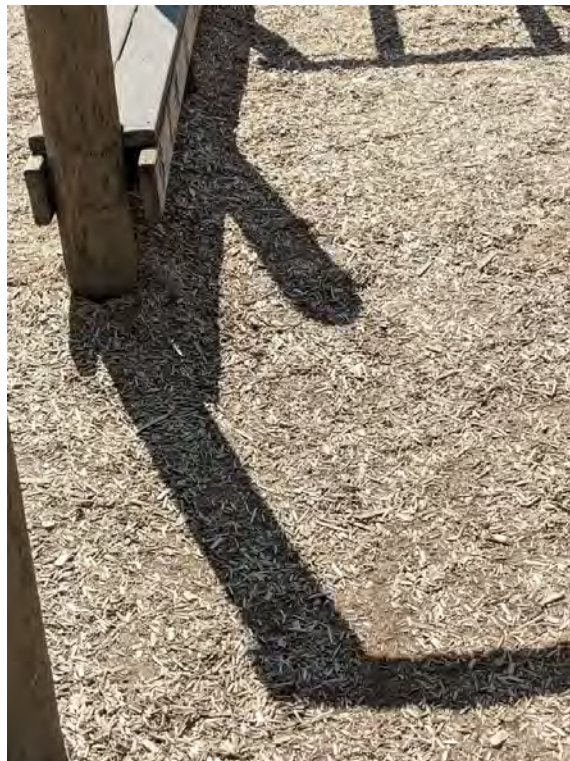
(25)

Multiple Cracks

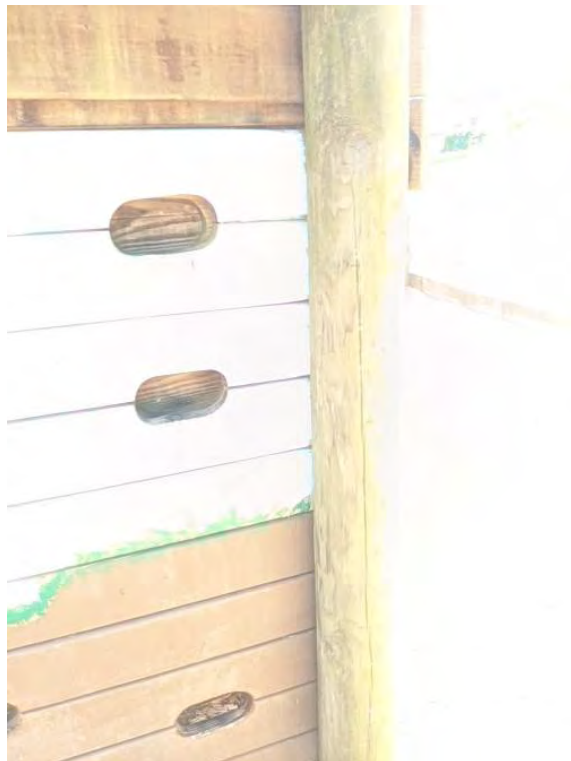
(37)

Small Cracks in Post

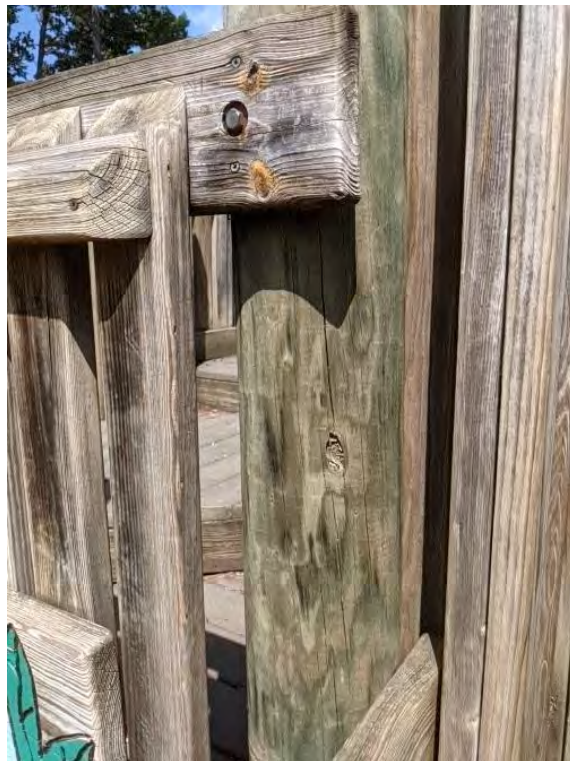
(39)

Cracks

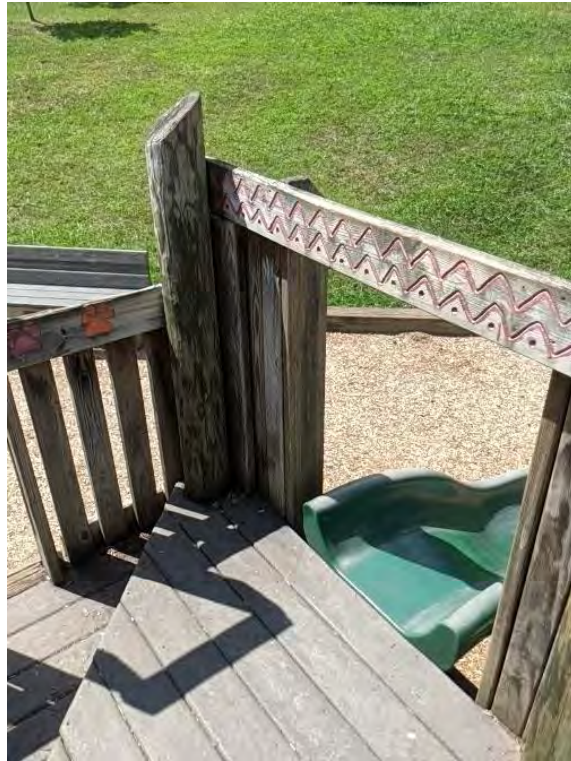
(40)

Cracks

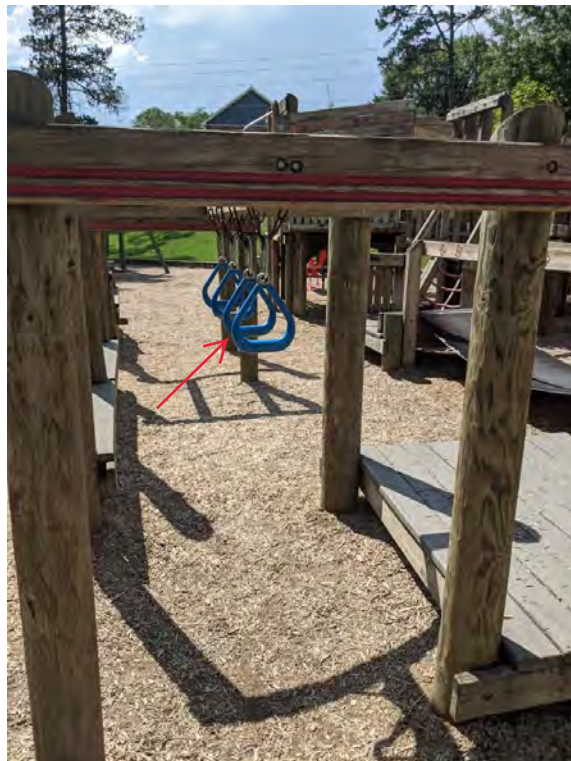
(41)

Multiple Cracks

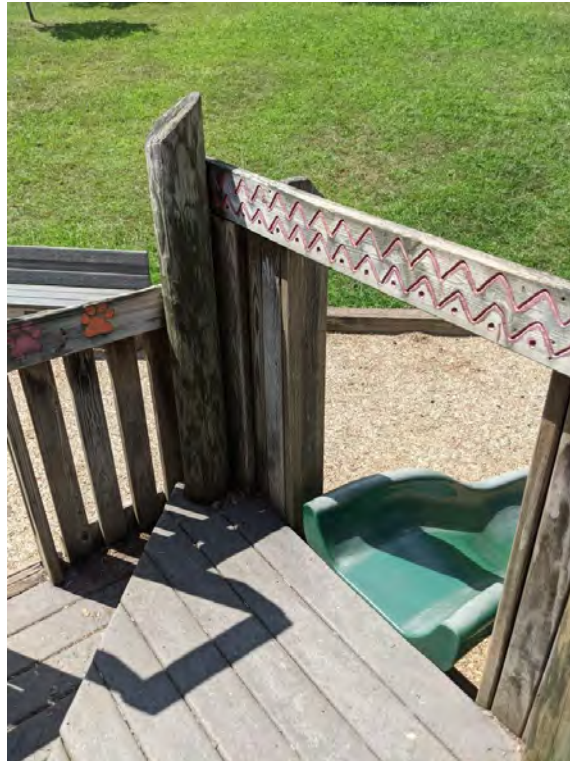
(47)

Slide Support Bracket is Missing a Bolt

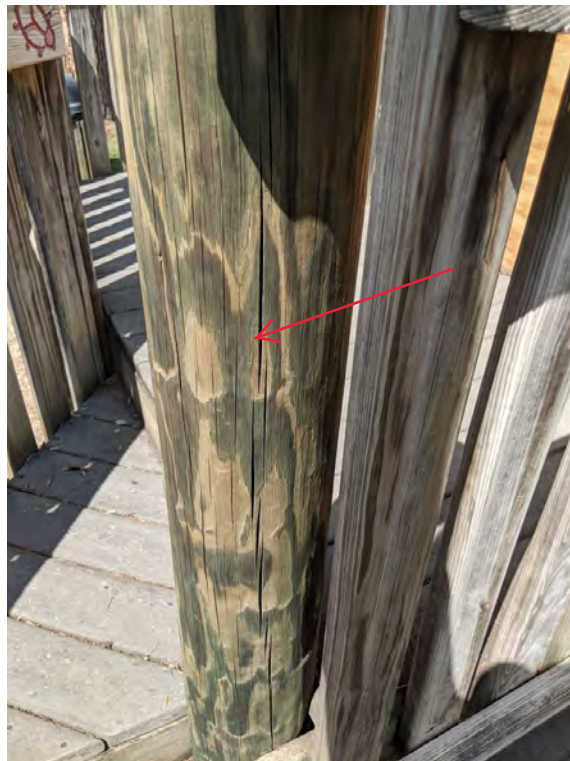
(54)

Comments Post Top Is Cracking

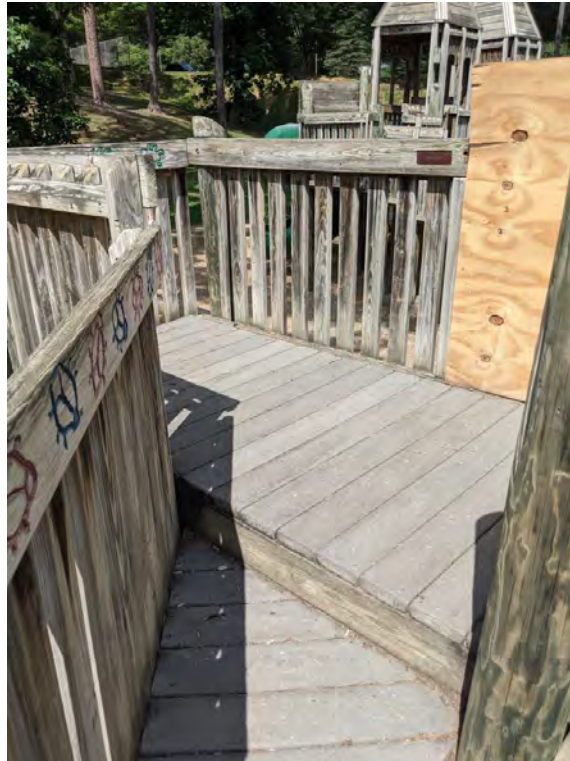
(55)

Comments Post Cracks

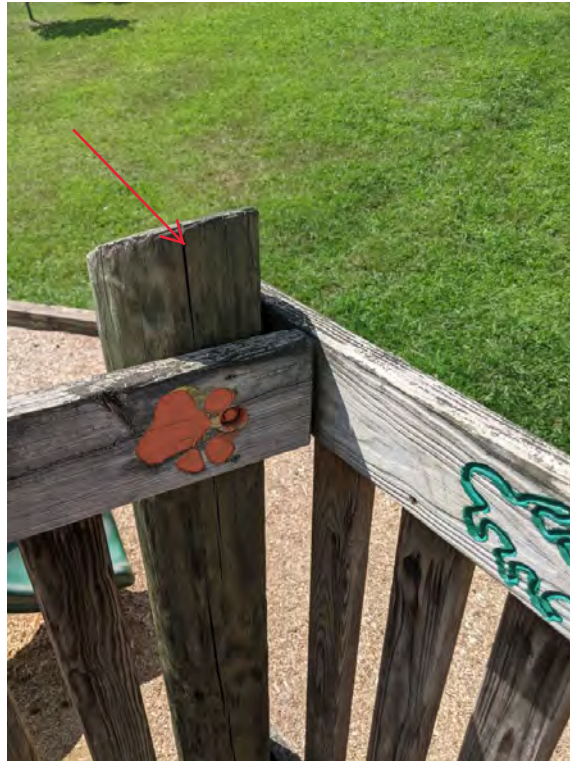
(57)

Post Cracks and Deck Board Is Split

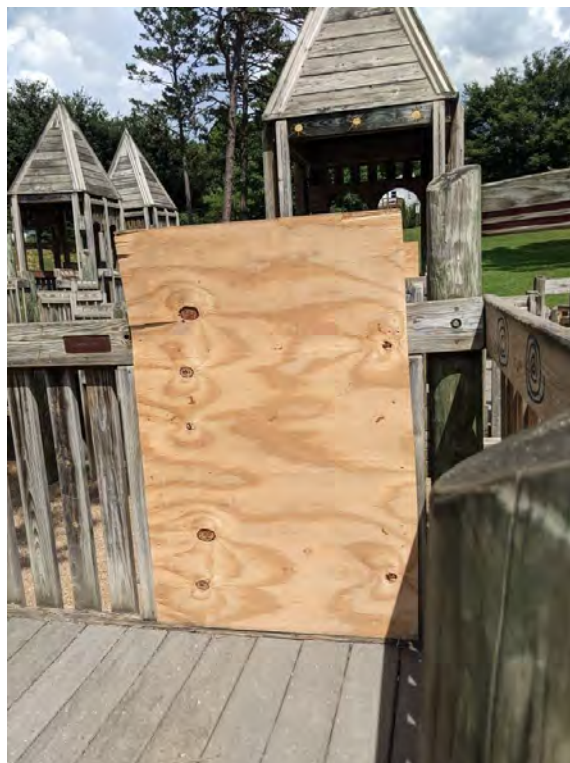
(58)

[Post Crack](#)

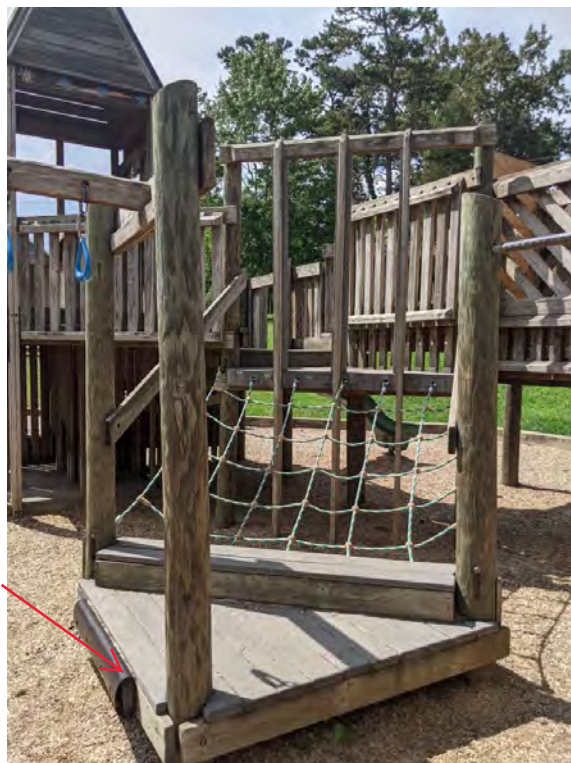
(60)

Comments Post - Deck and Net Have Damage
