FACILITY CONDITION ASSESSMENT & NETZERO ENERGY AUDIT

Dresden Athletic Fields
221 US Route 5 South
Norwich, Vermont 05055

December 13, 2022

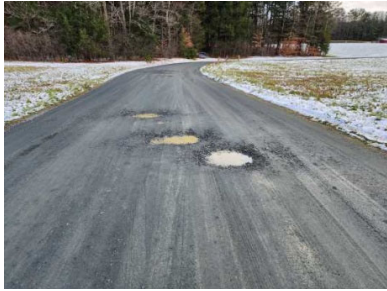
Roadways in Poor condition.

Pavement, Asphalt
Dresden Athletic Fields Roadway

Potholes observed on driveway to fields. Repair is recommended. - AssetCALC ID: 4566767

Uniformat Code: G2010
Recommendation: **Repair in 2022**

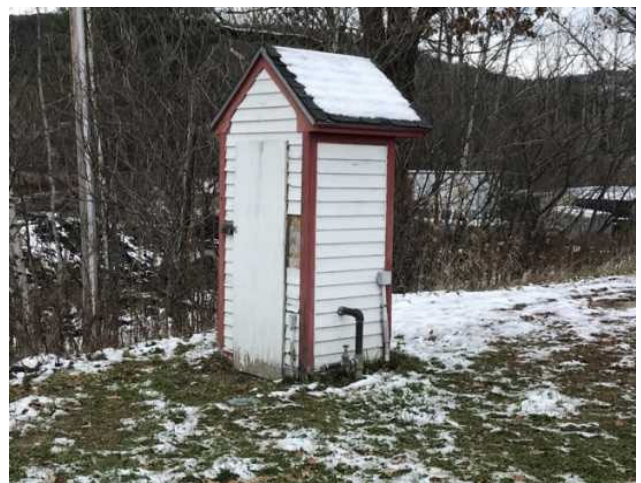
There is a drip irrigation system at the site for the baseball field and one of the soccer fields. The housing for the irrigation control panel is located next to the baseball field. The other soccer field and softball field can be irrigated by connecting sprinklers to ground hydrants. The equipment appears to be in working order. There are also two electronic scoreboards that are in overall fair condition.

6 - IRRIGATION HOUSING

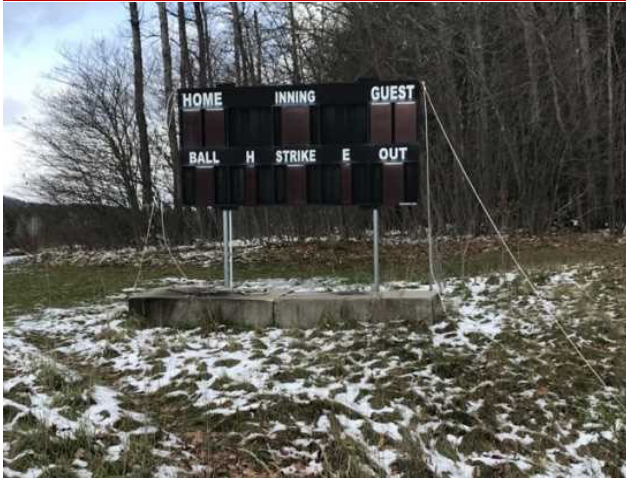
7 - SCOREBOARD

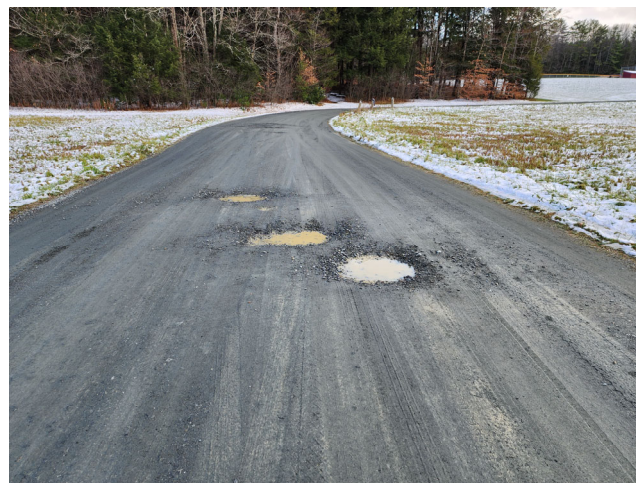
There is an unstriped gravel parking area near the sports fields. A few potholes were observed on the driveway leading to the parking area. Repair of the damaged pavement is recommended. There is no on-site lighting at the property. According to the point of contact, complaints about inadequate site lighting have not been reported. Landscaping and lawn maintenance are reportedly done weekly or as needed. The baseball and softball fields each have two dugout ancillary buildings.

12 - DRIVEWAY POTHOLES - REPAIR

| Uniformat Code | Location Description | ID | Cost Description | Lifespan (EUL) | EAge | RUL | Quantity | Unit | Unit Cost | Subtotal | 2022 | 2023 | 2024 | 2025 | 2026 | 2027 | 2028 | 2029 | 2030 | 2031 | 2032 | 2033 | 2034 | 2035 | 2036 | 2037 | 2038 | 2039 | 2040 | 2041 | 2042 | Deficiency Repair Estimate | | | | | | | | | | | |
|--|---|---|--|---|---|---|---|---|---|---|---|---|---|---|---|---|---|---|---|---|---|---|---|---|---|---|---|---|---|---|---|---|---|---|---|---|---|---|---|---|---|---|---|
| G2010 | Roadway | 4566767 | Roadways, Pavement, Asphalt, Repair | 0 | 0 | 0 | 130 | SF | \$7.70 | \$1,001 | \$1,001 | | | | | | | | | | | | | | | | | | | | | \$1,001 | | | | | | | | | | | |
