FACILITY CONDITION ASSESSMENT & NETZERO ENERGY AUDIT

Marion Cross School
22 Church Street
Norwich, Vermont 05055

158531.22R000-002.379

November 17, 2022

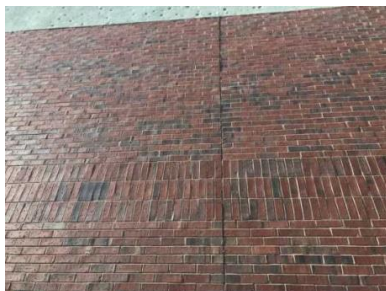
Exterior Walls in Poor condition.

Brick
 Marion Cross School Building Exterior

Brick veneer cracking at expansion joints. Caulking recommended - AssetCALC ID: 4512478

Uniformat Code: B2010
 Recommendation: **Repair/Repoint in 2022**

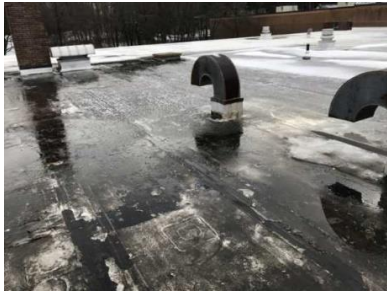
Roofing in Poor condition.

Single-Ply Membrane, EPDM
Marion Cross School Roof

Roof is aged and worn out. Leaks have occurred and are patched up as needed. Prior moisture analysis report showed isolated areas of moisture issues. - AssetCALC ID: 4512411

Uniformat Code: B3010
Recommendation: **Replace in 2022**

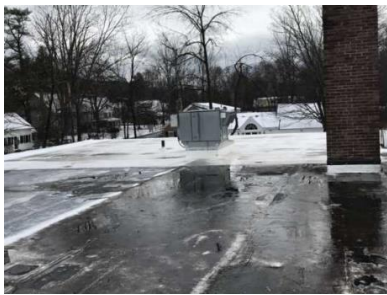
Roofing in Poor condition.

Single-Ply Membrane, TPO/PVC
Marion Cross School Roof

Roof is aged and worn out. Leaks have occurred and are patched up as needed. Prior moisture analysis report showed isolated areas of moisture issues. - AssetCALC ID: 4512455

Uniformat Code: B3010
Recommendation: **Replace in 2022**

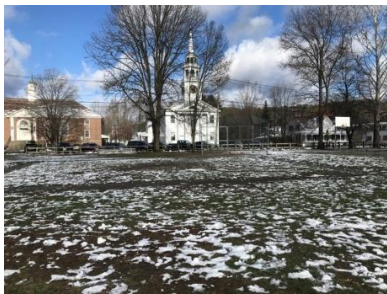
Storm Drainage System in Poor condition.

Inlets & Underground Piping, All-Inclusive
Marion Cross School Rear Playground Area

Significant ponding in the rear and front fields. There is only one site drain at the southern end of the front field. There have been issues with the sewage system where sewage would come up onto the front field. A State Engineer has already come to observe the issues. The system is reportedly quite aged. - AssetCALC ID: 4512383

Uniformat Code: G3030
Recommendation: **Replace in 2022**

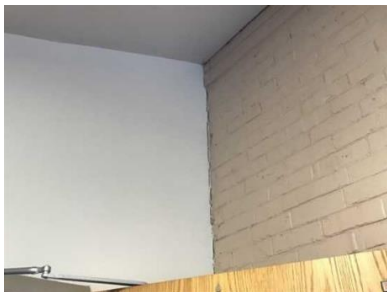
Interior Wall Construction in Poor condition.

Brick
Marion Cross School Stairwell

Interior wall cracking observed in stairwell. Repair is recommended. - AssetCALC ID: 4512362

Uniformat Code: C1010
Recommendation: **Repair in 2022**

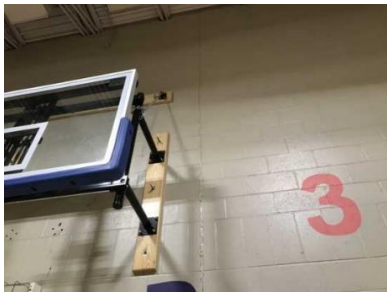
Interior Wall in Poor condition.

Concrete Block (CMU)
Marion Cross School Gymnasium

Interior wall cracking at expansion joints - AssetCALC ID: 4512447

Uniformat Code: C1010
Recommendation: **Repair/Repoint in 2022**

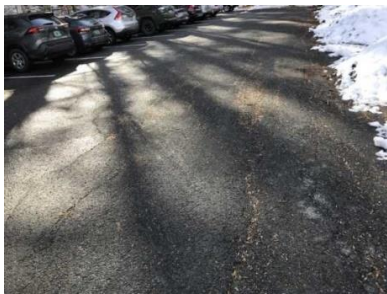
Parking Lots in Poor condition.

Pavement, Asphalt
Marion Cross School Rear Parking

Significant alligator cracking - AssetCALC ID: 4512433

Uniformat Code: G2020
Recommendation: **Mill & Overlay in 2023**

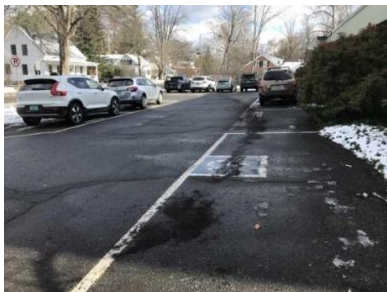
Parking Lots in Poor condition.

Pavement, Asphalt
Marion Cross School North Entrance Parking

Isolated areas of asphalt cracking and pothole - AssetCALC ID: 4512349

Uniformat Code: G2020
Recommendation: **Mill & Overlay in 2023**

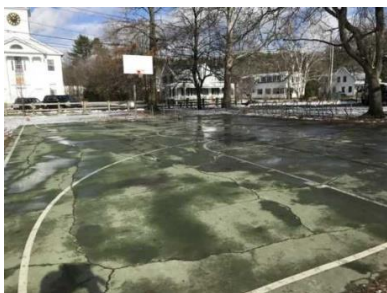
Athletic Surfaces & Courts in Poor condition.

Basketball/General, Asphalt Pavement
Marion Cross School Site

Cracking on basketball court. POC reported that repairs will occur only after site drainage issues are resolved.
- AssetCALC ID: 4512392

Uniformat Code: G2050
Recommendation: **Mill & Overlay in 2023**

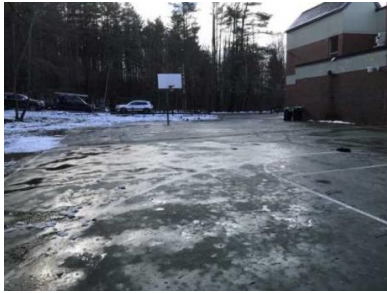
Athletic Surfaces & Courts in Poor condition.

Basketball/General, Asphalt Pavement
 Marion Cross School Site

Cracking on basketball court. POC reported that repairs will occur only after site drainage issues are resolved.
 - AssetCALC ID: 4512423

Uniformat Code: G2050
 Recommendation: **Mill & Overlay in 2023**

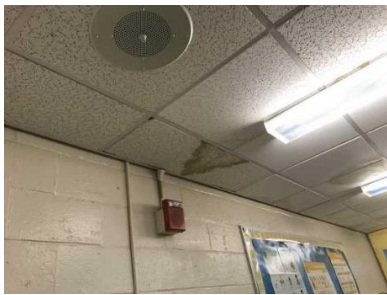
Suspended Ceilings in Poor condition.

Acoustical Tile (ACT)
 Marion Cross School Throughout building

Isolated ceiling tiles damaged by leaks. Replacement is recommended to prevent mold issues. - AssetCALC ID: 4512354

Uniformat Code: C1070
 Recommendation: **Replace in 2024**

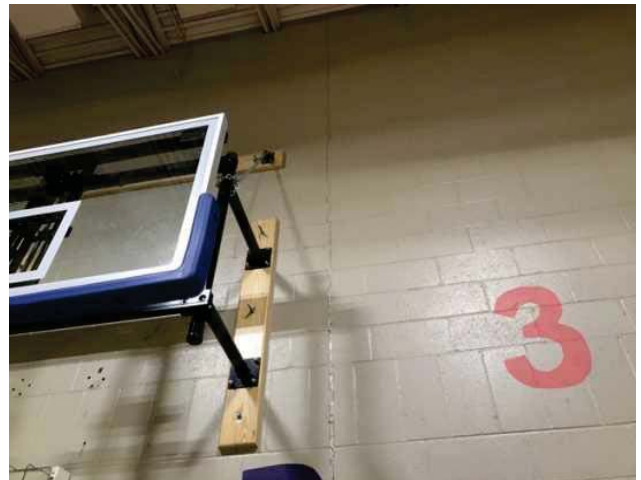
34 - INTERIOR WALL CRACKING - SEAL

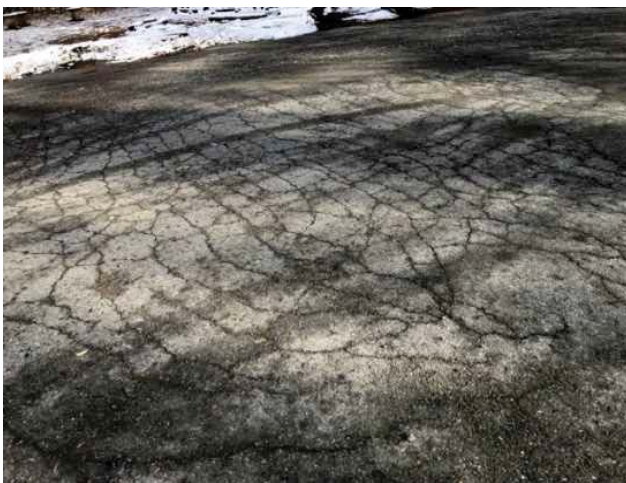
35 - ALLIGATOR CRACKING - REPAIR

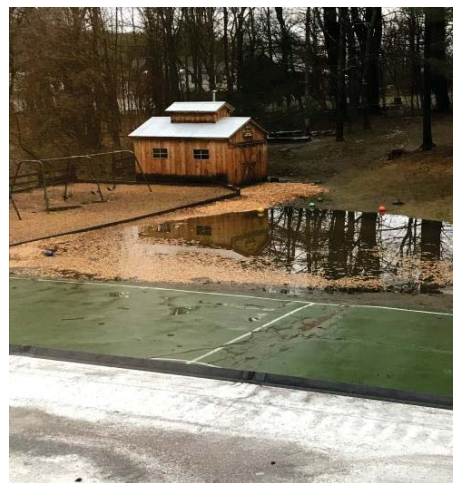
36 - SITE PONDING - REPAIR
