FACILITY CONDITION ASSESSMENT FINDINGS

School Administrative Unit 70
August, 2023

Presenter:
Mary Venable, CEM, RA

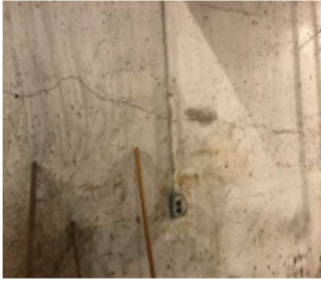
Interior Wall in Poor condition.

Concrete
Bernice A. Ray School Mechanical room

Uniformat Code: C1010
Recommendation: **Repair in 2022**

Priority Score: **84.9**

Concrete cracking in mechanical room. Repair is recommended. - AssetCALC ID: 4714410

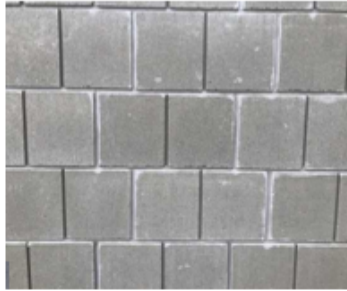
Exterior Walls in Poor condition.

Concrete Block (CMU)
Frances C. Richmond Middle School Building
Exterior

Uniformat Code: B2010
Recommendation: **Repair/Repoint in 2022**

Priority Score: **88.9**

Exterior wall is recommended for repointing - AssetCALC ID: 4714639

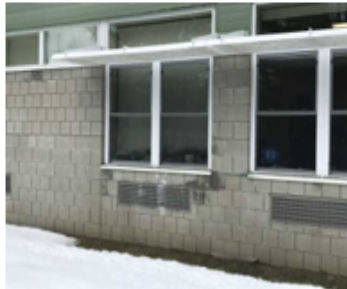
Basement Wall in Poor condition.

any type, Waterproofing of Exterior Face
Frances C. Richmond Middle School Building
exterior

Uniformat Code: A2010
Recommendation: **Replace in 2022**

Priority Score: **86.9**

Moisture on exterior walls of classrooms 810 and 800. - AssetCALC ID: 4714541

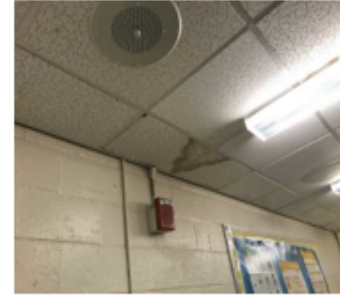
Suspended Ceilings in Poor condition.

Acoustical Tile (ACT)
Buildings and Site Marion Cross School
Throughout building

Uniformat Code: C1070
Recommendation: **Replace in 2024**

Priority Score: **81.8**

Isolated ceiling tiles damaged by leaks. Replacement is recommended to prevent mold issues. - AssetCALC ID: 4512349

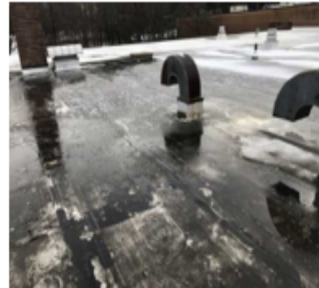
Roofing in Poor condition.

Single-Ply Membrane, EPDM
Buildings and Site Marion Cross School Roof

Uniformat Code: B3010
Recommendation: **Replace in 2022**

Priority Score: **88.9**

Roof is aged and worn out. Leaks have occurred and are patched up as needed. Prior moisture analysis report showed isolated areas of moisture issues. - AssetCALC ID: 4512411

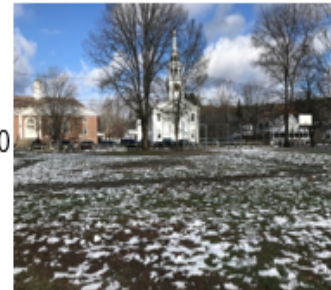
Storm Drainage System in Poor condition.

Inlets & Underground Piping, All-Inclusive
Buildings and Site Marion Cross School Rear
Playground Area

Uniformat Code: G3030
Recommendation: **Replace in 2022**

Priority Score: **86.9**

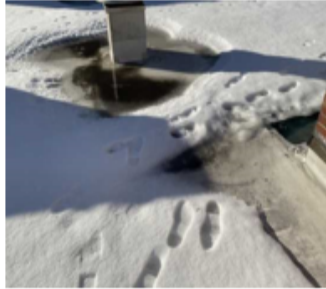
Roofing in Poor condition.

Single-Ply Membrane, TPO/PVC
Hanover High School Roof

Uniformat Code: B3010
Recommendation: **Replace in 2024**

Priority Score: **88.8**

The white TPO areas of the roof were reportedly last replaced in 1991 and there are reported leaks that periodically arise. Overall, the membrane is still functional but given its age and the prevalence of leaks, roof replacement is forecast in the near-term timeframe. - AssetCALC ID: 4728420

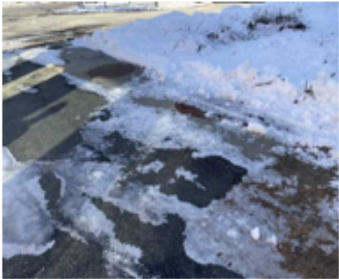
Storage Tank in Poor condition.

Site Fuel, Underground
Hanover High School Site

Uniformat Code: G3060
Recommendation: **Replace/Install in 2024**

Priority Score: **85.8**

The underground fuel oil tank has exceeded its estimated useful life. The tank will require replacement in the near future to ensure the safety and performance of the system. - AssetCALC ID: 4728267

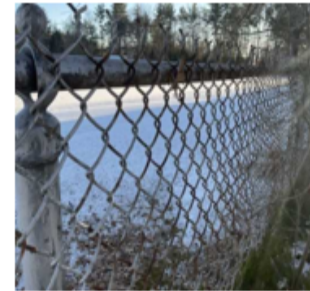
Fences & Gates in Poor condition.

Fence, Chain Link 6'
Hanover High School Site

Uniformat Code: G2060
Recommendation: **Replace in 2023**

Priority Score: **81.9**

There are sections of the chain link fence that are excessively aged and recommended for replacement. - AssetCALC ID: 4728228

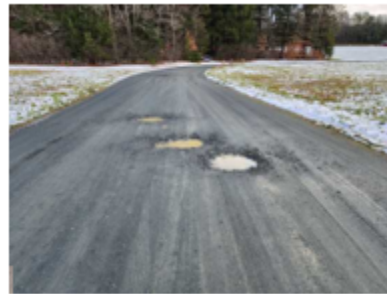
Roadways in Poor condition.

Pavement, Asphalt
Dresden Athletic Fields Roadway

Uniformat Code: G2010
Recommendation: **Repair in 2022**

Priority Score: **84.9**
