Santa Clara Unified
School District

Casa Del Maestro Facility Assessment Summary

3445, 3455, 3459 & 3465 Lochinvar Avenue | Santa Clara, CA 95051 | 9/8/23

PHYSICAL NEEDS ASSESSMENT

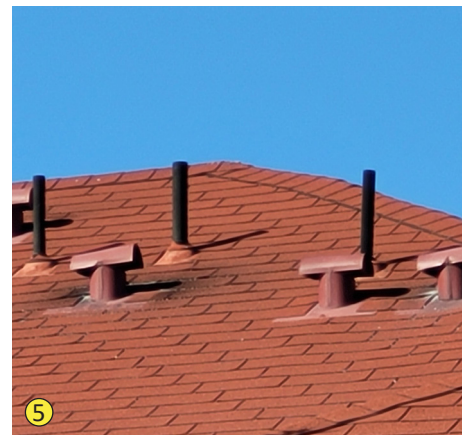
Existing roof shingles.

Roofing is aged and requires replacement.

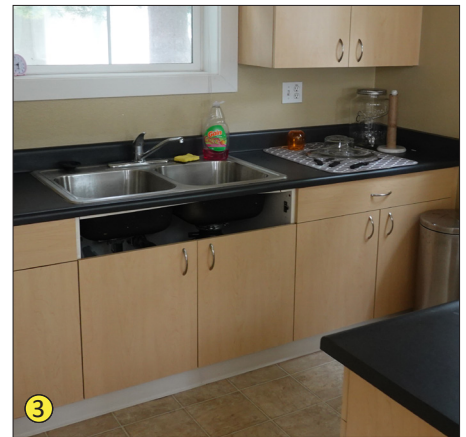
Kitchen sink cabinet face trim panel is missing. The kitchenette used by the community.

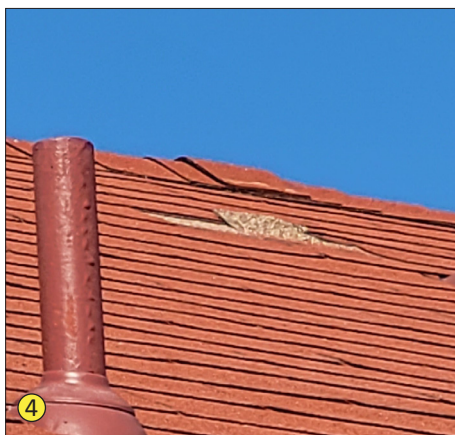
4
Missing one single at right wing of building 3459.

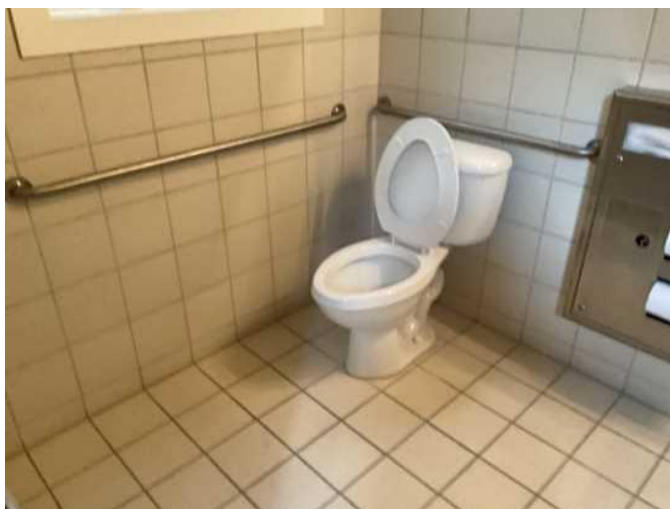
21 - 3455: Toilet stall overview

Electrical	Source and Distribution: Main panel with copper wiring Interior Lighting: CFL, incandescent Emergency: None	Good
Fire Alarm	Smoke detectors, exit signs	Good
Key Issues and Findings	Minor ADA Issues were observed at the recreation building: No pipe wrap on the restroom sinks Flush handle facing the wall on the toilet Non-compliant lock on the entry doors The recreation building is considered a public building because it is owned by a public agency.
