Limited Hazardous Building Materials Inspection

Boiler Replacement Project
Roger Sherman Elementary School – Boiler Room
250 Fern Street
Fairfield, Ct

**Re: Limited Hazardous Building Materials Inspection
Boiler Replacement Project
Roger Sherman Elementary School – Boiler Room
Fuss & O'Neill Project No. 20180955.A60**

**Limited Hazardous Building Materials Inspection Report
Boiler Replacement Project
Roger Sherman Elementary School
Fairfield Public Schools**

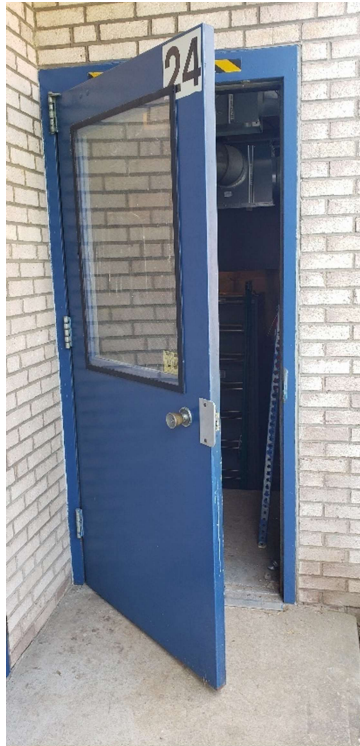
Door/Window with <1% Asbestos-Containing Glazing Compound

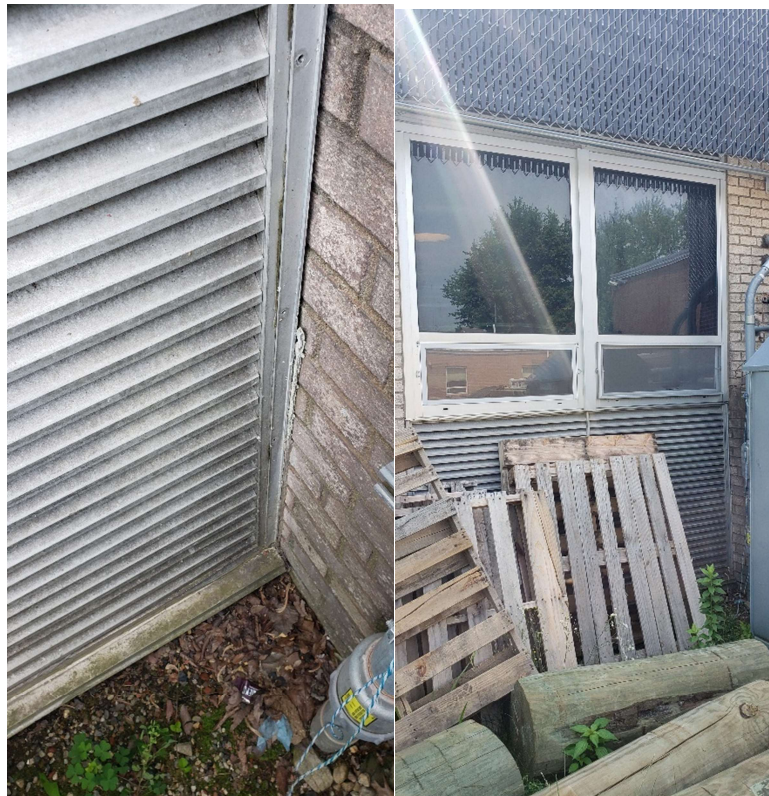
Window/Louver Vent with Asbestos Containing Caulking Compound

Prior to disturbance, ACM that would likely be impacted by the proposed renovation activities must first be abated by a state-licensed Asbestos Abatement Contractor. This is a requirement of CTDPH and EPA NESHAP regulations governing asbestos abatement.

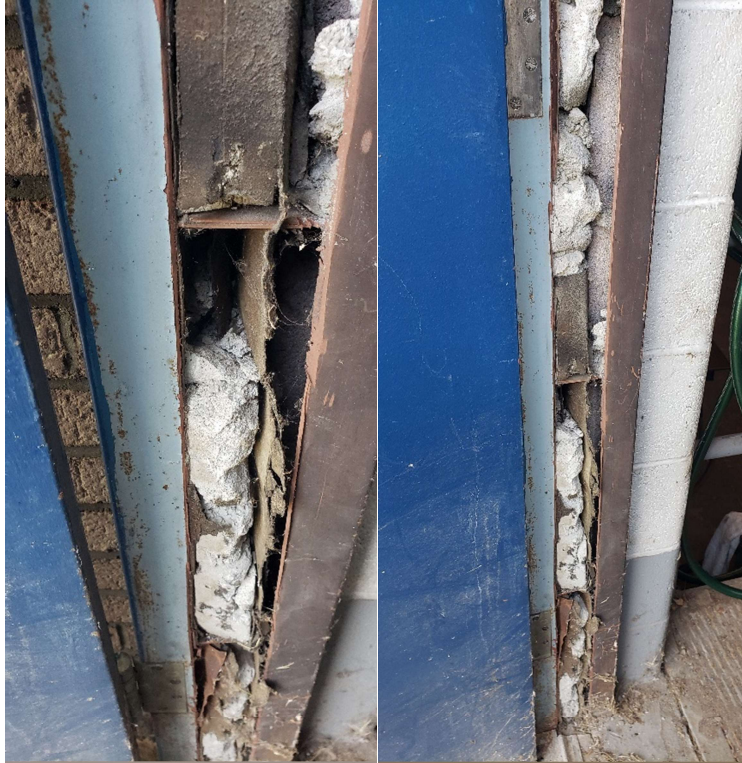
Asbestos-Containing Black Damp Proofing in Wall Cavity by Door 24

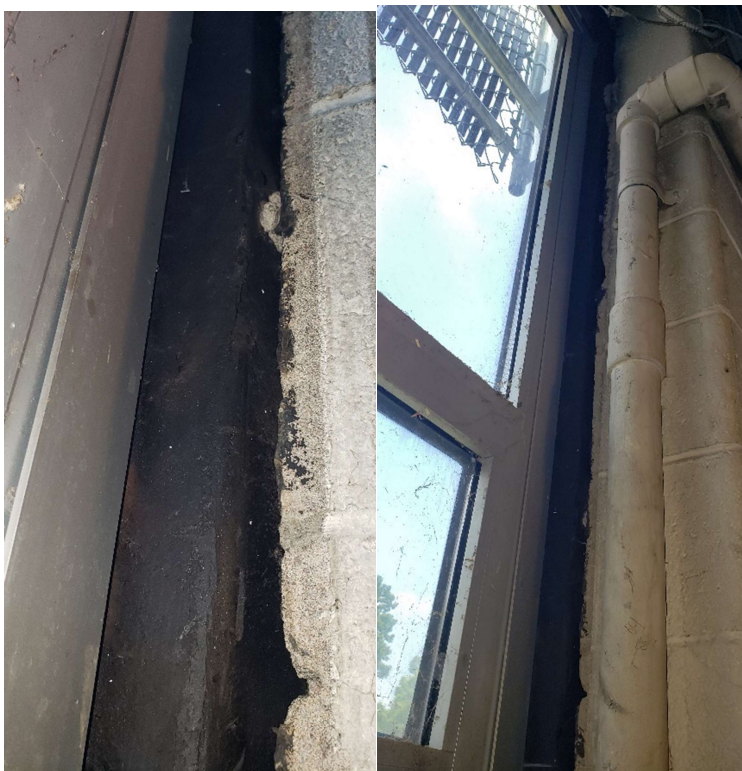
Asbestos-Containing Black Damp-proofing in Wall Cavity by Window/Louver Vent

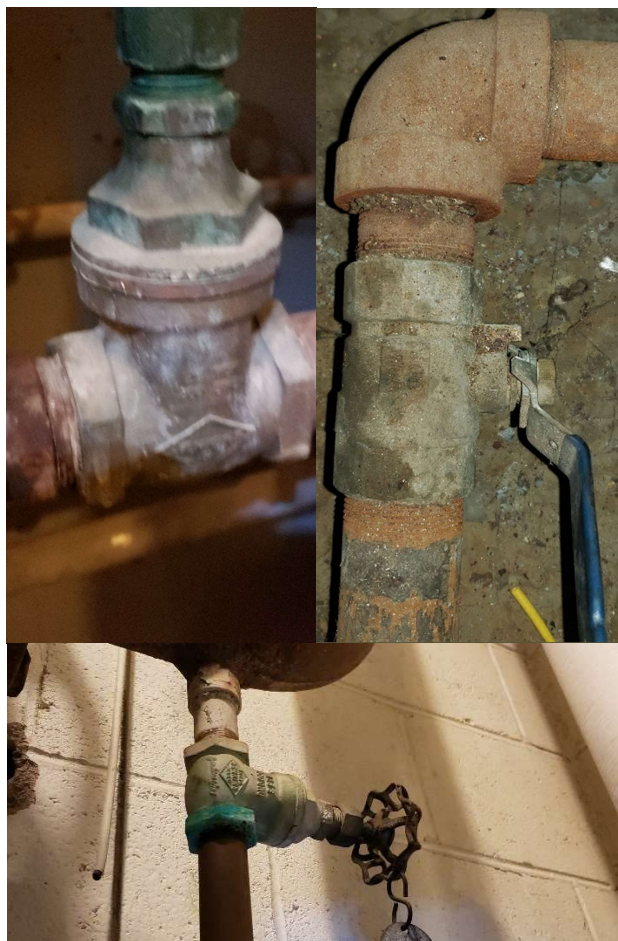
Based on our LBP determination results, LBP is present on metal valves, elbows and T connectors associated with piping located in the boiler room at the Site that were tested by XRF as part of this limited inspection.

Pipe Elbows, Tees, and Connector – Lead Containing
(Material Not Painted)

If disturbed and managed off-site, non-porous LBP-coated building materials (i.e., metals) may be segregated and recycled as scrap metal. Metal LBP-coated building components cannot be subject to grinding, sawing, drilling, sanding, or torch cutting.
