Middle School Facilities Assessment

Albemarle County
Public Schools

FACILITIES ASSESSMENT REPORT

Burley Middle School

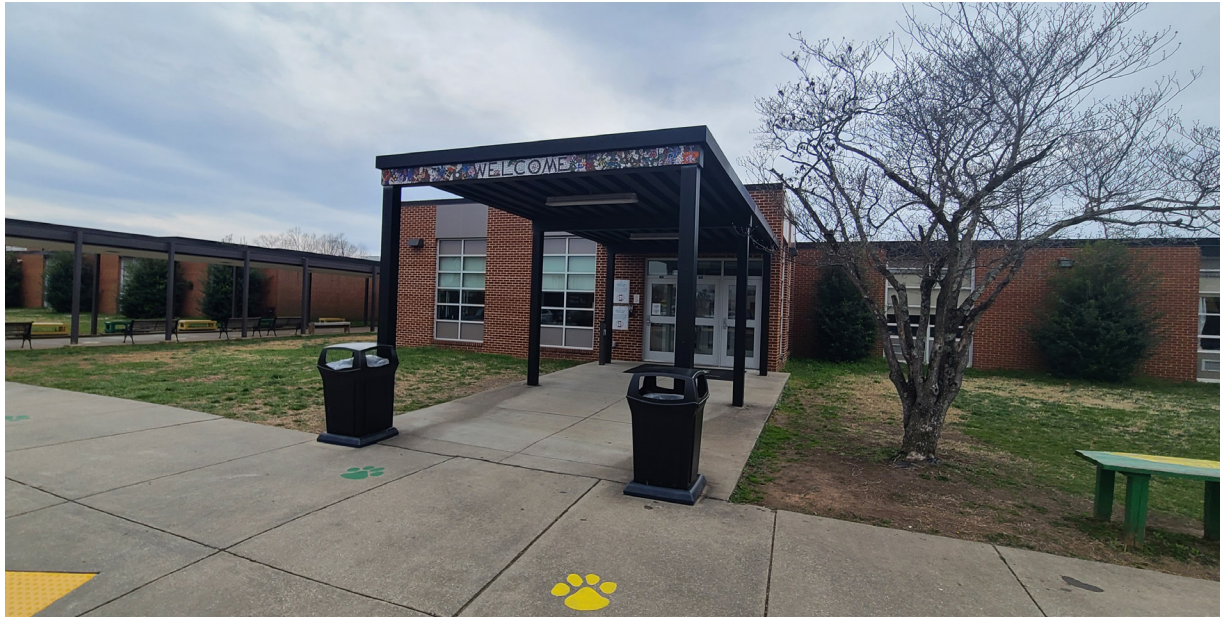
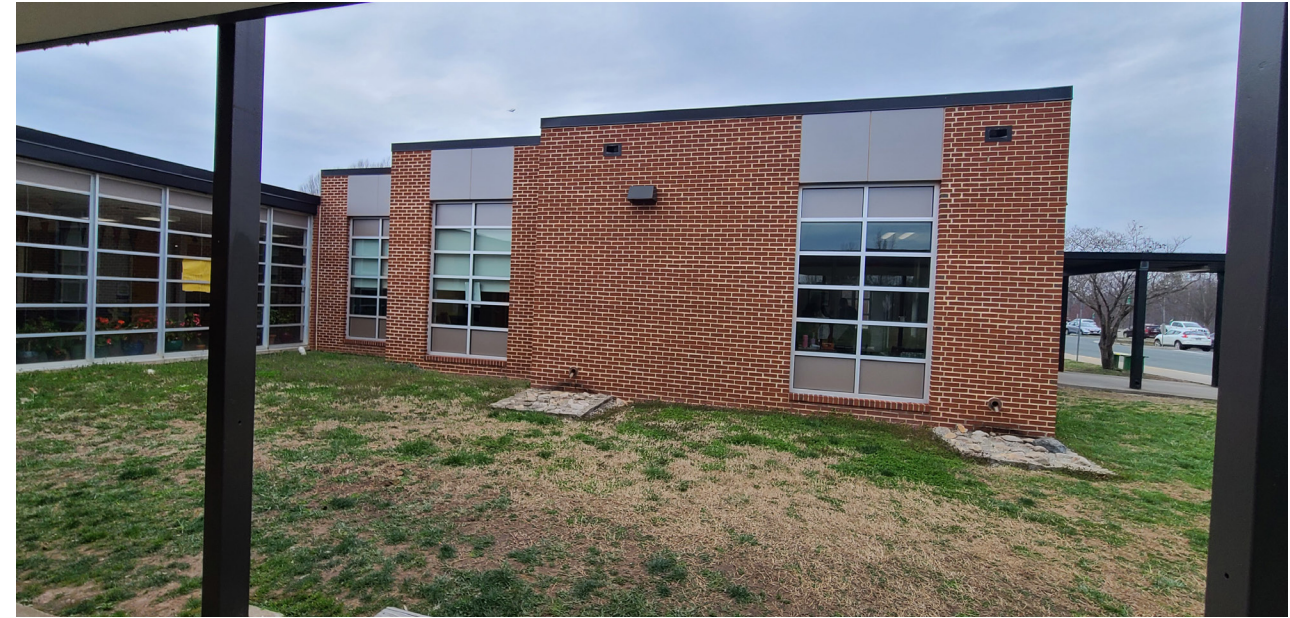
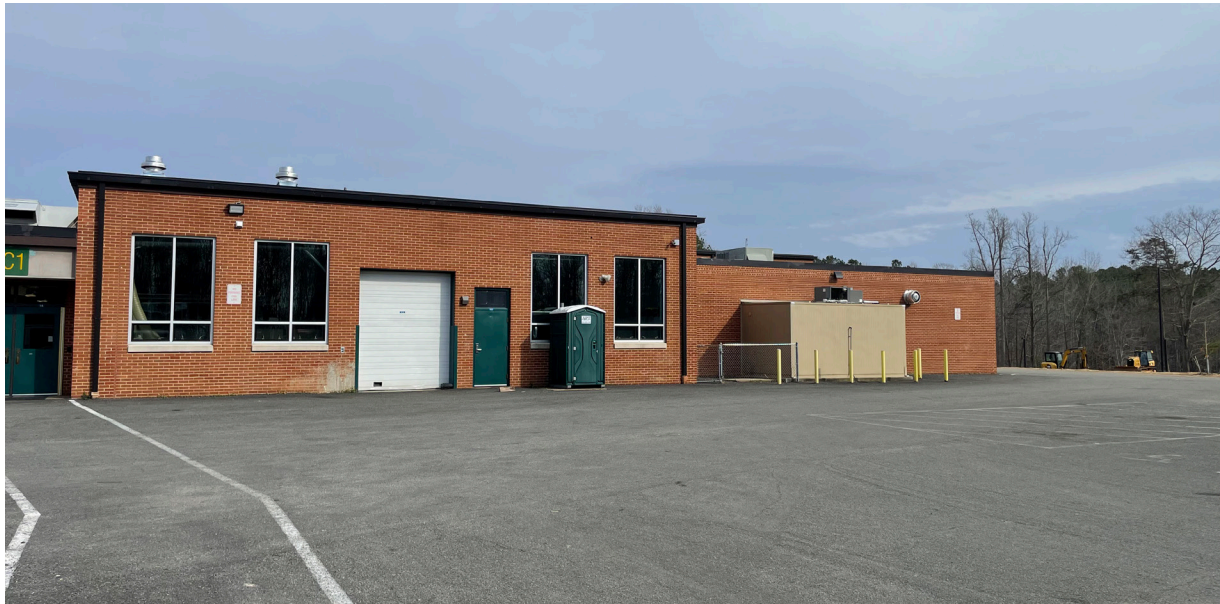
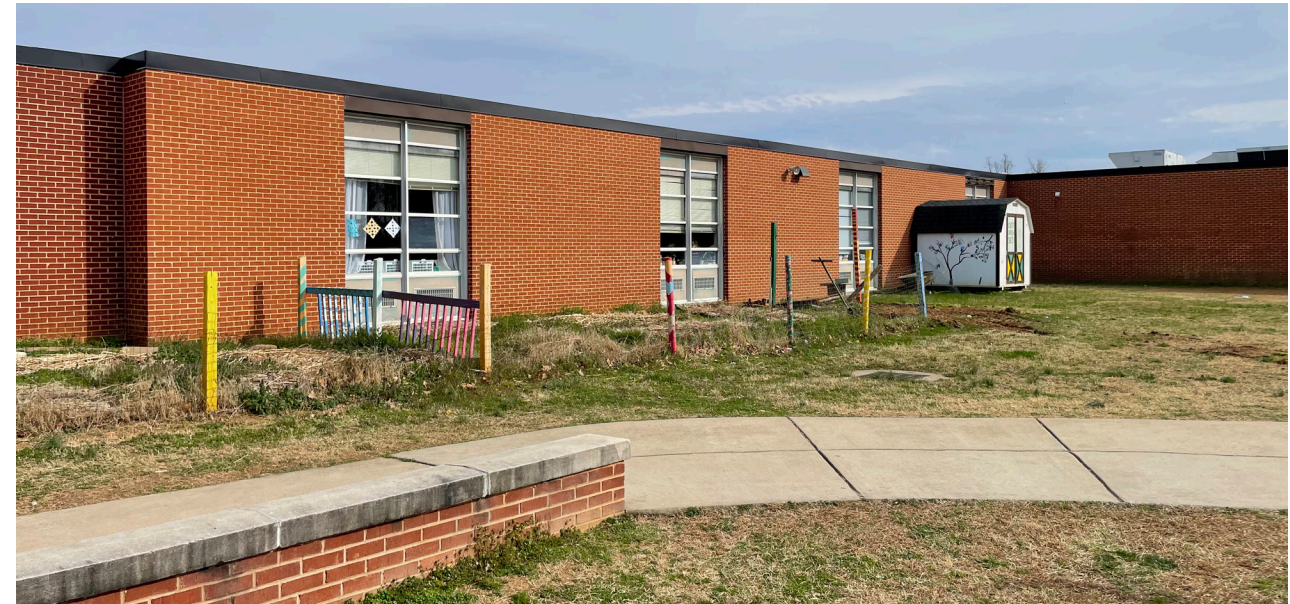
In general, the building is not aging as well as her sister since the joint reinforcement is starting to rust and spall the horizontal mortar joints.

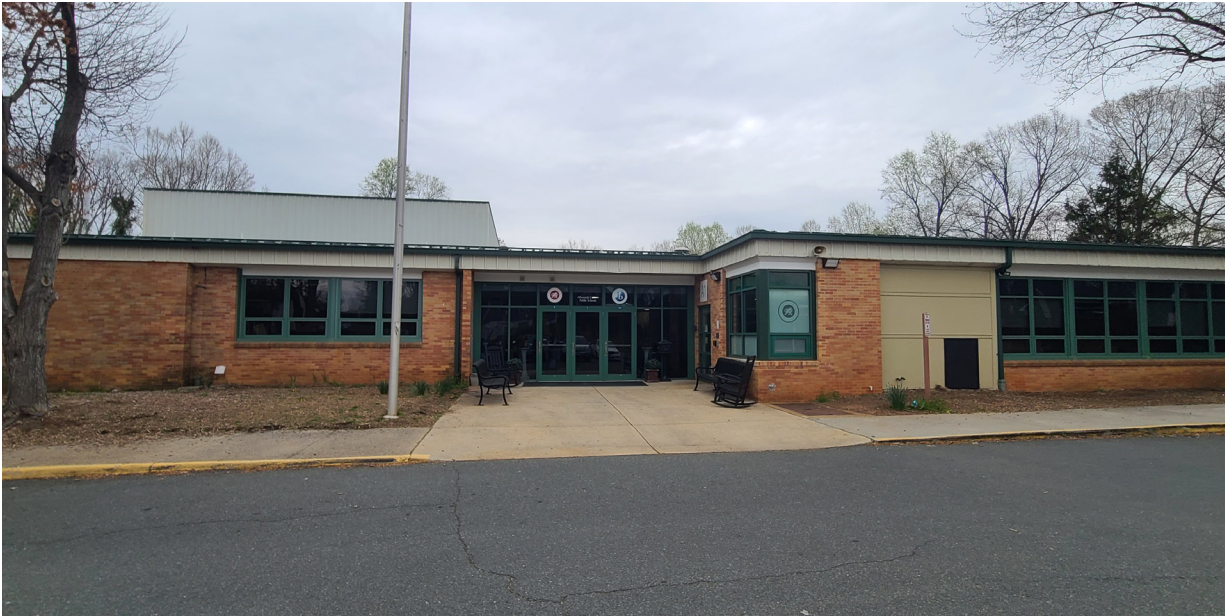
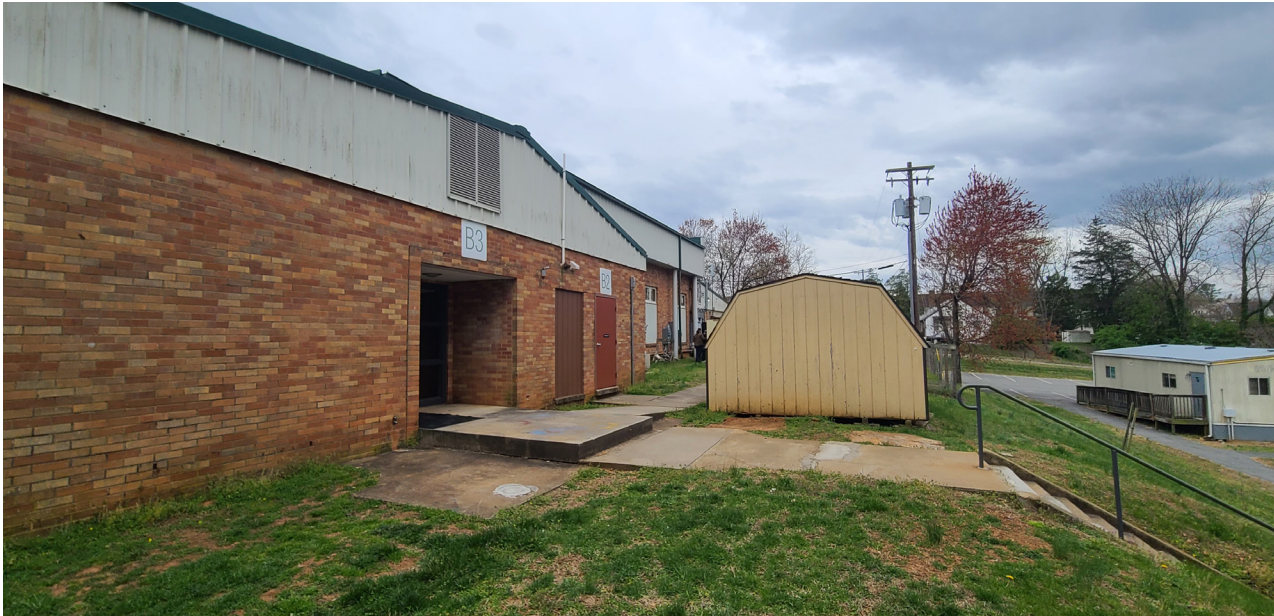
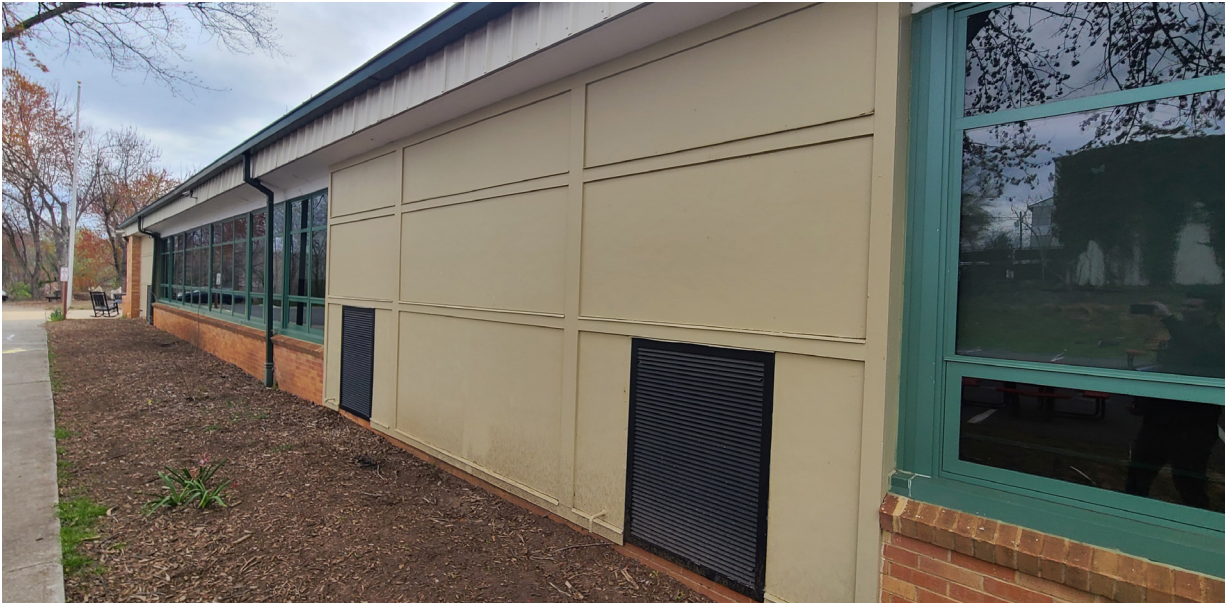
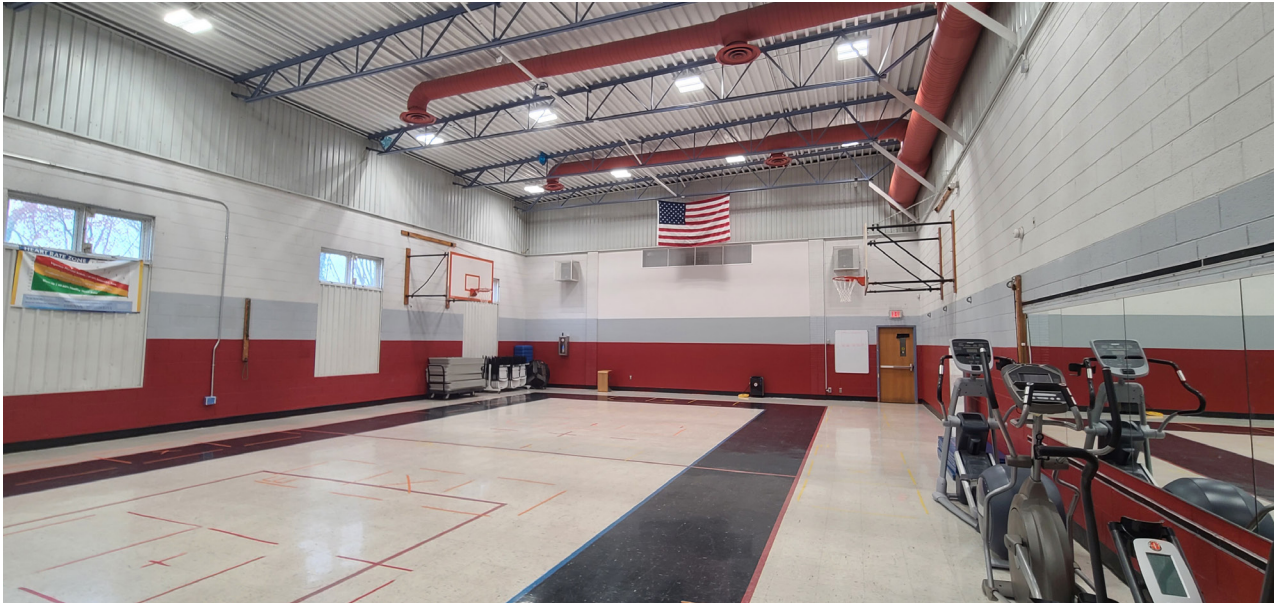
- Numerous elevations have grade with back slopes to the building.
- A disconnected downspout occurs on the east end of the south elevation causing water to pool next to the foundation.
- The west elevation has numerous rusting lintels and a few others occur around the rest of the building.
- The window infill panels that occur on all classroom elevations are not constructed of long-life materials
