# RA Longview Portico stone

- Aug 21<sup>st</sup> 2024
- Ray Elkins
- D&R Masonry
- 8890 SE McLoughlin Blvd, Portland OR 97222
- RE: Condition Assessment for located at 2903 Nichols Blvd, Longview WA 98632.
- Structural observations performed by **Kyle Kraxberger**

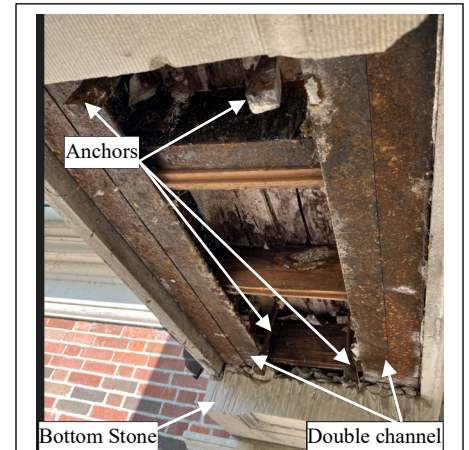
- The primary support for the Portico is (2) back-to-back steel channels with flat unreinforced cast stone top and bottom. The two stones are tied together with embed steel anchors (see photo # 1).
- This element spans between either two columns or a column and the building (see photo #2).
- This element bears on the URM wall and supports the roof framing as well as a concrete ceiling slab.

*Photo 1: Portico Framing*

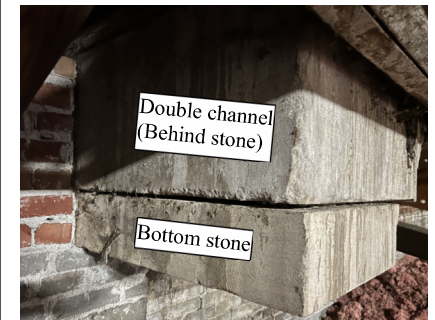
*Photo 2: Portico Stone inside attic space*

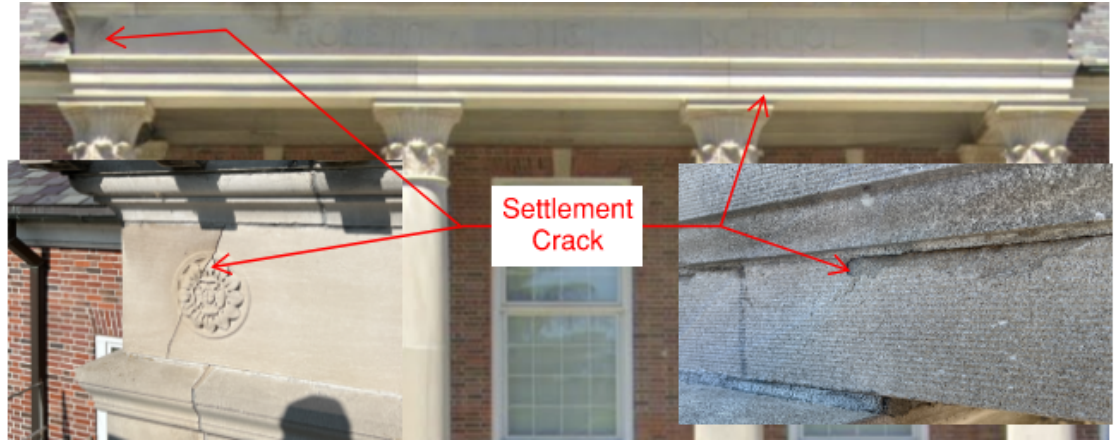
Based on our observations it appears the VA Longview's two corner columns of the portico have settled more than the two interior columns. Settlement cracks tend to be diagonal but not exclusively. Other cracks and minor spalling were also observed supporting settlement our conclusion.

*Figure 1 Front elevation and settlement cracks.*

Settlement can be slowed but not stopped entirely, by adding deep foundation elements such as micro piles. Micro piles are steel rods drilled or driven deep into the ground, often over 50ft, and then a steel bracket is attached at the foundation. These elements will need to be added in triplicate or more under each column for stability reasons. This is a very expensive solution and will require additional exploration in the form of soil borings and structural analysis.
