EAST HELENA PUBLIC SCHOOLS FACILITIES CONDITIONS REPORTS

EAST HELENA, MONTANA
EAST HELENA PUBLIC SCHOOLS MASTER PLAN
NOVEMBER 2023

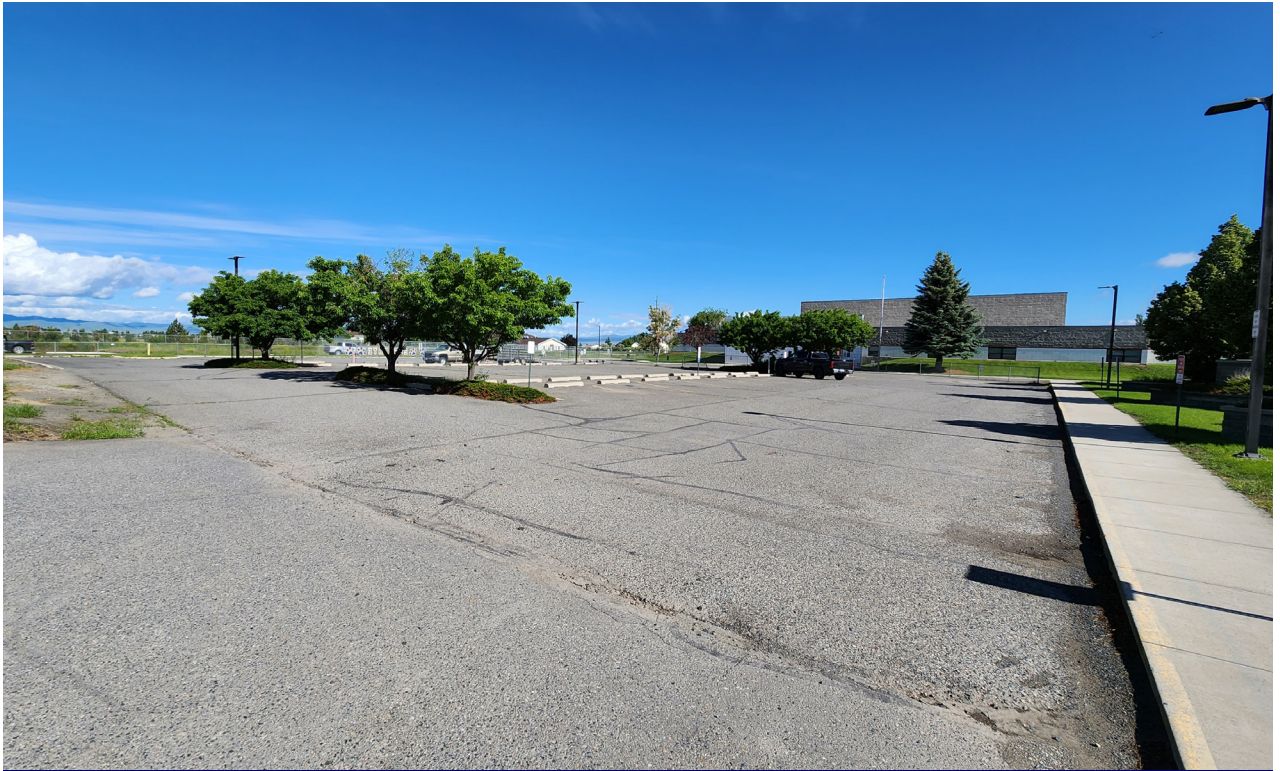
View of south parking lot looking northwest. Note cracking and damage to asphalt.

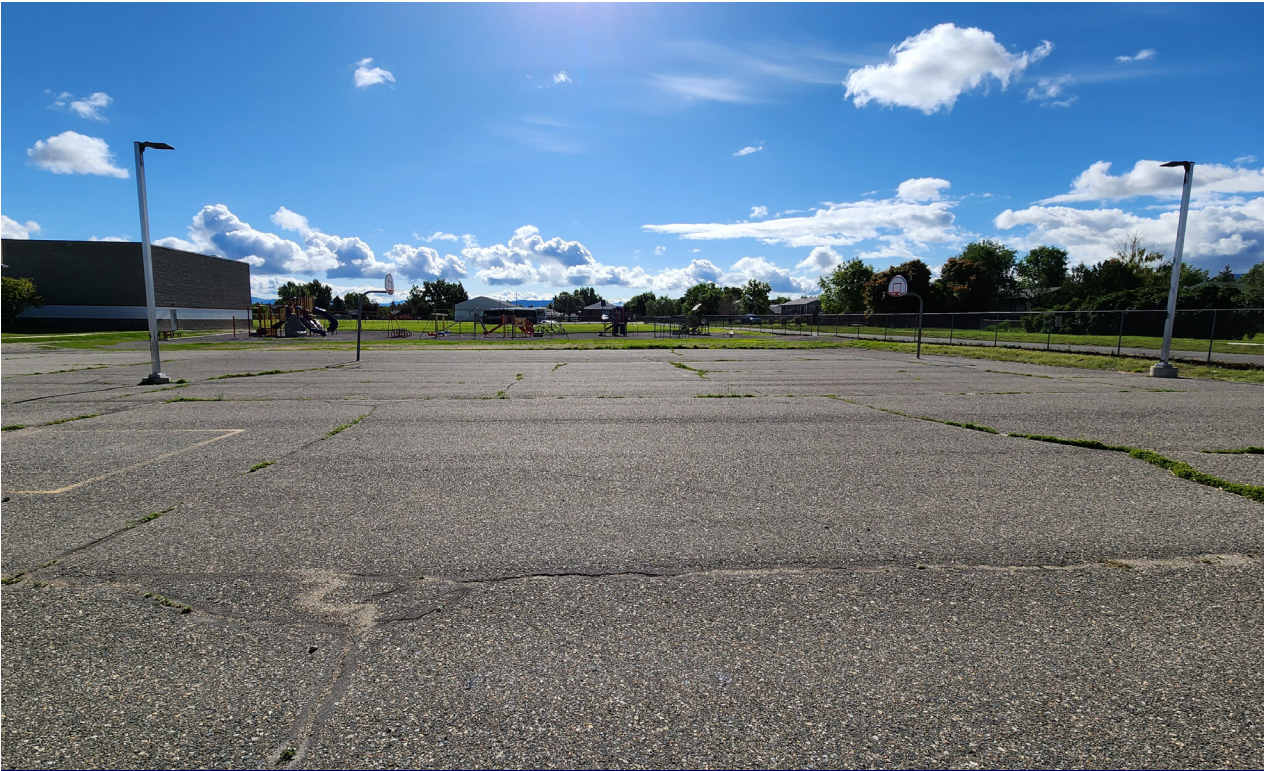
Asphalt play areas. Note cracked and damaged asphalt and sports hoops in disrepair.

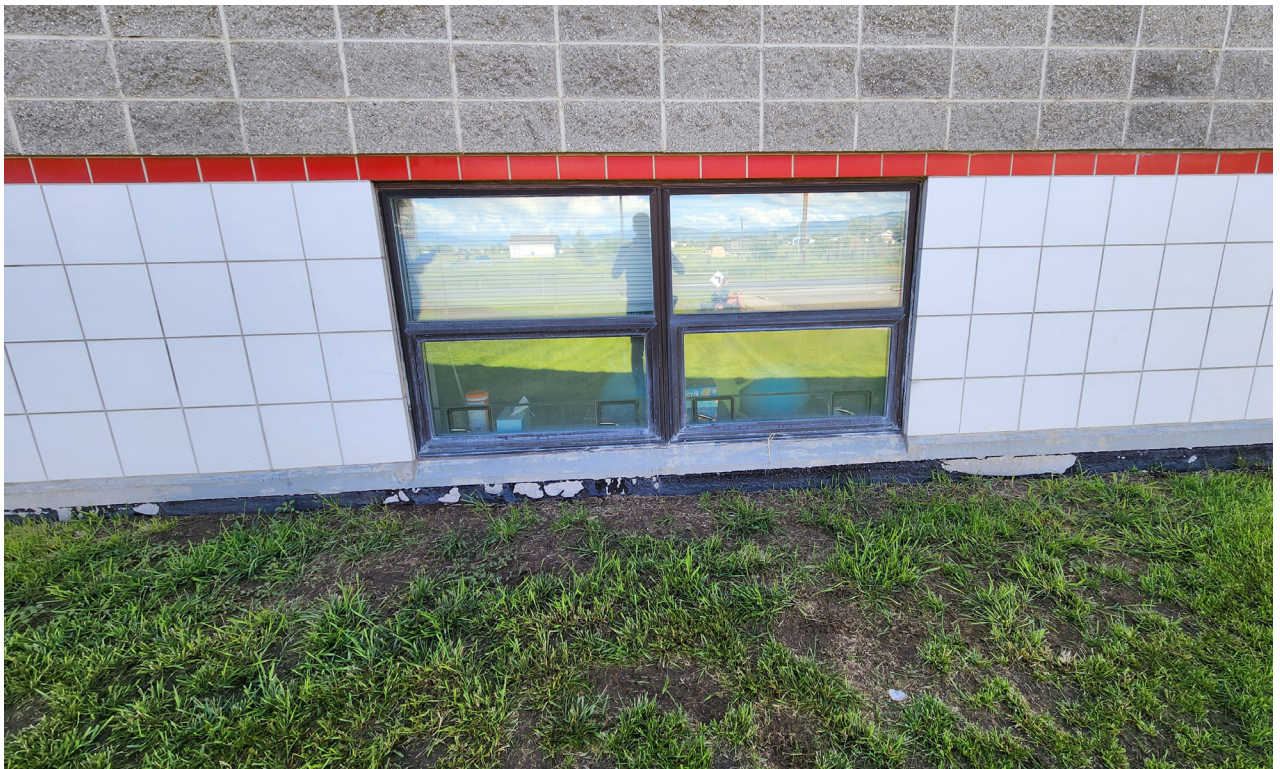
View of foundation and window showing water-proofing peeling from foundation.

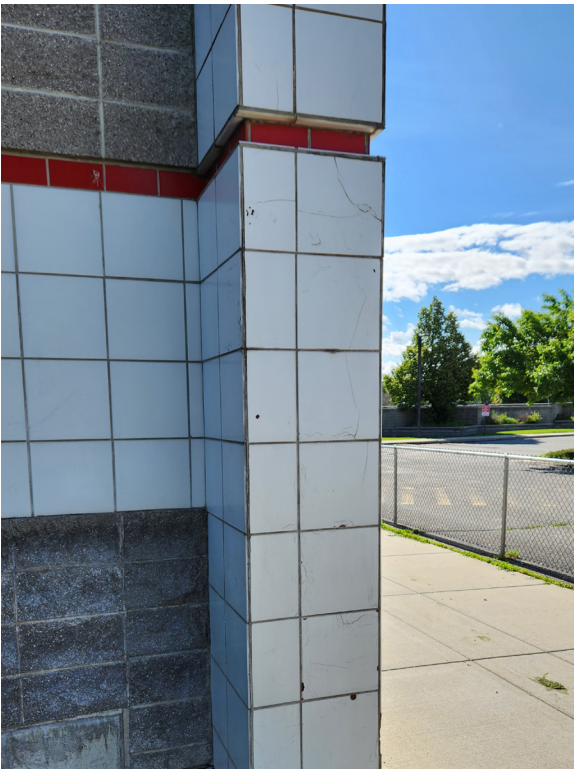
View of cracked and damaged glazed tile at main entry.

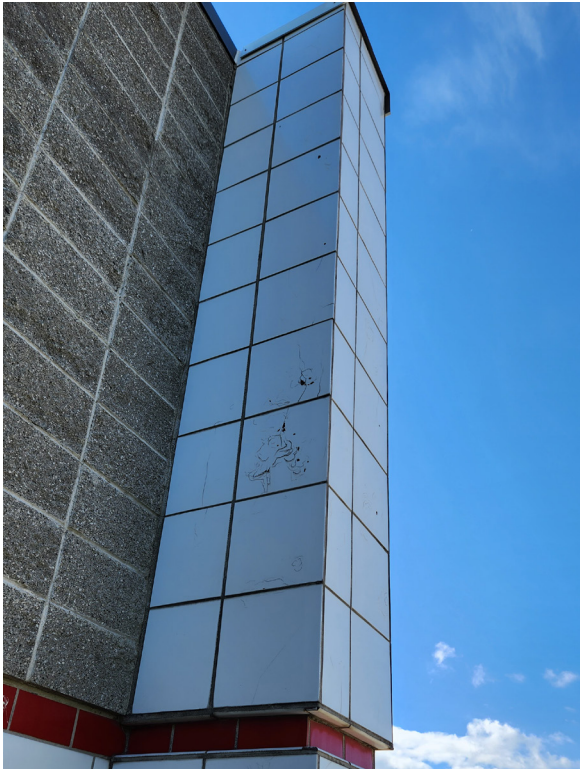
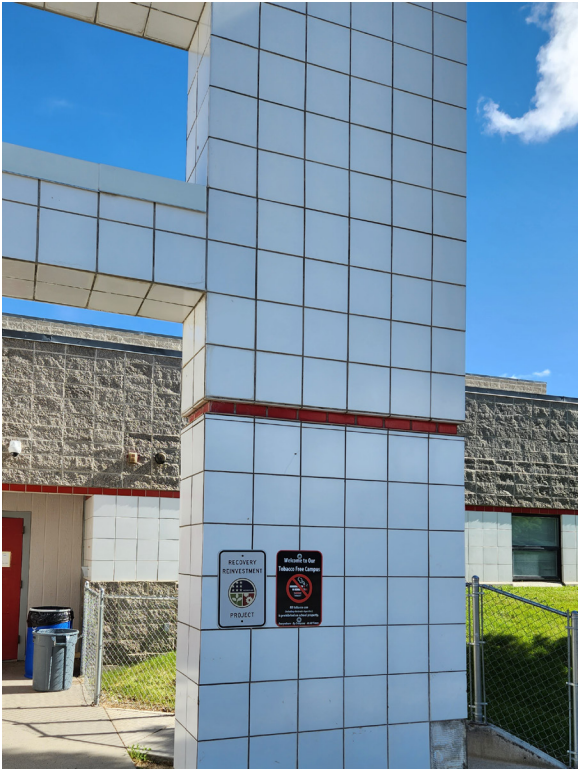
View of damaged glazed tile at main entry.

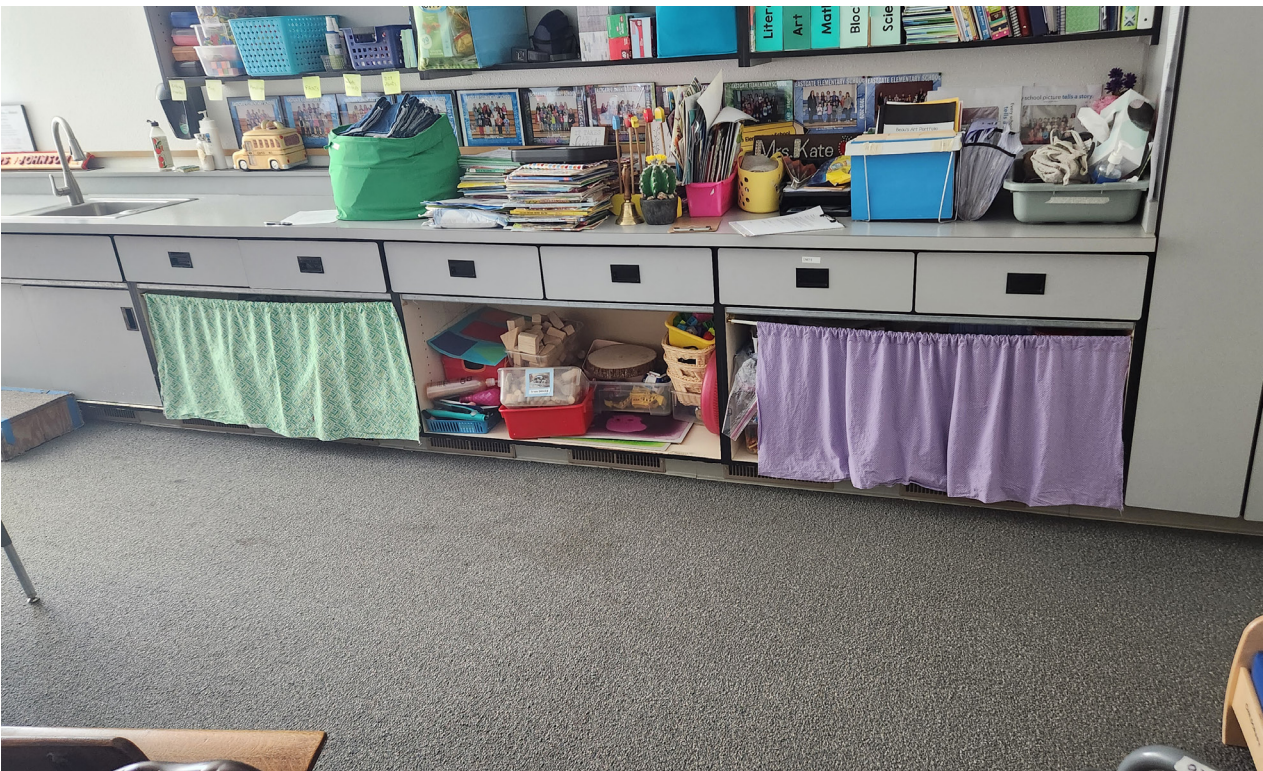
View of classroom cabinets missing door fronts.

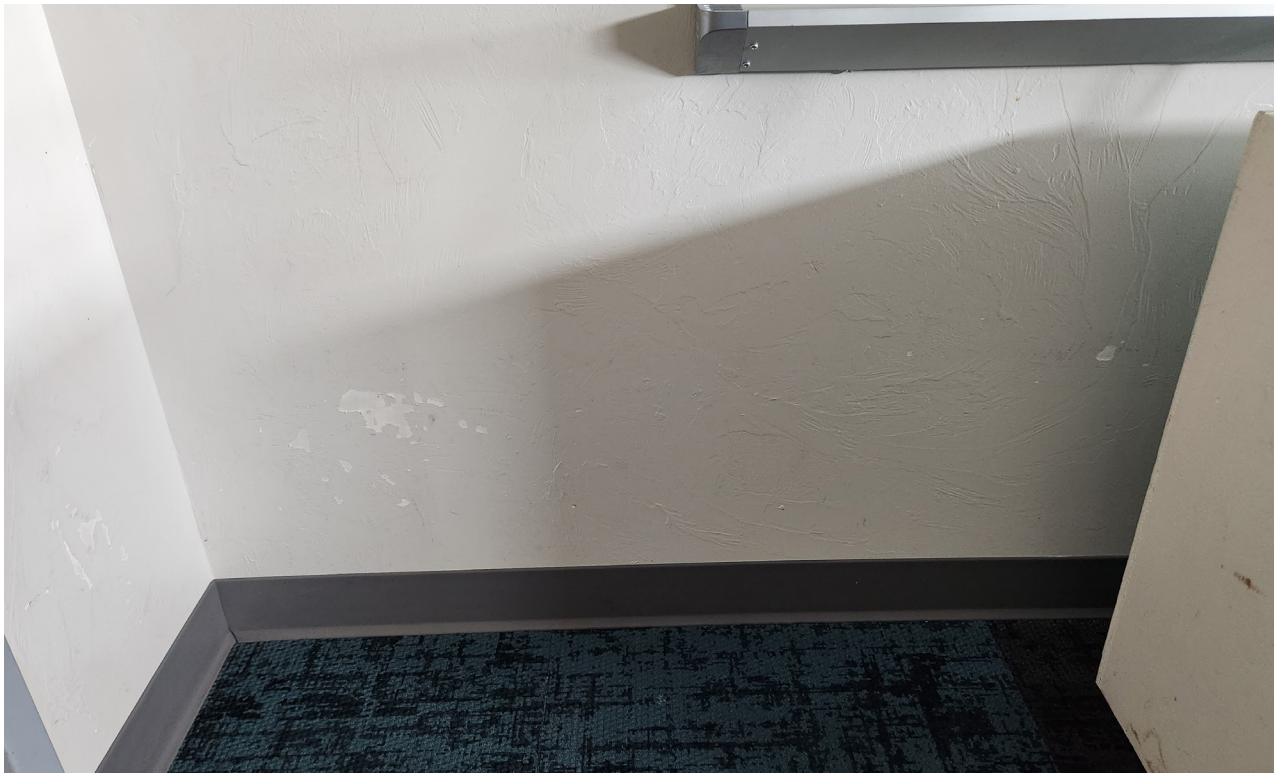
Typical minor damage to drywall finish due to moving furniture.

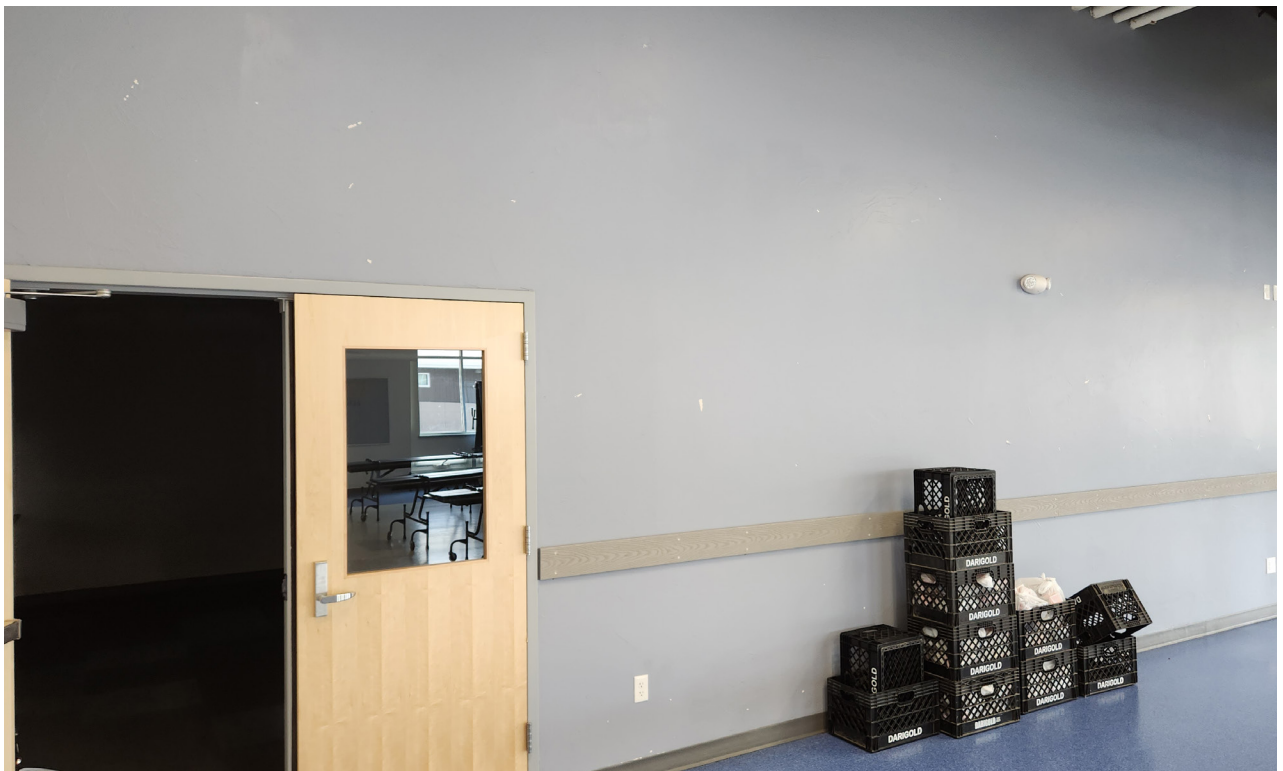
View of drywall damage at wall in the commons area.

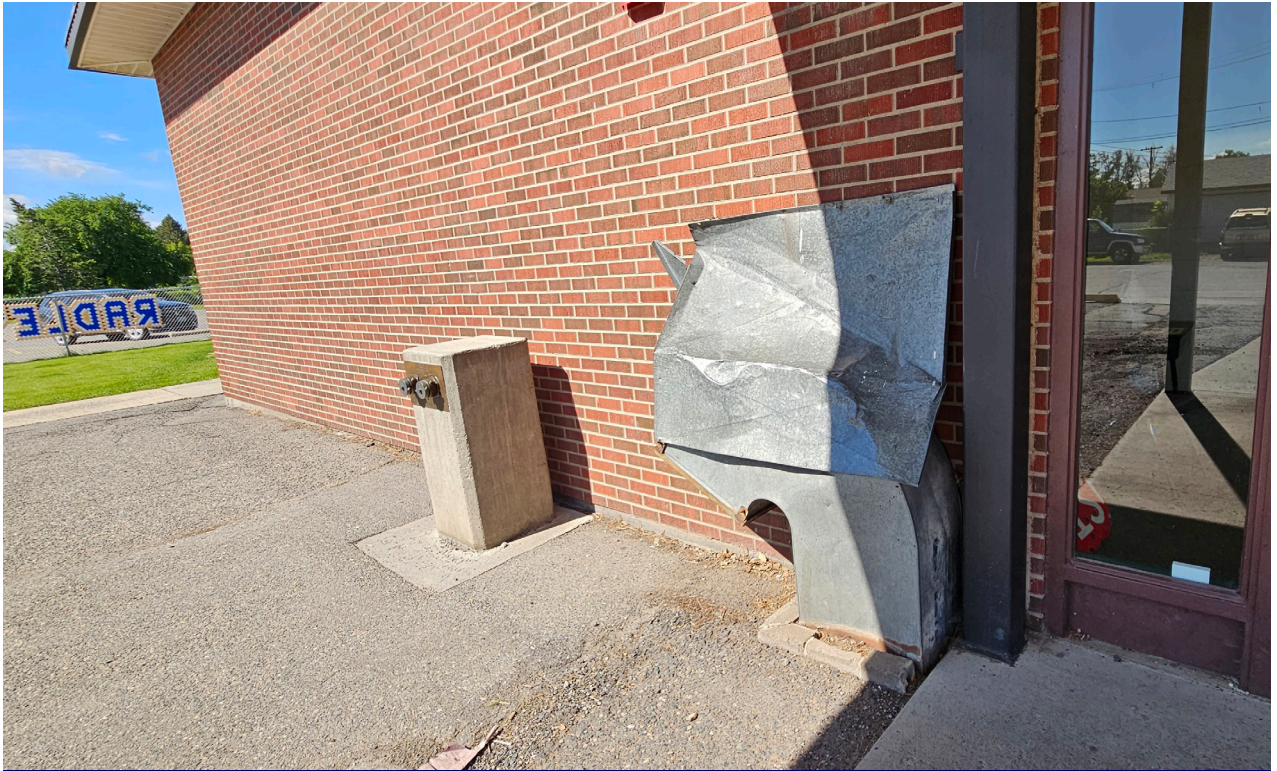
East side of exterior, damaged metal ductwork.

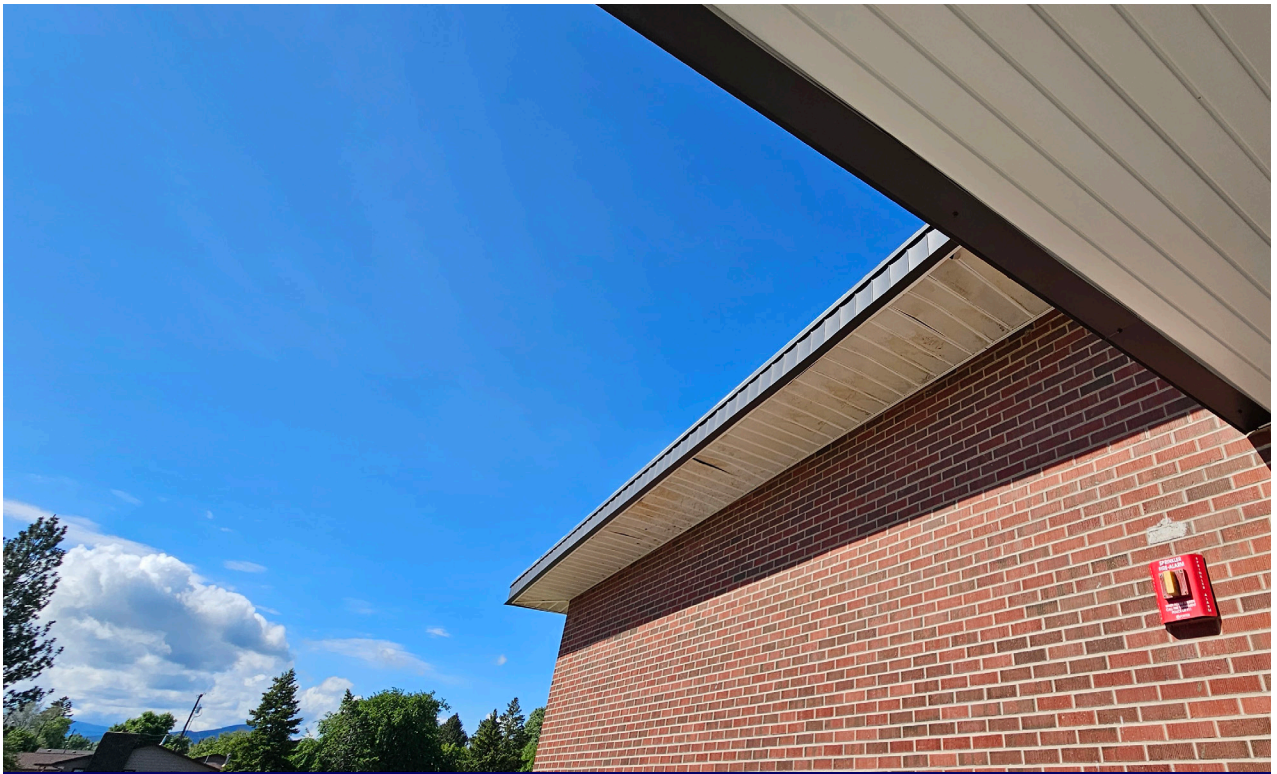
East side of building, damaged soffit panels common around the building.

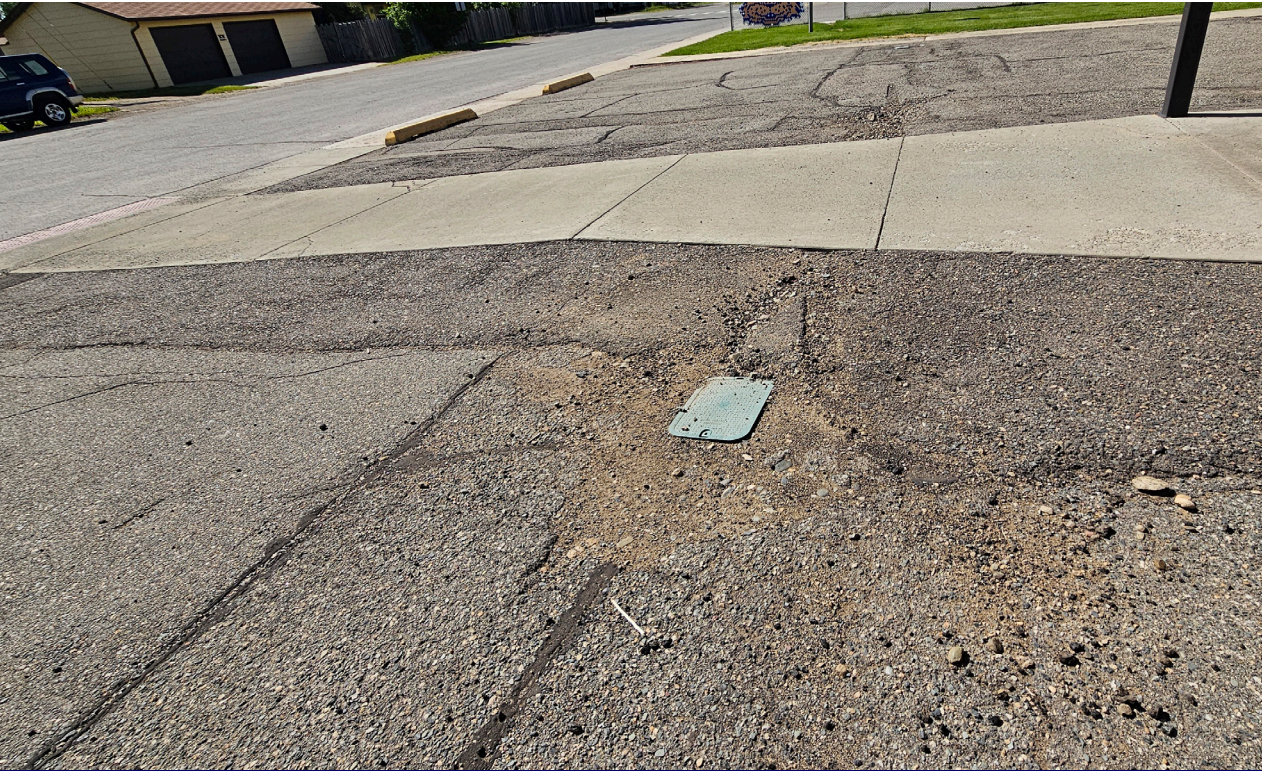
East paved areas, cracked and uneven areas of asphalt.

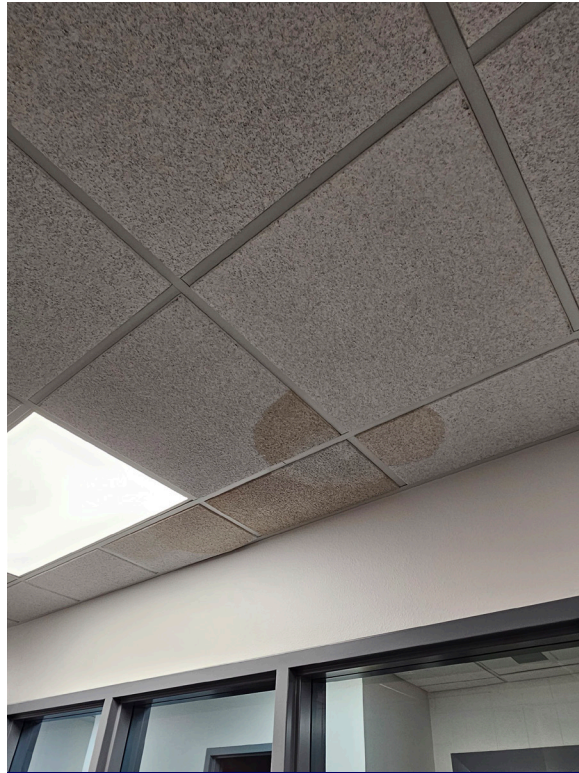
View of water-damaged ceiling.

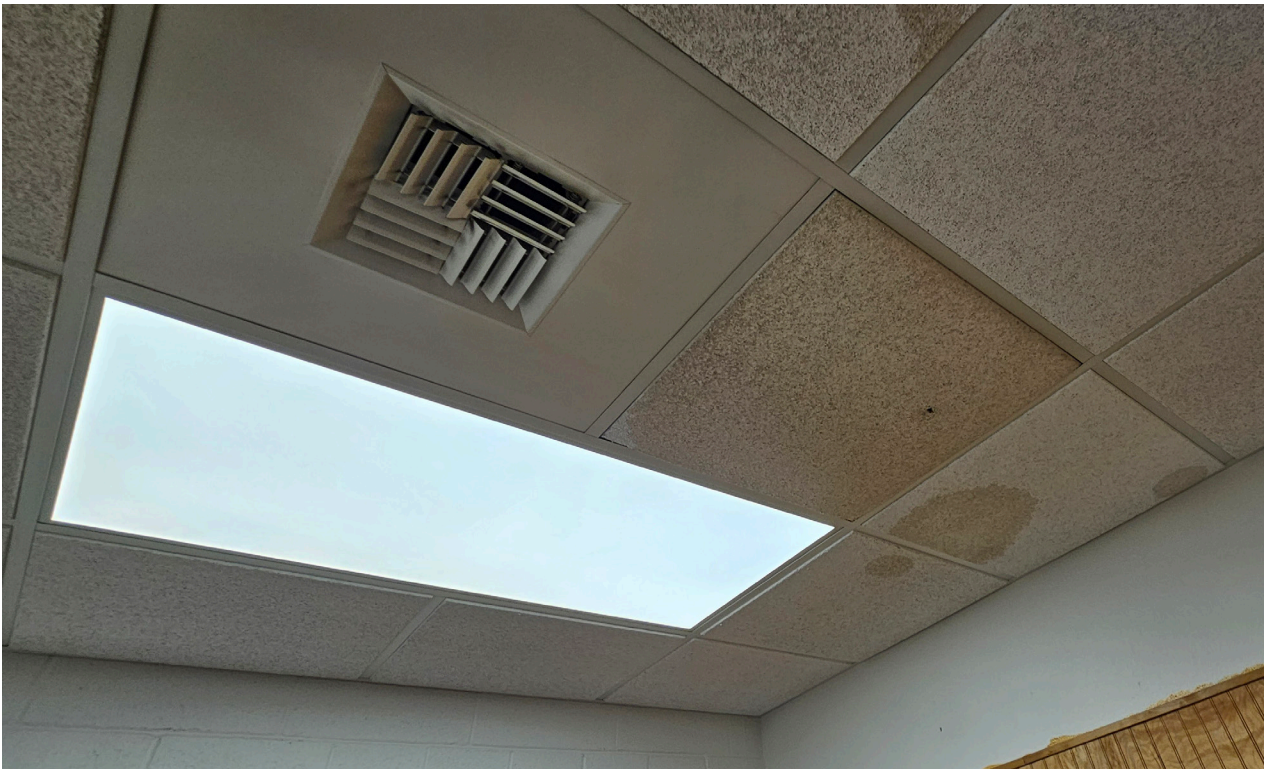
View of damaged ceiling tile.

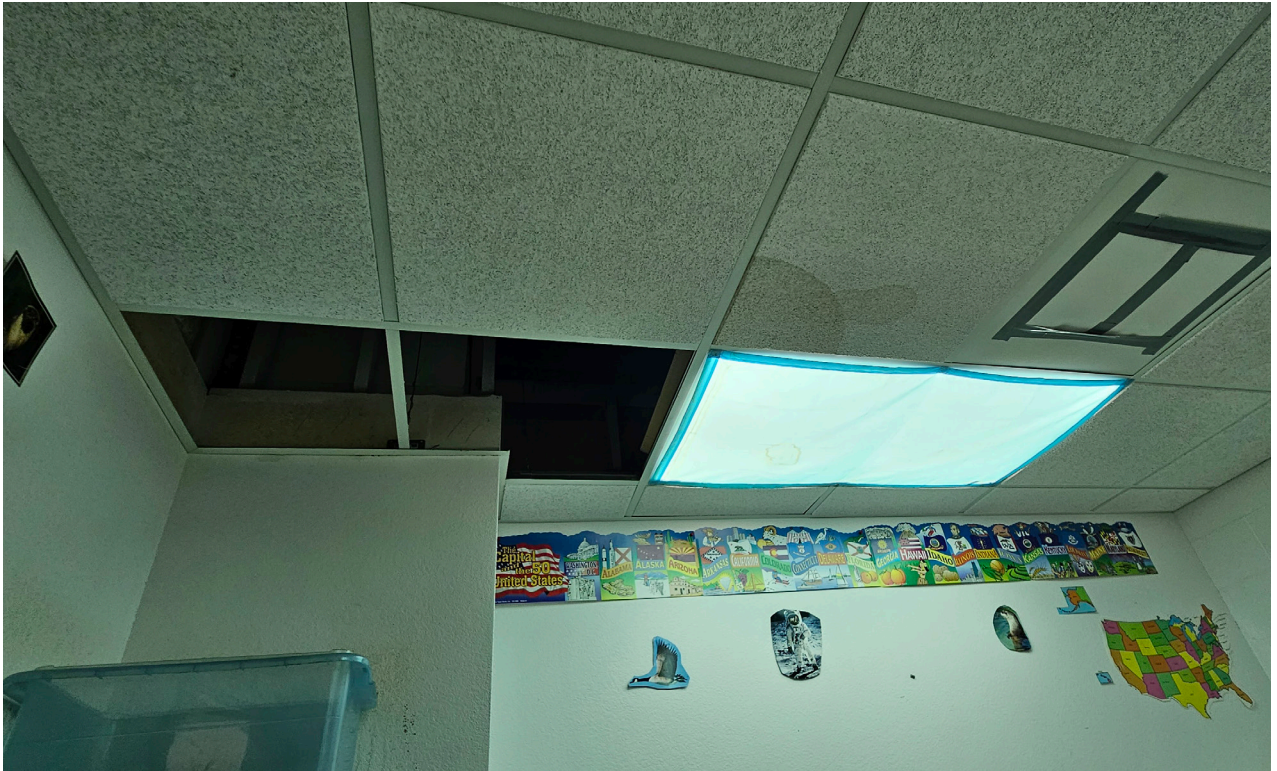
View of damaged ceiling tile.

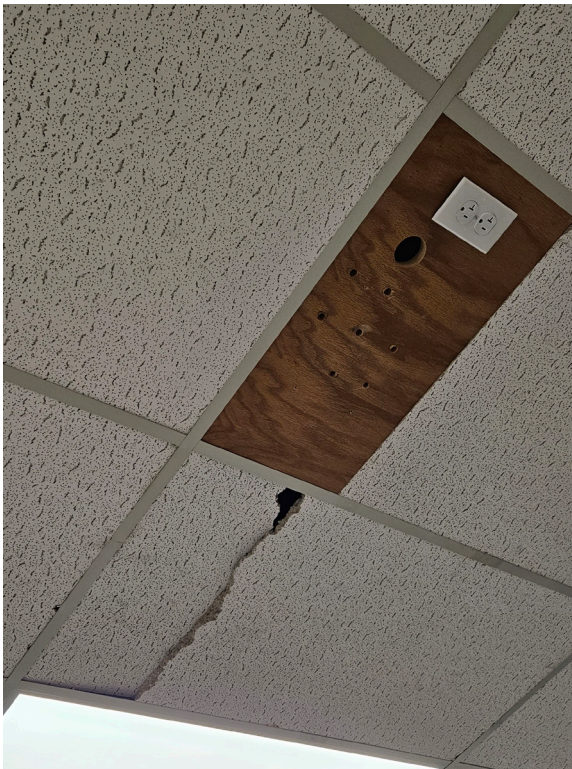
View of damaged ceiling tile.

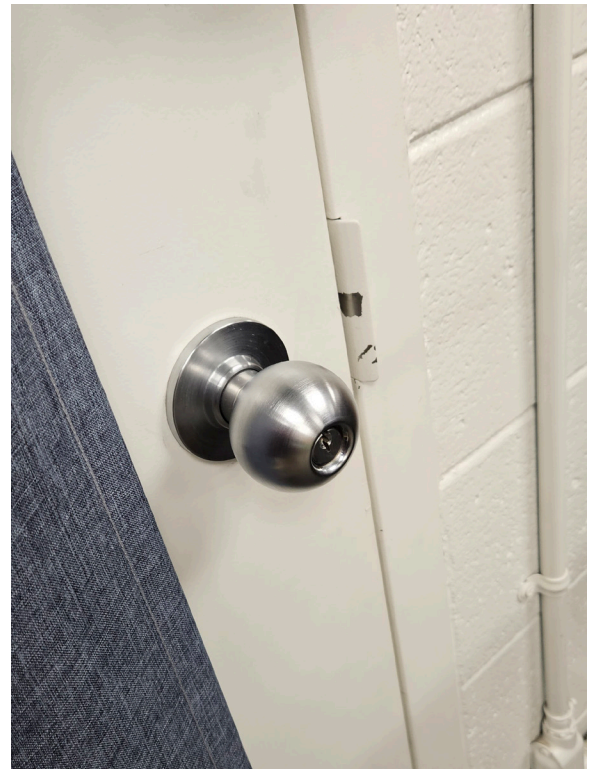
Non-conforming knob-style door hardware.

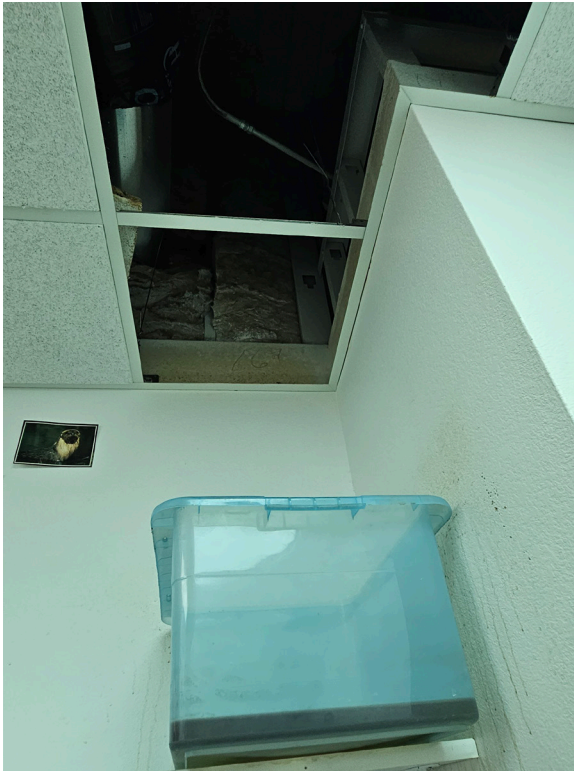
View of damaged ceiling tile.

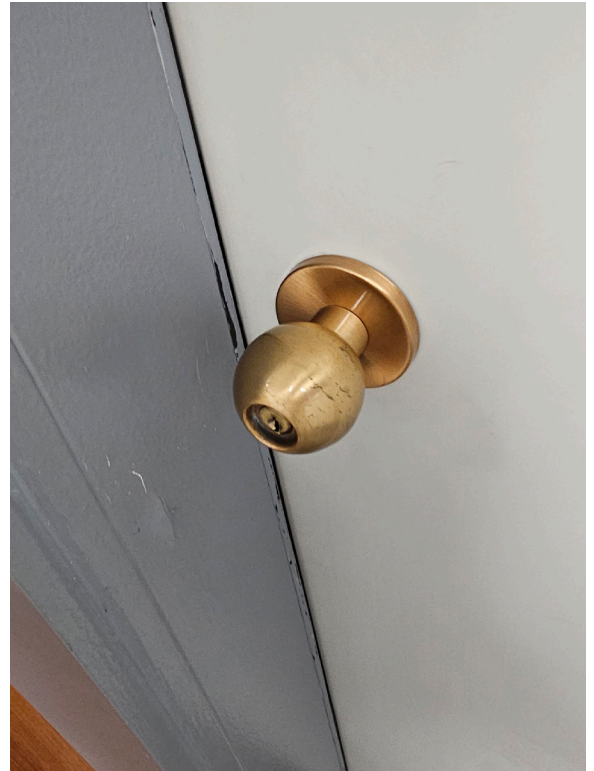
Non-conforming knob-style door hardware.

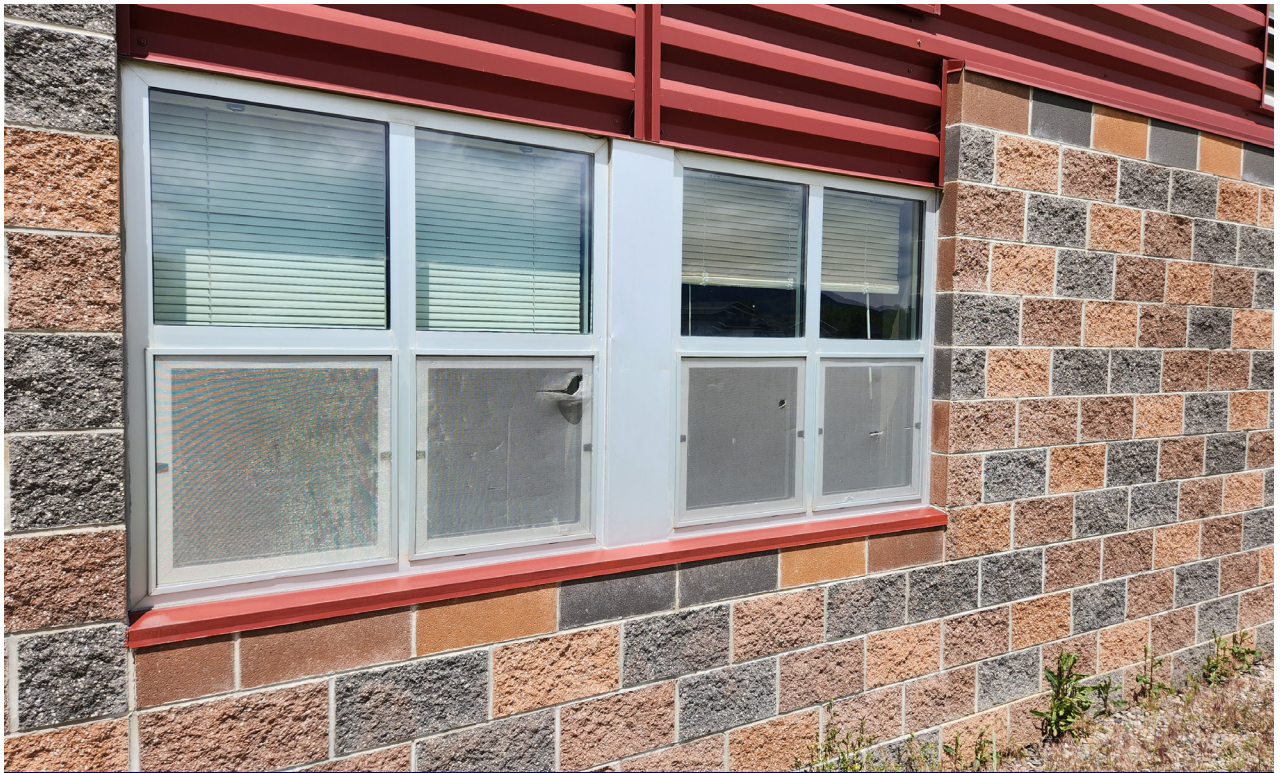
View of damaged exterior window screens.

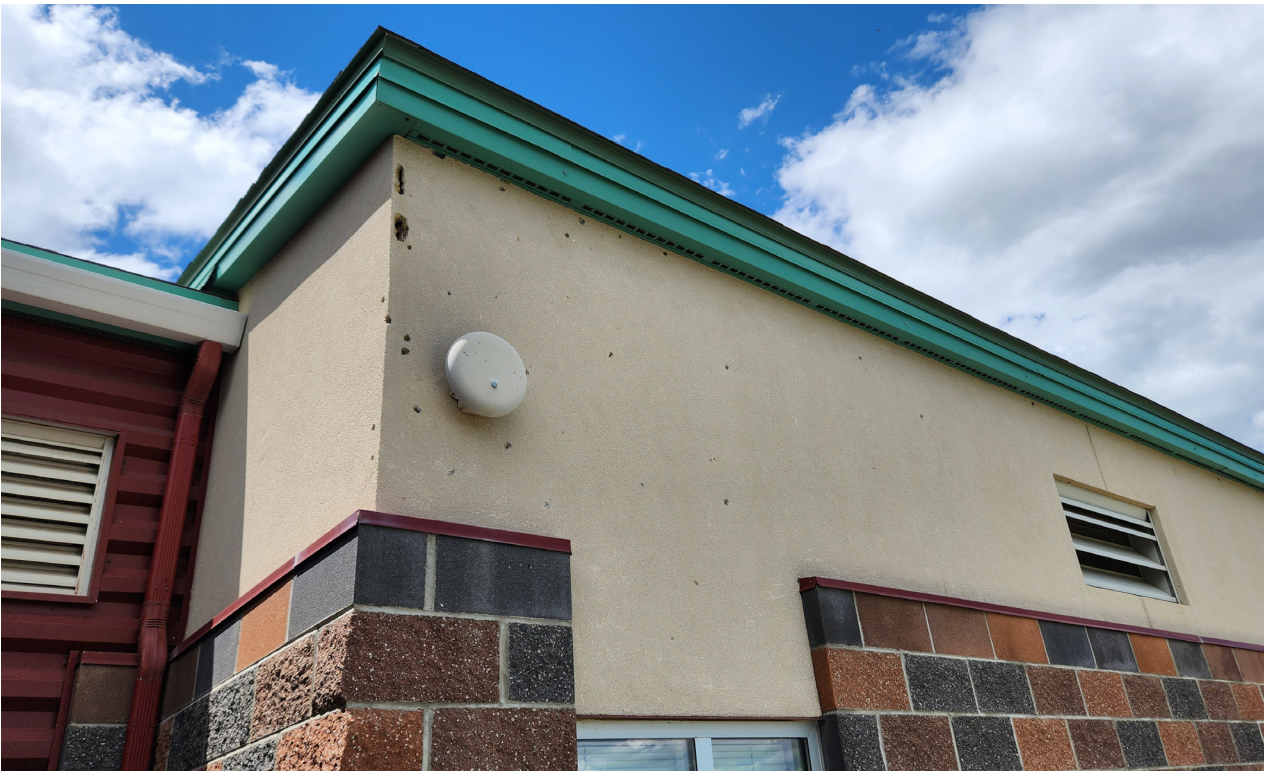
View of damage to the exterior insulation and finish system (EIFS).

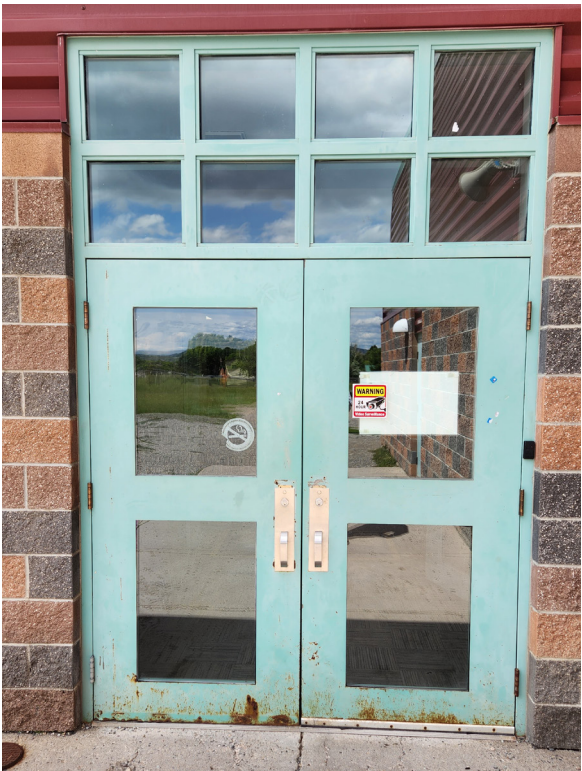
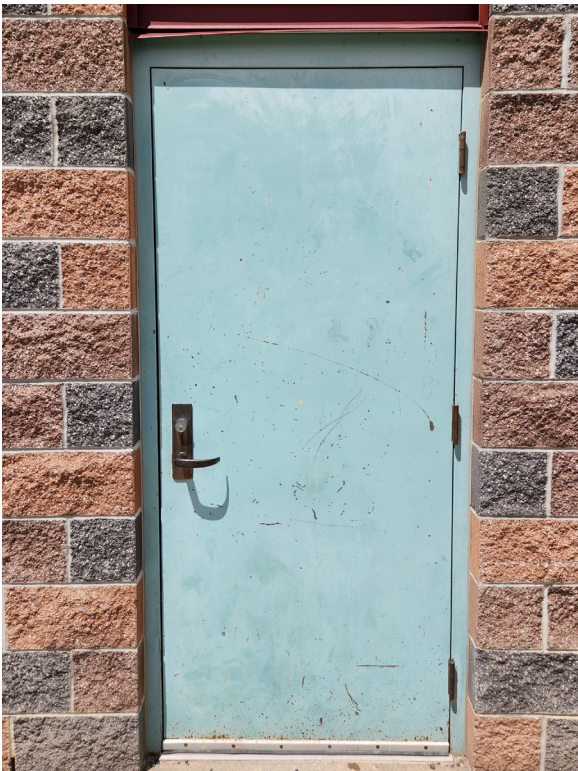
Example views of hollow metal door conditions.

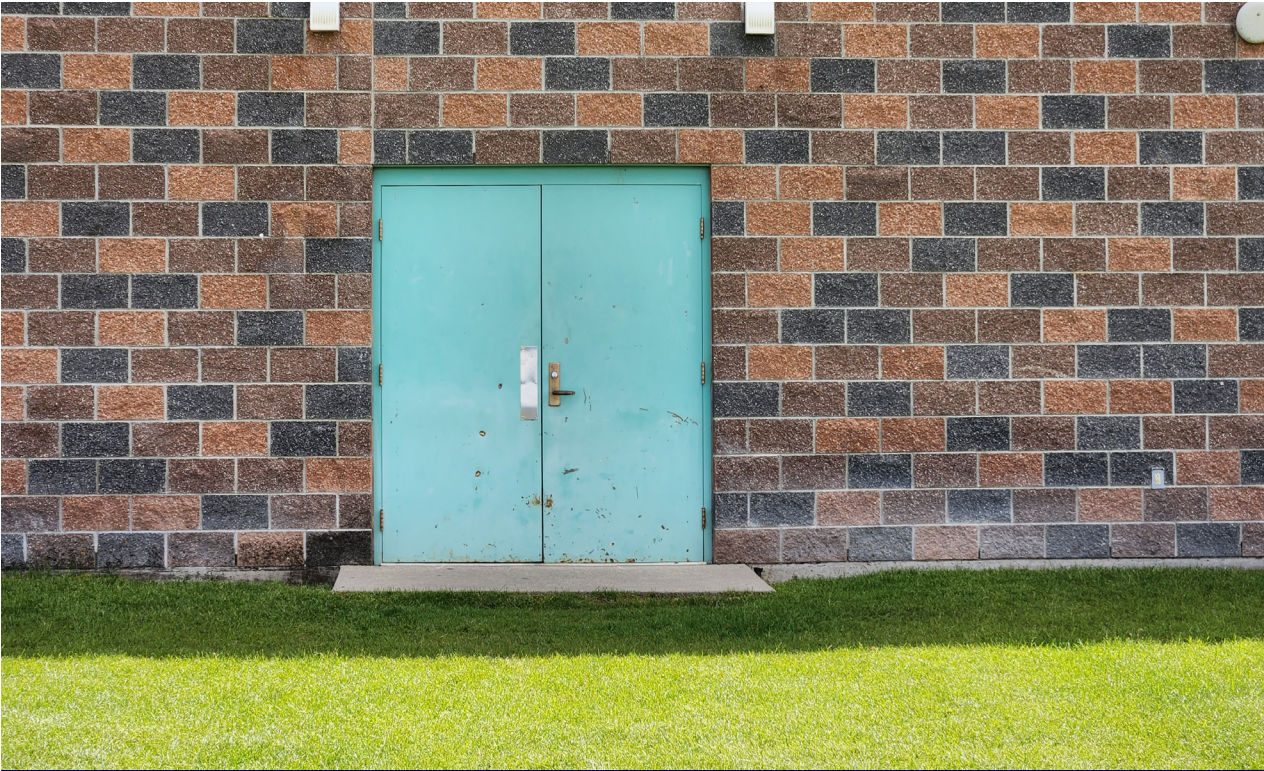
Example view of the condition of the hollow metal doors and frames.

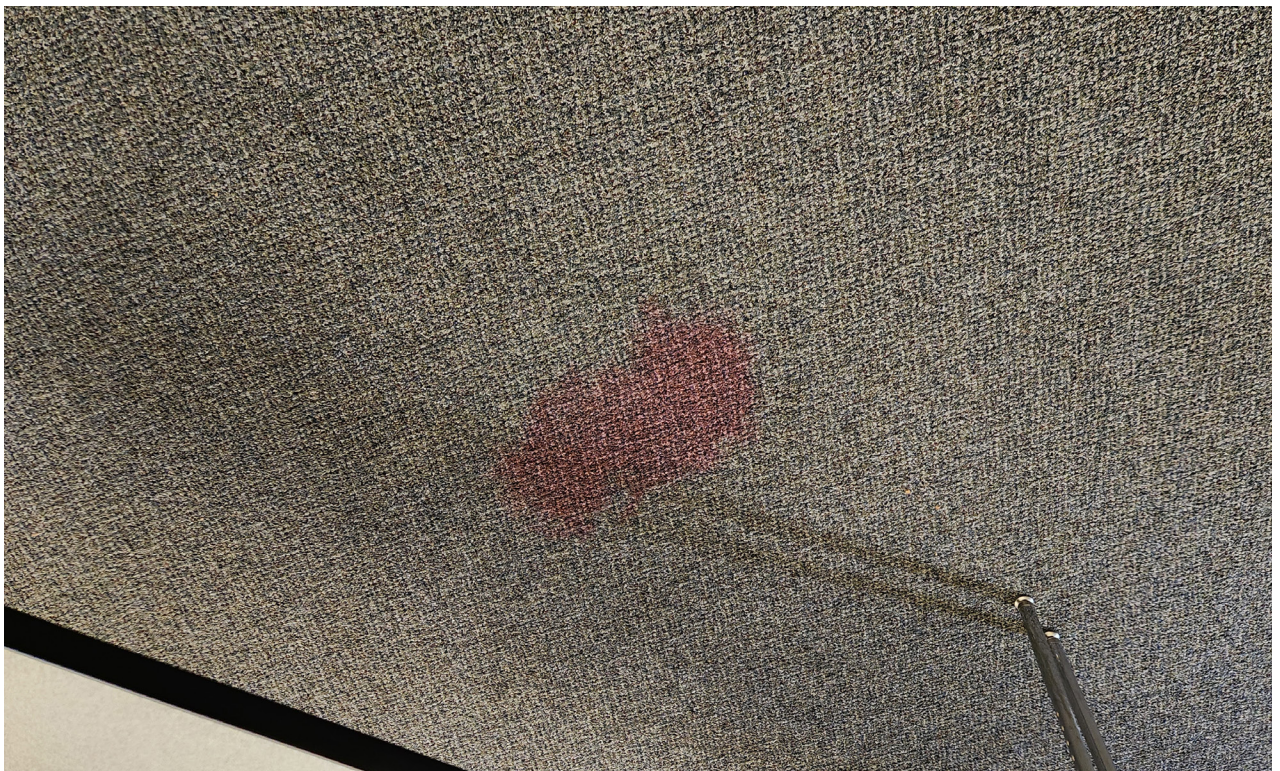
Example view of carpet staining.

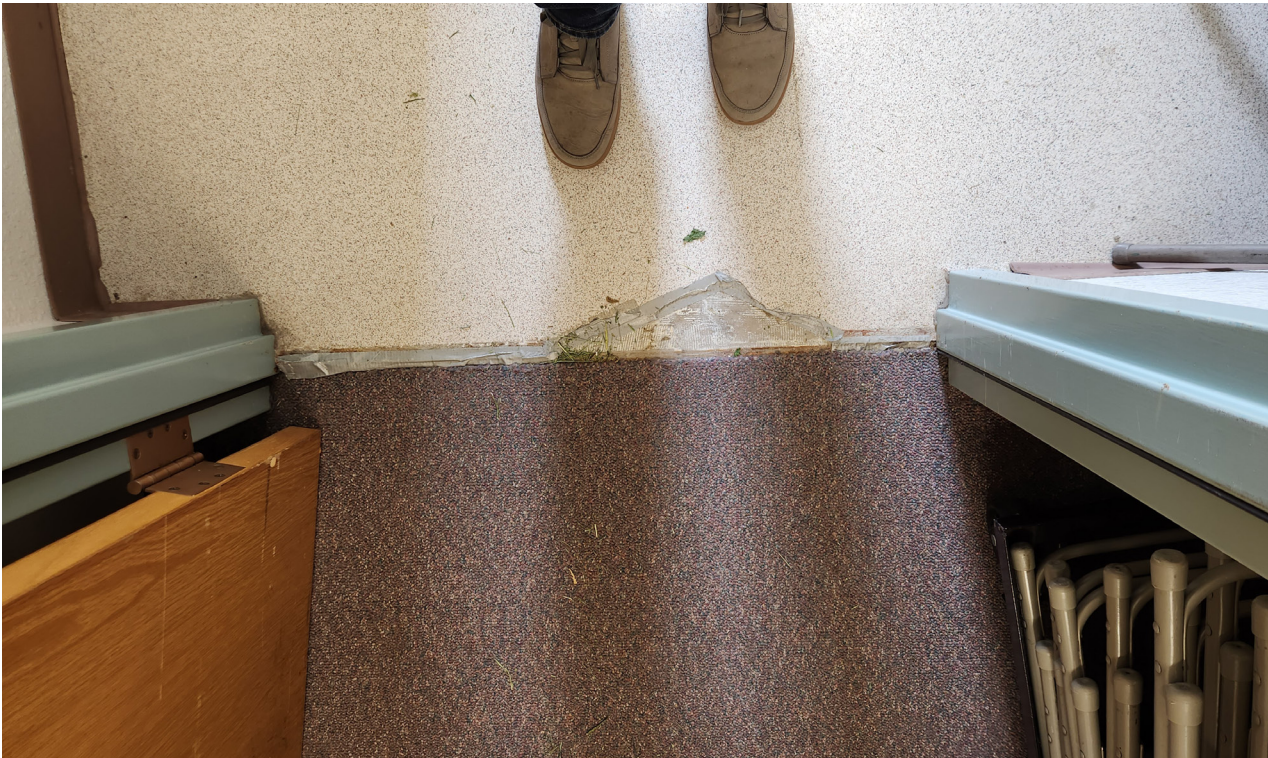
Example of damage at flooring transition.

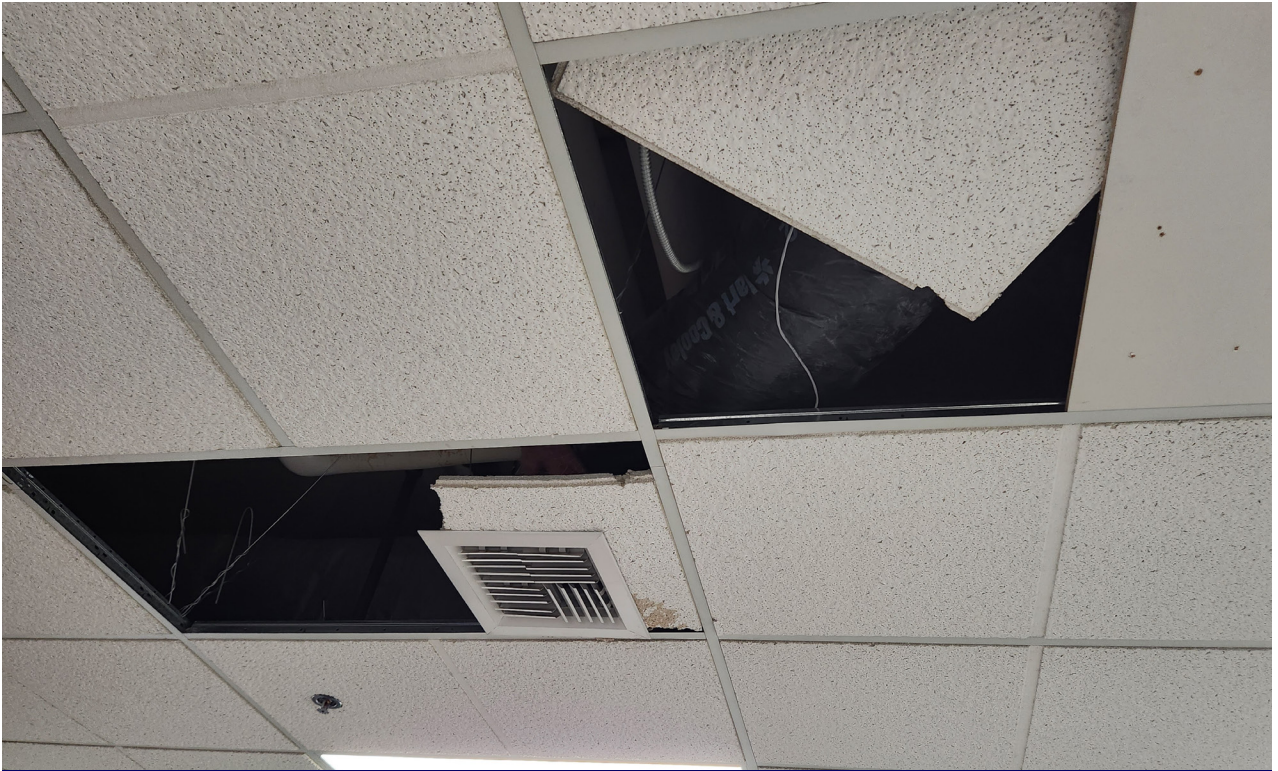
Example of damaged and missing ceiling tiles.

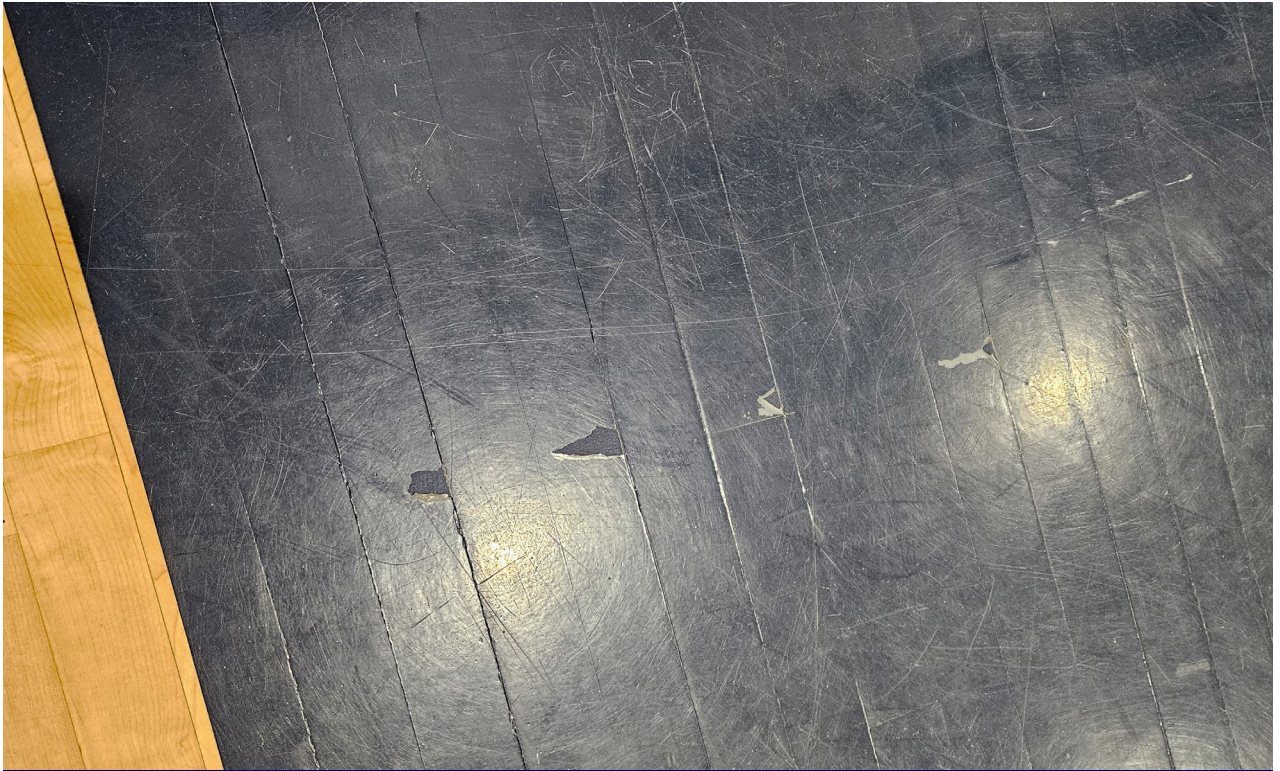
Gym floor finish showing wear and tear.

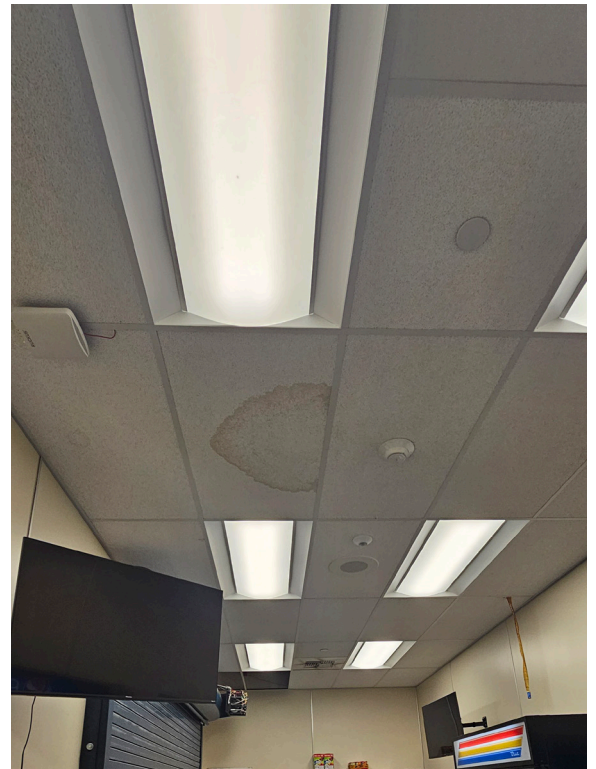
Ceiling tile in Concessions area showing signs of water damage.
