EAST HELENA PUBLIC SCHOOLS FACILITIES CONDITIONS REPORTS

EAST HELENA, MONTANA
EAST HELENA PUBLIC SCHOOLS MASTER PLAN
NOVEMBER 2023

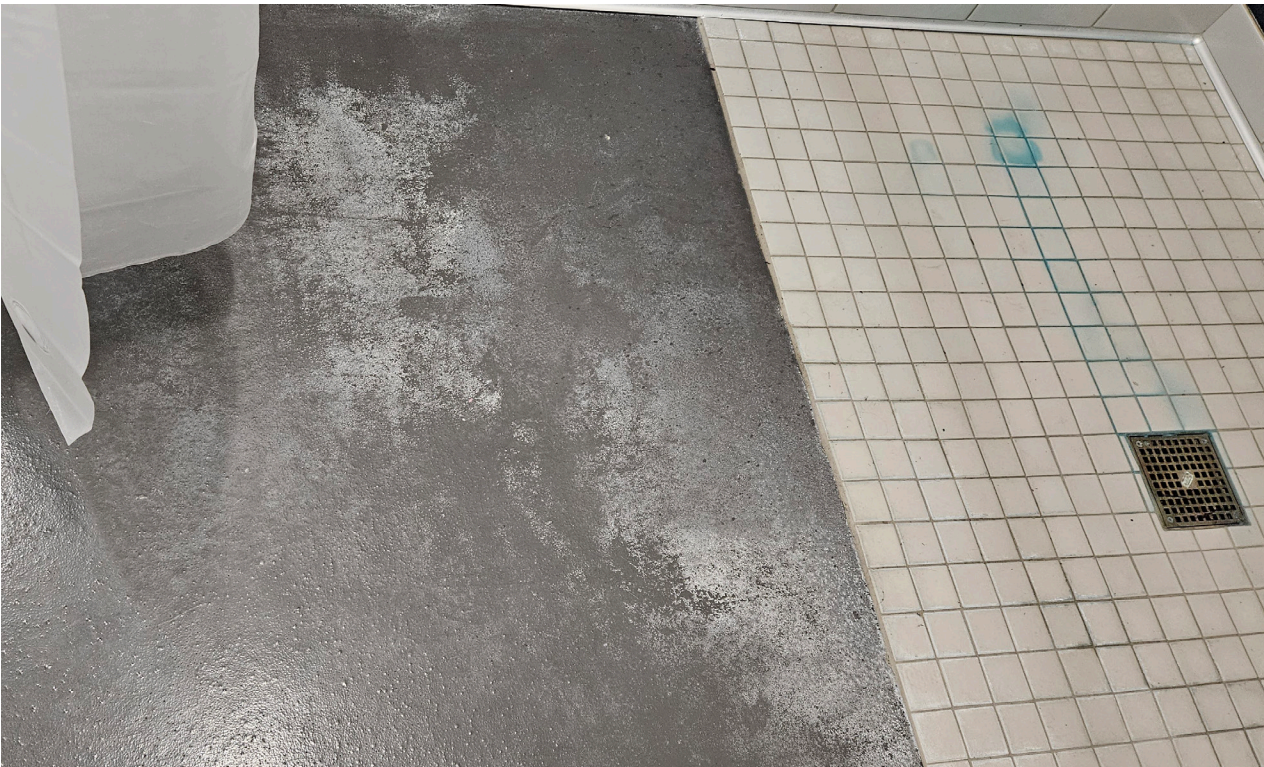
Locker room floor showing wear and tear and grout discoloration.

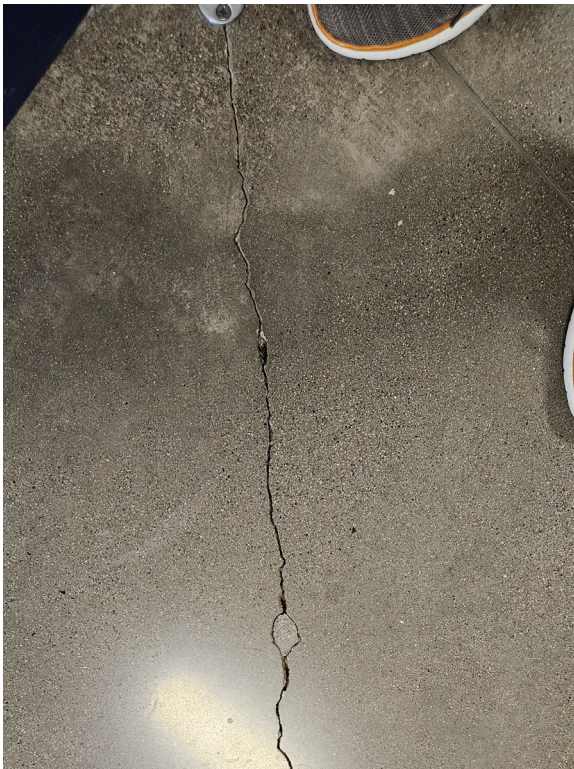
Typical concrete cracking at polished concrete floors.

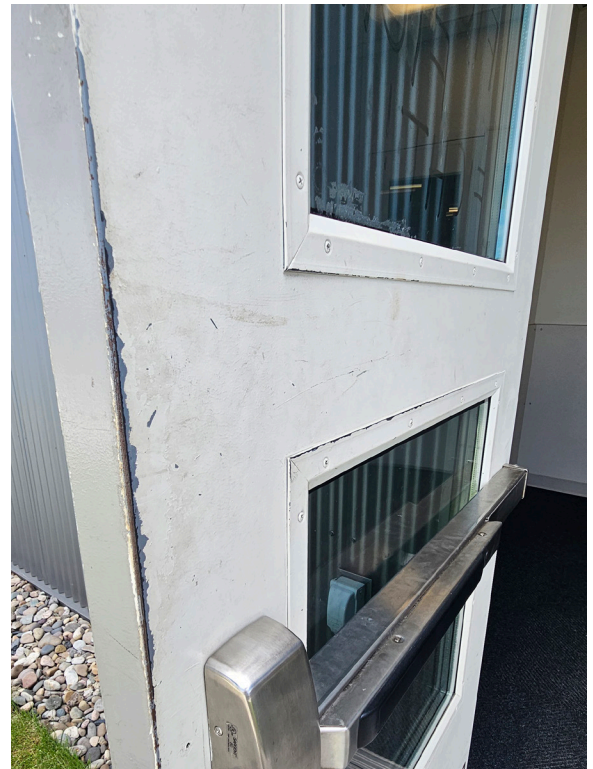
Wear and tear at hollow metal exit door.

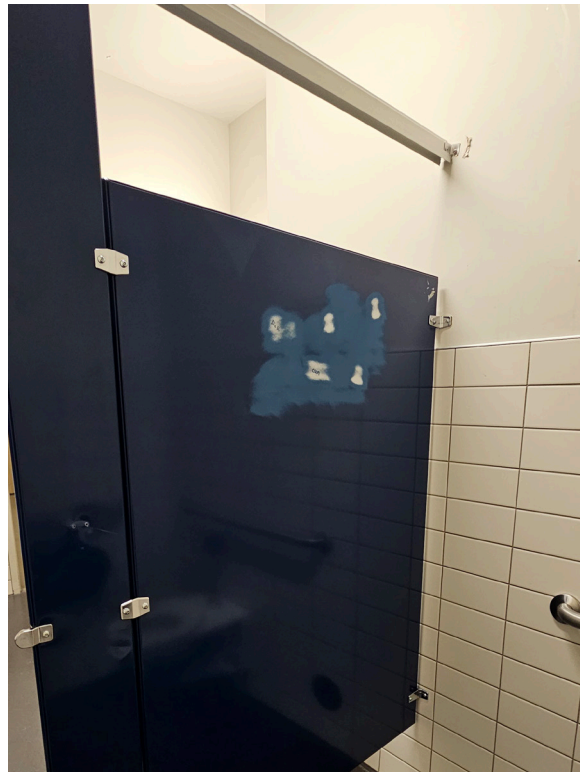
View of damage to toilet partitions.
