MEMORANDUM | August 21, 2024

Long Lots Elementary School

Short-Term Sealant Repair Strategies and Prioritization

SHORT-TERM WINDOW SEALANT REPAIRS

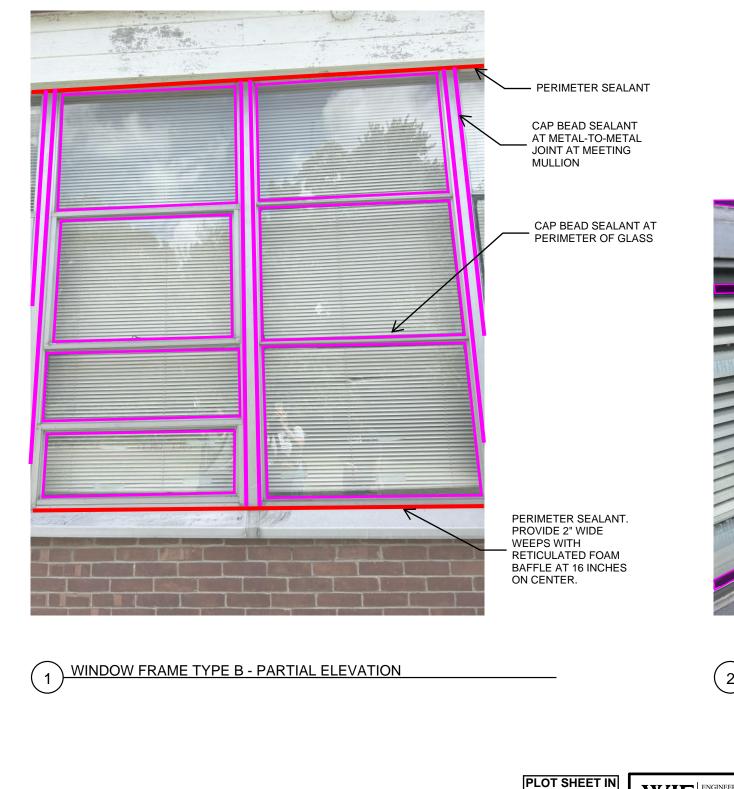
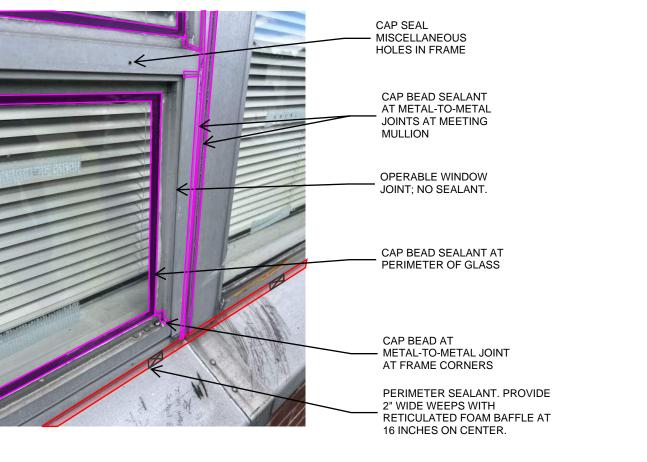
- 2. Windows at the 1953 Building Wing Window Framing Type B.
 - a. These windows have been identified as a priority based on reports of draftiness, evidence of past sealant repairs, daylight being visible through joints in the windows, and evidence of interior water staining.

PERIMETER SEALANT. REMOVE EXISTING
 POLYURETHANE PERIMETER SEALANT.
 PREPARE SUBSTRATES AS RECOMMENDED 0 BY SEALANT MANUFACTURER AND PROVIDE NEW SILICONE SEALANT AND BACKER ROD. SEE DETAIL 1/A-11. - CAP BEAD. CUT BACK EXISTING BUTYL

SEALANT OR REMOVE EXISTING SILICONE 0 CAP BEAD, WHERE PRESENT. PROVIDE NEW SILICONE CAP BEAD. SEE DETAIL 2/A-11.

- METAL-TO-METAL JOINT. PROVIDE PRE-FORMED SILICONE SHEET SPANNING ACROSS METAL-TO-METAL JOINT. SEE DETAIL 3/A-11.

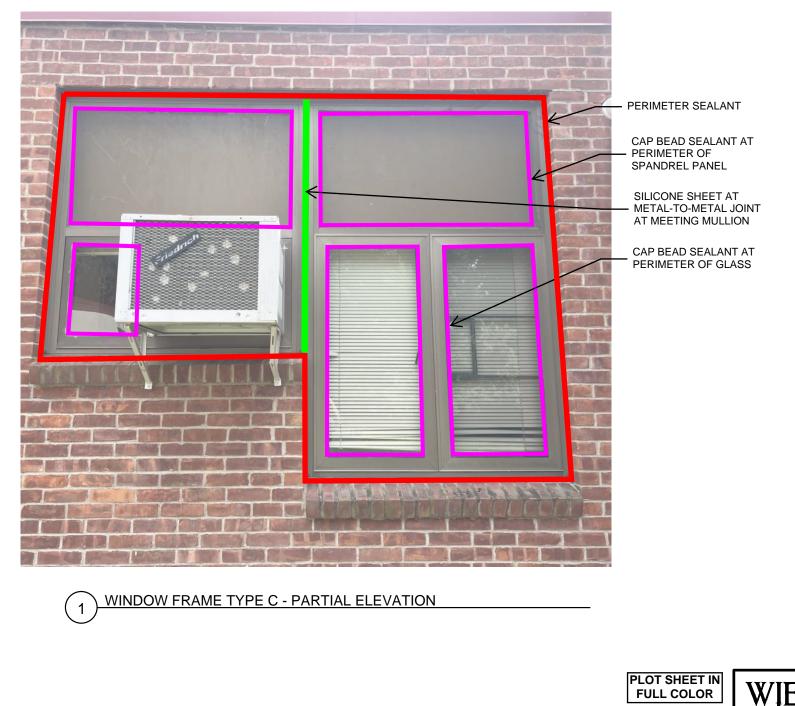
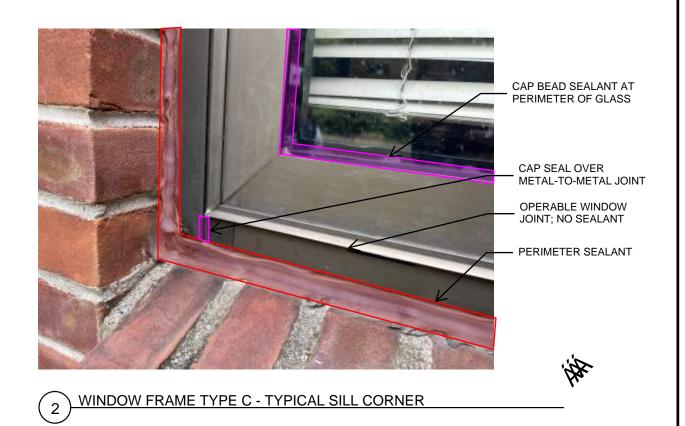
- 4. Windows at the 1974 Building Wing Window Framing Type C that are within the stucco-clad wall assembly.

- a. These windows have been identified as a priority because water leakage into the wall assembly can lead to corrosion of concealed metal framing and gypsum wall board. WJE observed loose wall cladding panels during our 2022 assessment, both below and adjacent to windows.

PERIMETER SEALANT. REMOVE EXISTING POLYURETHANE PERIMETER SEALANT. PREPARE SUBSTRATES AS RECOMMENDED BY SEALANT MANUFACTURER AND PROVIDE NEW SILICONE SEALANT AND BACKER ROD. SEE DETAIL 1/A-11. 	Ξ
- CAP BEAD. CUT BACK EXISTING BUTYL SEALANT OR REMOVE EXISTING SILICONE CAP BEAD, WHERE PRESENT. PROVIDE NEW SILICONE CAP BEAD. SEE DETAIL 2/A-11.	
- METAL-TO-METAL JOINT. PROVIDE PRE-FORMED SILICONE SHEET SPANNING ACROSS METAL-TO-METAL JOINT. SEE DETAIL 3/A-11.

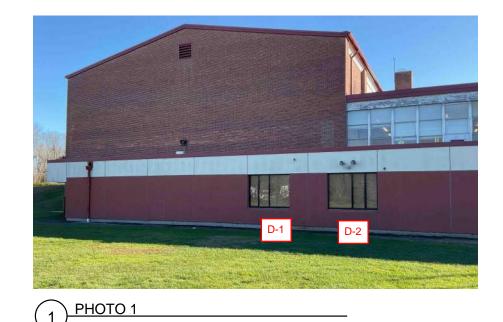
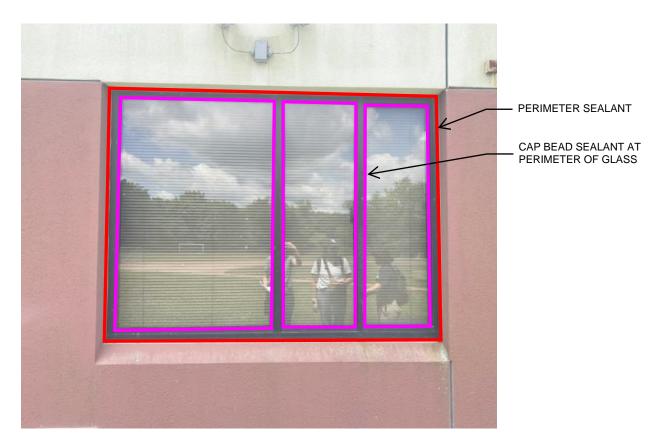
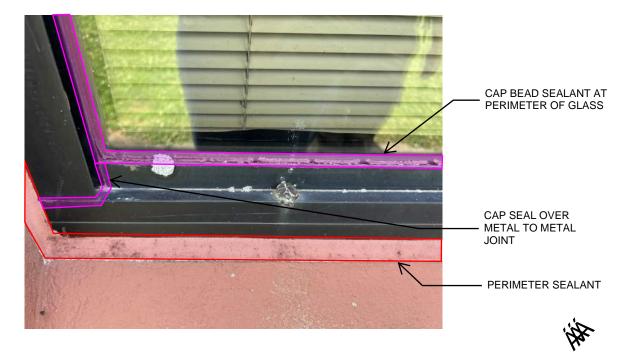
WINDOW FRAME TYPE D - PARTIAL ELEVATION

- 5. Window framing Type D near the baseball field.
 - a. These windows have been identified as a priority because water leakage into the wall assembly can lead to corrosion of concealed metal framing and gypsum wall board. These windows are a lower priority compared to Window Framing Type C because the rooms at the interior of these windows are unused.

LEGEND:	LEGEND:
D-1 ROUGH OPENING NUMBER OF THAT FRAMING TYPE	- PERIMETER SEALAN POLYURETHANE PE PREPARE SUBSTRA BY SEALANT MANUF NEW SILICONE SEAL SEE DETAIL 1/A-11.
WINDOW FRAMING TYPE NOTE: NUMBER OF WINDOW ROUGH OPENINGS ARE PROVIDED FOR CONTRACTOR	- CAP BEAD. CUT BAC SEALANT OR REMOV CAP BEAD, WHERE F SILICONE CAP BEAD
AND OWNER REFERENCE AND BIDDING PURPOSES. FIELD VERIFY.	- METAL-TO-METAL JC PRE-FORMED SILICO ACROSS METAL-TO-I DETAIL 3/A-11.
