**LAKE OSWEGO
SCHOOL DISTRICT**

**FACILITY CONDITION
ASSESSMENT**

OCTOBER 19, 2015

OH PLANNING + DESIGN, ARCHITECTURE

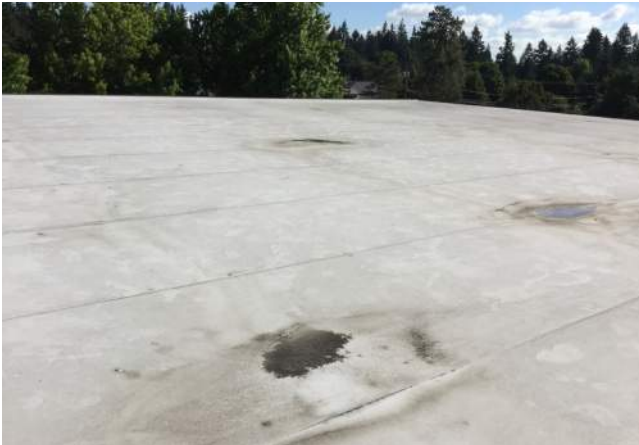
TPO Roofing as a Replacement Roofing Material Lakeridge Junior High

11 of the 17 sites have TPO roofing. The TPO roofing is to be a replacement roofing system applied within the last (3 to 14) years. Bubbling of the roofing material was consistently observed. The roofing condition inhibits drainage and results in ponding. There is evidence of regularly standing water. Brent Paul, LOSD Director of Facility Operations, confirmed that the roofing system is proving to be difficult to chase leaks. A pin hole can allow water into the single layer roofing system and the source can rarely be identified.

Recommendation: Implement a roofing maintenance plan that will replace the TPO roofs with an SBS built up roofing system, for durability, low maintenance, and longevity of materials.

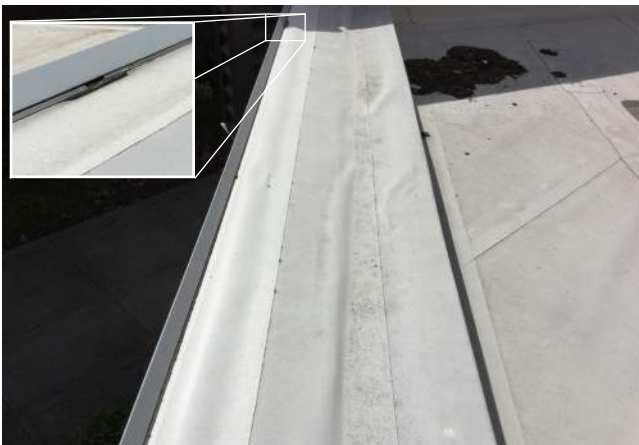
TPO Parapet Flashing Detail Lake Oswego High School

At the parapet edge, there is a consistent detail of a small metal edge cap that is clipped onto a cleat and sealed with a bead of all-purpose sealant. There is a weep system included in the metal edge cap that allows water to drain down the exterior surface of the parapet edge. This leads to regular staining of the parapet cap and potential water infiltration under the roofing membrane. The TPO roofing system on the parapet often appeared bubbled; not allowing water to drain onto the roof.

Recommendation: Replace the metal edge cap with a full sheet metal cap flashing to maintain drainage off parapet edges, at all buildings with this parapet flashing detail.

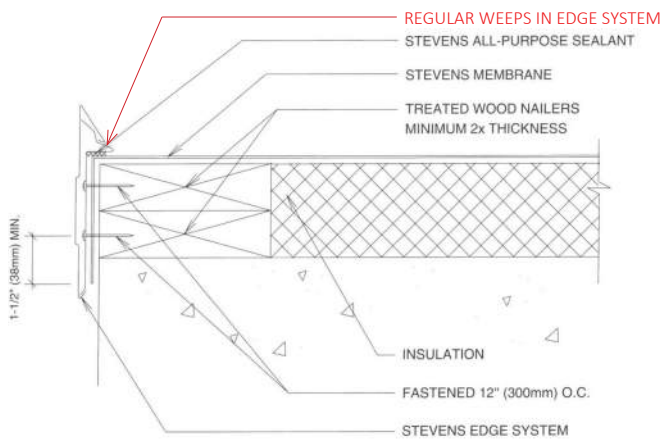
NOT RECOMMENDED
single ply roofing membrane flashing detail

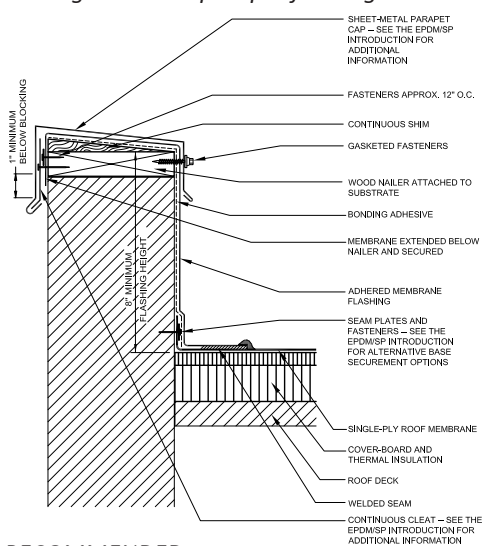
RECOMMENDED
single ply roofing membrane flashing detail

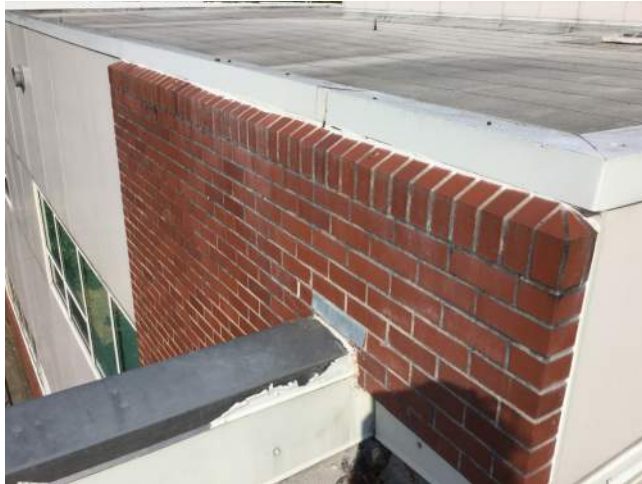
Exposed Brick Course Proud of Roof Edge Oak Creek Elementary School

Parapet does not extend out to cover the brick veneer. The building envelope relies on a bead of sealant between the top row of brick and the bottom of flashing for preventing water infiltration. A bead of sealant as the first and only line of defense requires regular and rigorous maintenance at these conditions.

Recommendation: Replace the cap flashing and build up the brick to align with the top of parapet; install new sheet metal cap flashing over the brick and parapet, and drain back onto the roof.

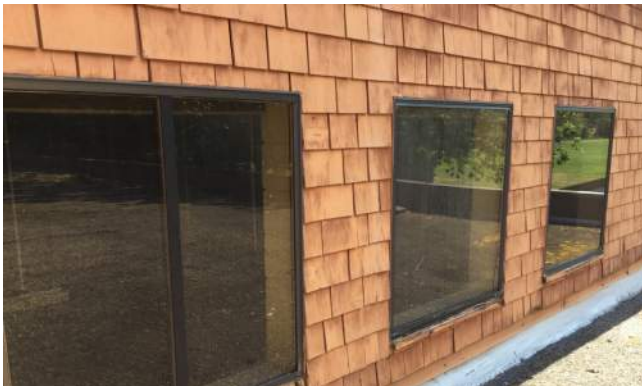
Lack of Window Head or Sill Flashing Westridge Elementary School

Windows are missing head and sill flashing allowing water to penetrate the building envelope.

Recommendation: Install head and sill flashing at all exterior windows.

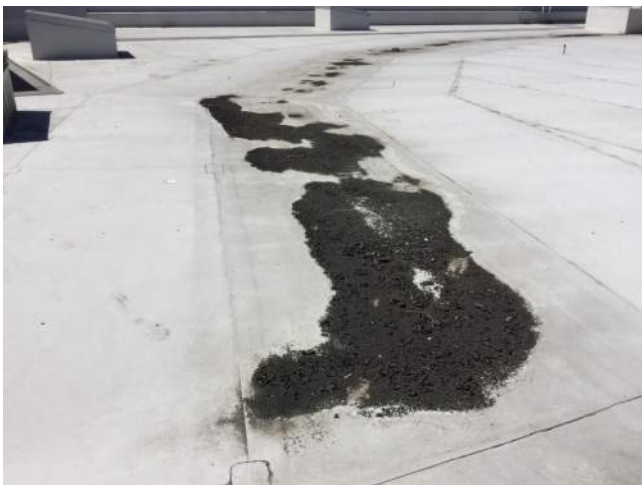
Inadequate Roofing Crickets Lakeridge High School

All sites at LOSD have observed cricket deficiencies to adequately drain water off the roof. Distance to reach drains is too far, cricket slopes are not steep enough to move the water and, as a result, sediment builds up.

Recommendation: Replace and raise the slope of roofing crickets. At some locations, additional drains may be needed to shorten the drainage distance.

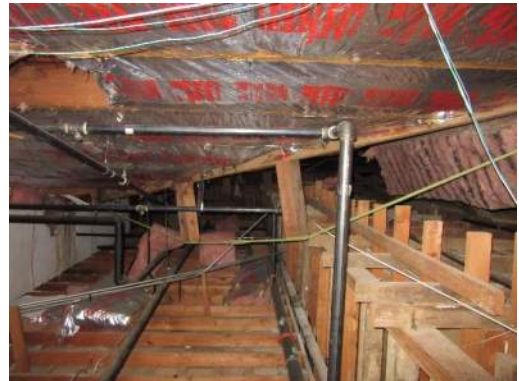
Irregular Timber Beam

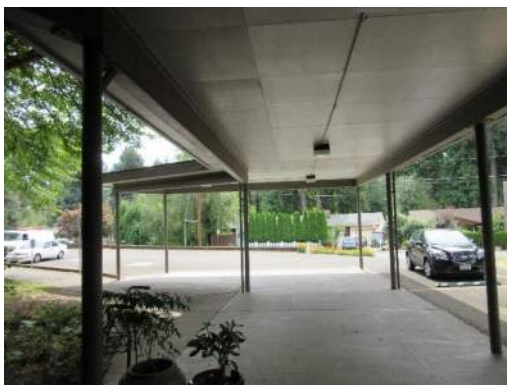
Seismically Deficient Entry Canopy

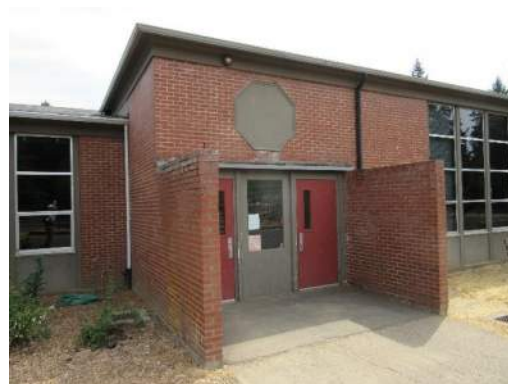
Seismically Deficient URM Side Entry

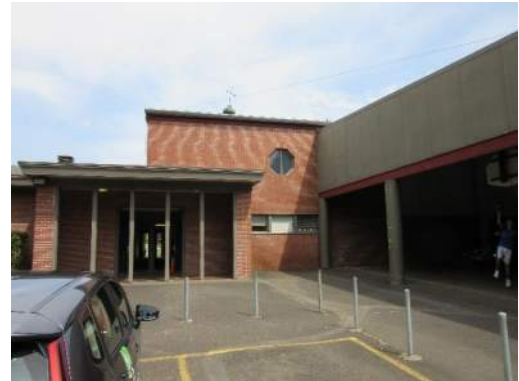
Possible Vertical Irregularity

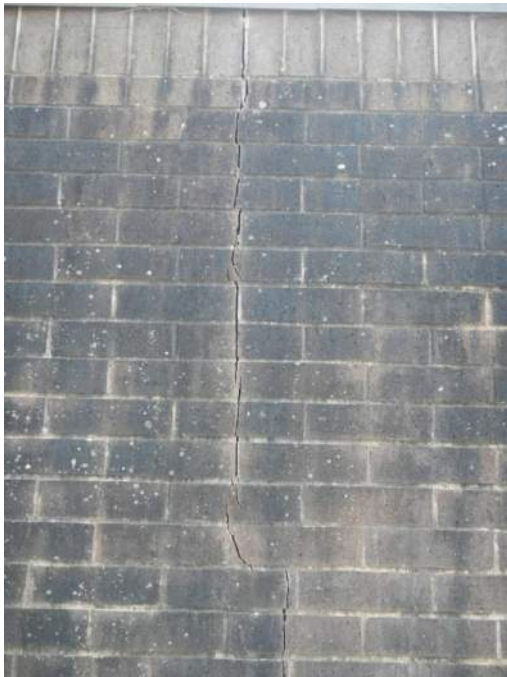
Cracking at Exterior Veneer

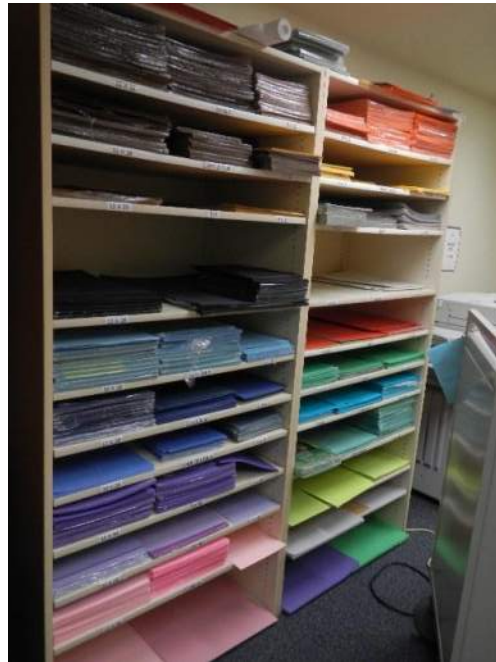
Fall Prone Contents

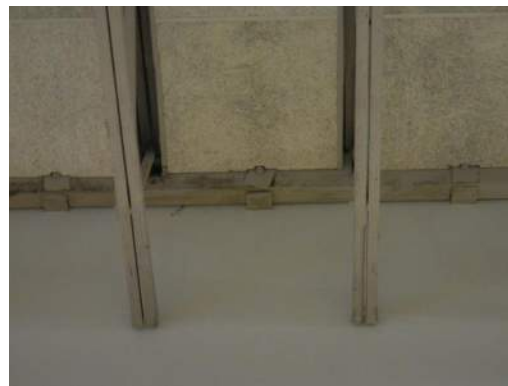
Inadequate Diaphragm Connection

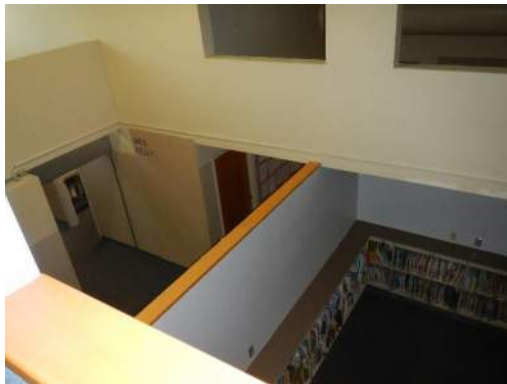
Unbraced Partial Height Walls

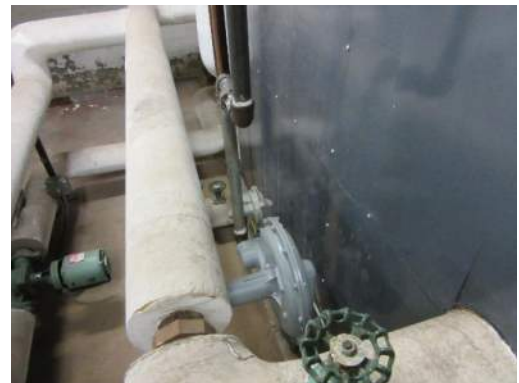
Hard Connected Gas Line

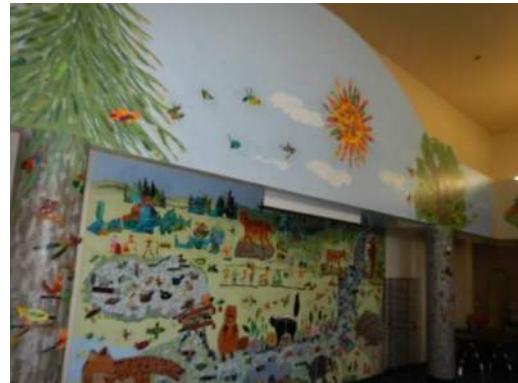
Location of Cracked Beam

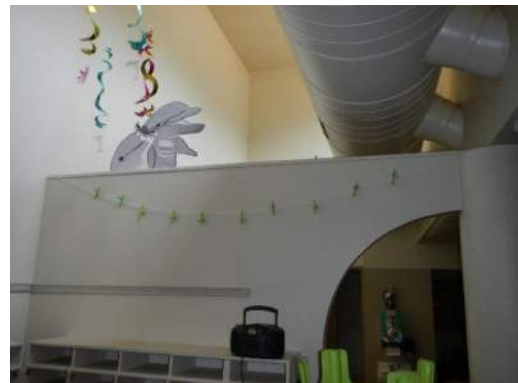
Unbraced Partial Height Wall

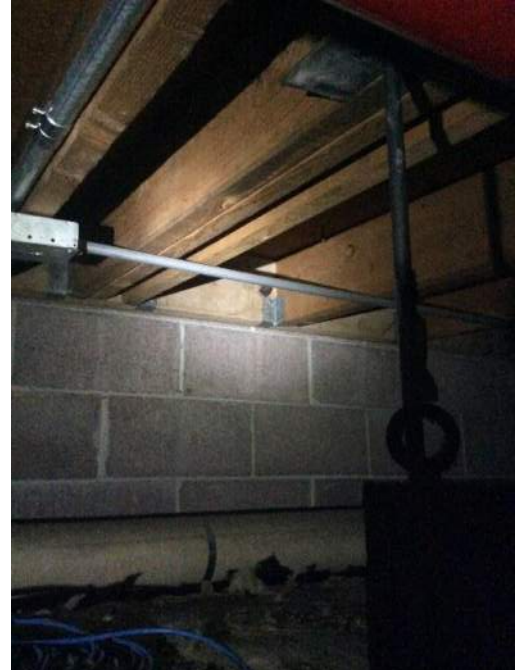
Inadequate Diaphragm Connection

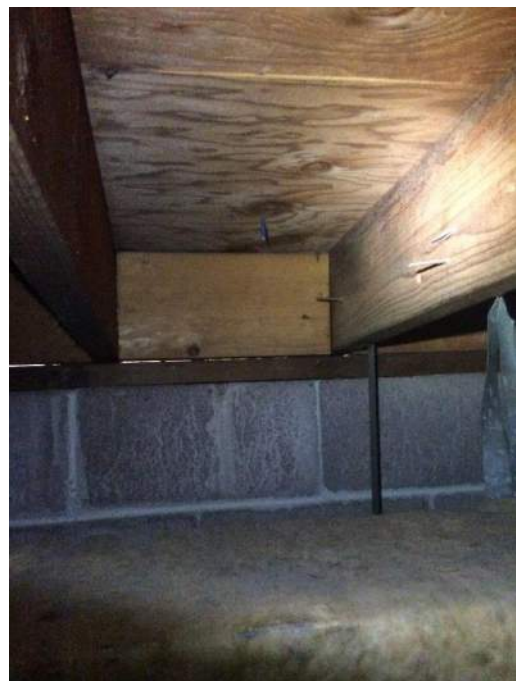
Inadequate Joist Connection

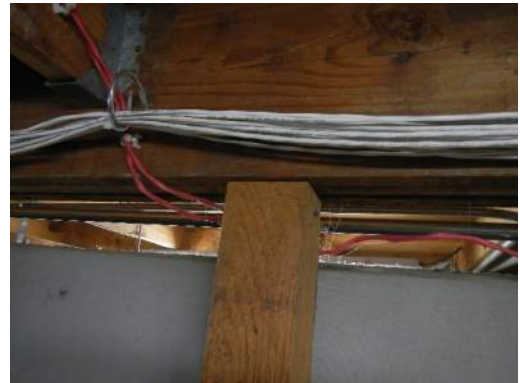
Post to Girder Inadequate Connection

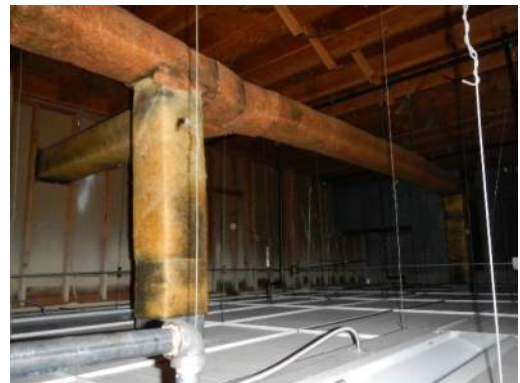
Unbraced Ceiling Tiles

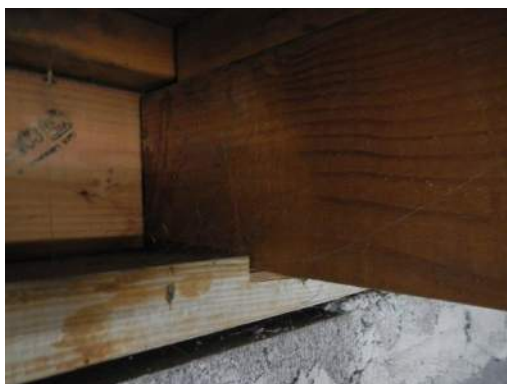
Inadequate Joist Connection to Wall

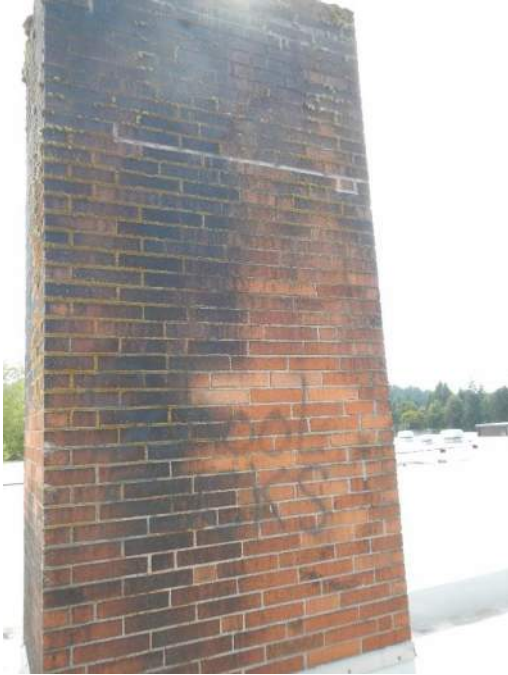
URM Chimney

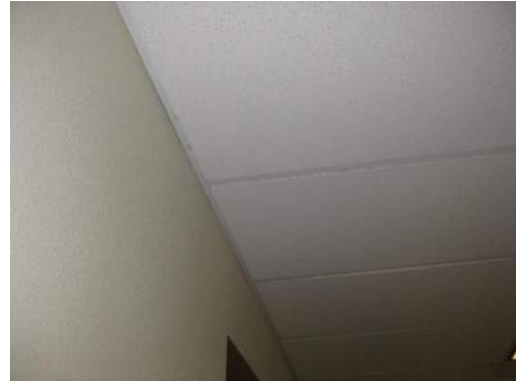
Ceiling Edge Clearance Deficient

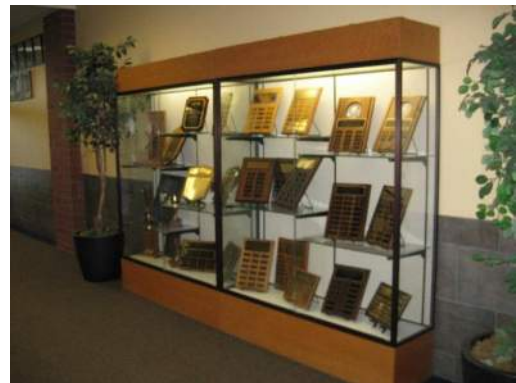
Trophy Cabinet Not Anchored

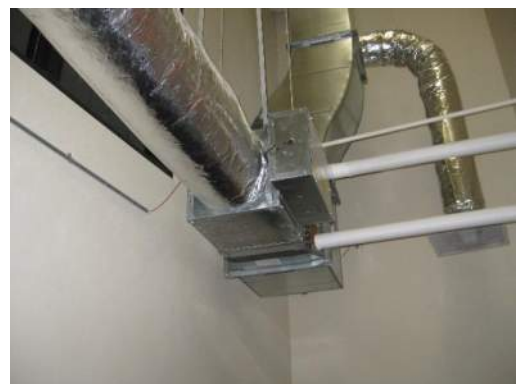
In-line Equipment Not Braced

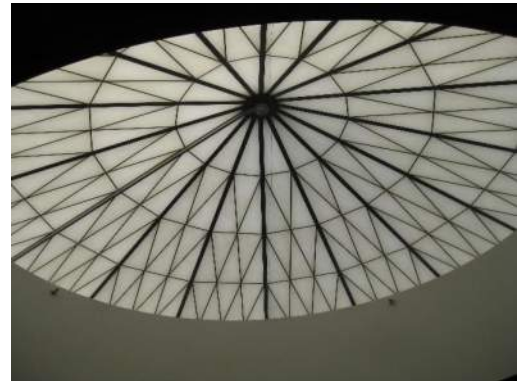
Overhead Glazing Falling Hazard

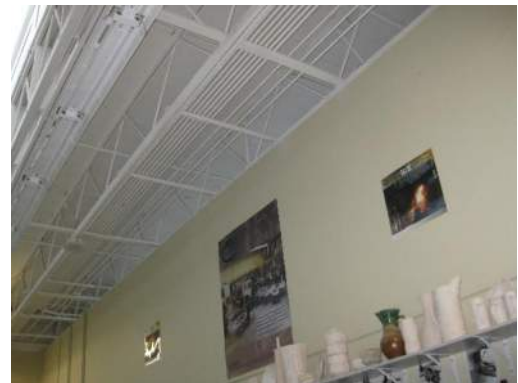
Partition Wall Attached to Unbraced Bottom
Truss Chord

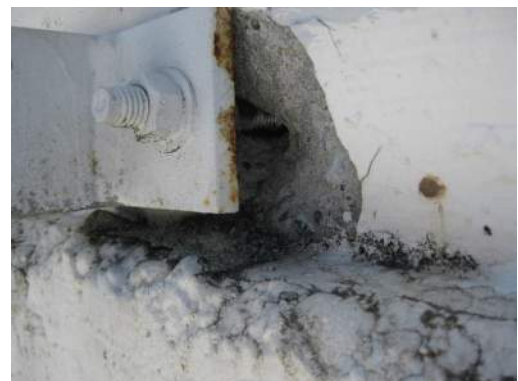
Spalling at Ladder Anchorage

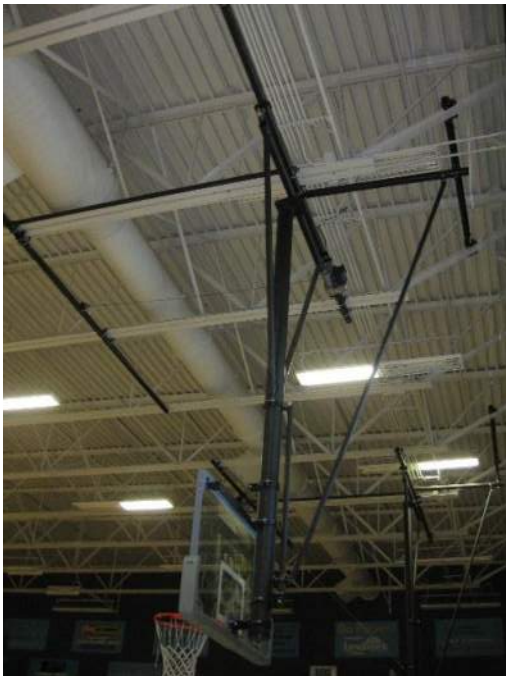
Backboard Braced to bottom of Truss –
Deficiency

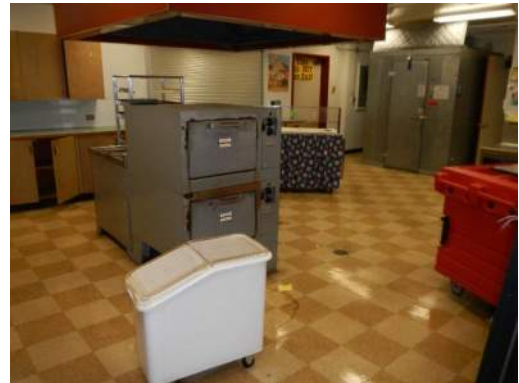
Unanchored Equipment in Kitchen

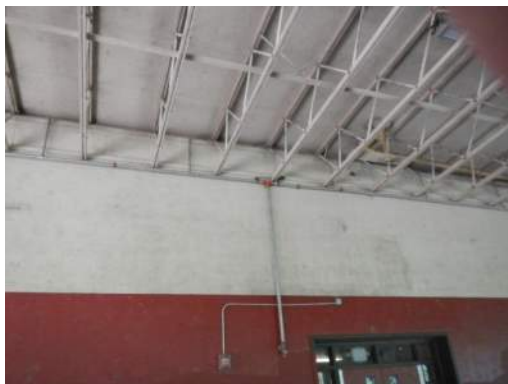
Inadequate Diaphragm Connection

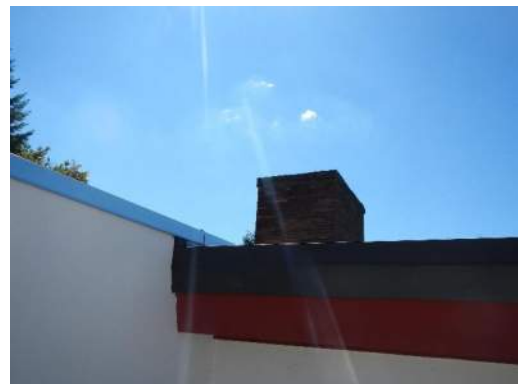
URM Chimney

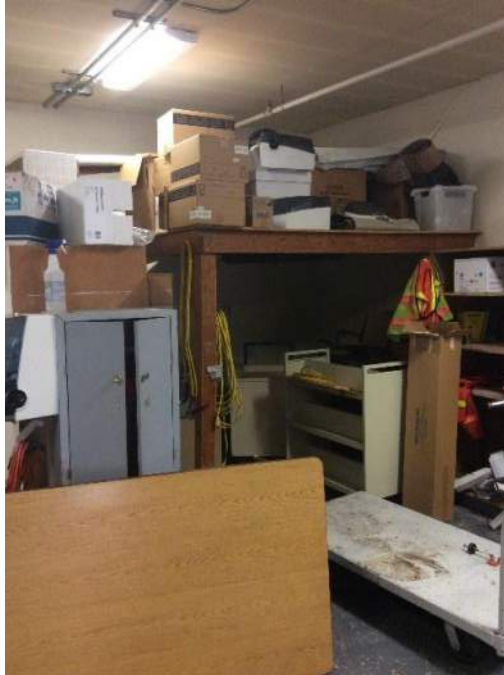
Fall Prone Contents

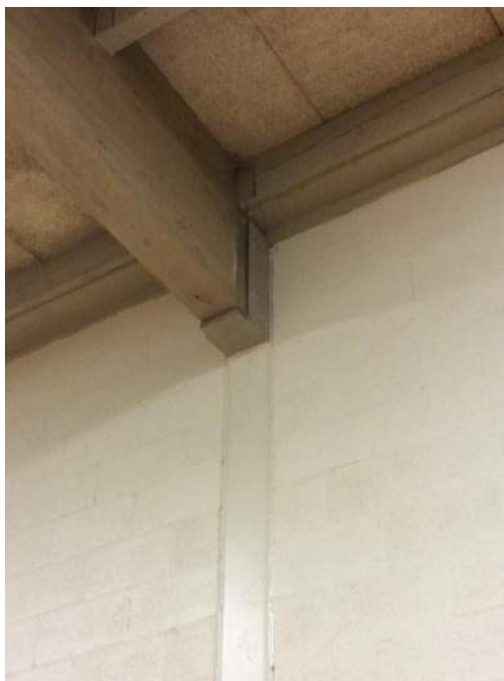
Inadequate Diaphragm Connection

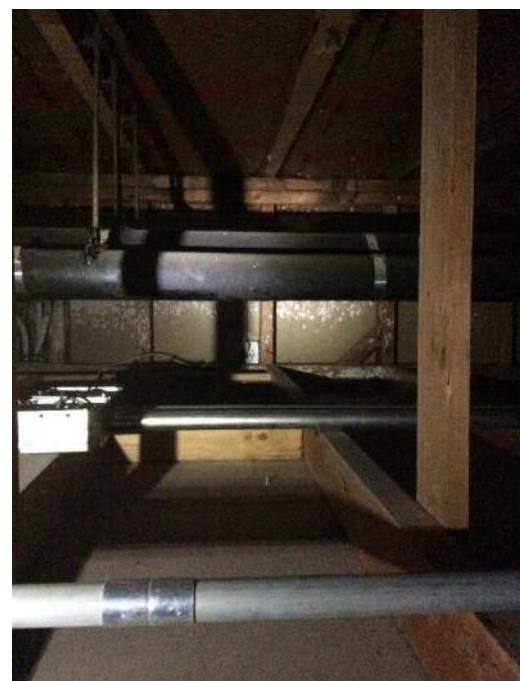
Unbraced Piping

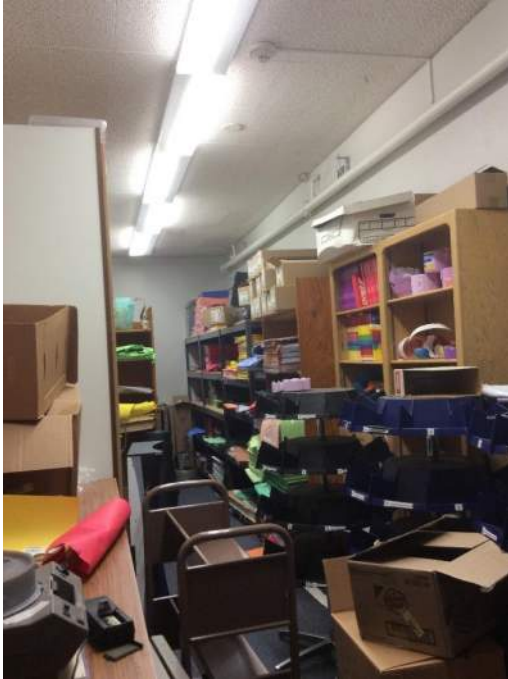
Unbraced Shelving

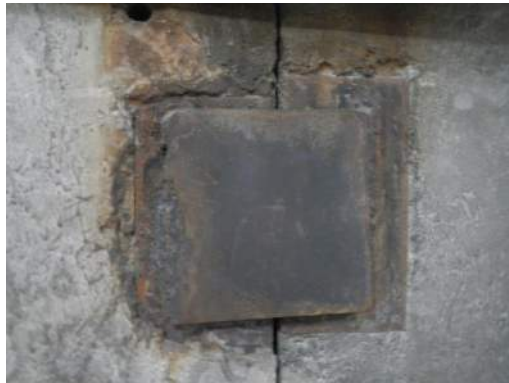
Corrosion in Panel Connections

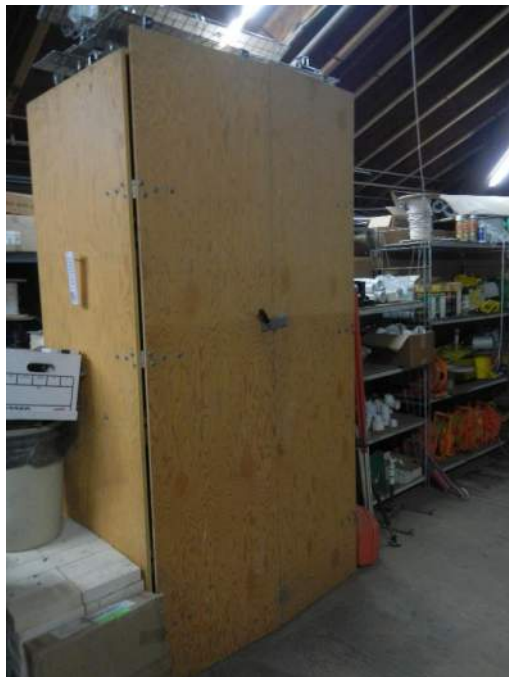
Fall Prone Contents

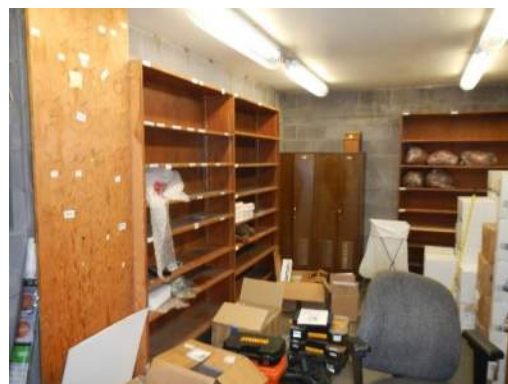
Unbraced Shelving

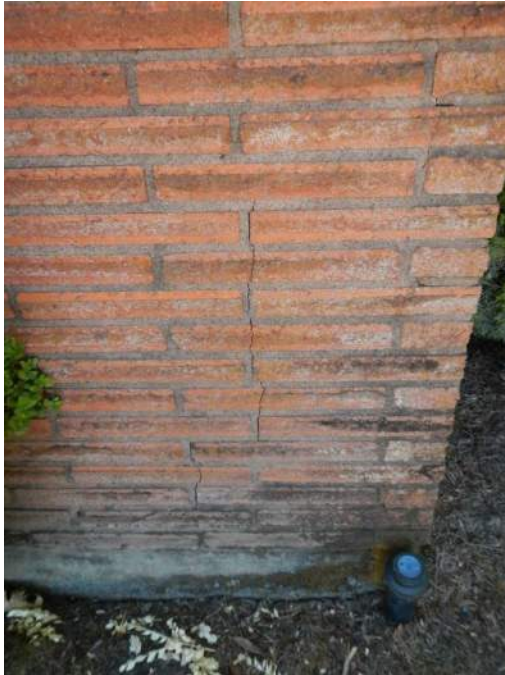
Cracking in Brick Veneer
