Building Assessment Narrative

Wooster High School

Building Information - Wooster City (45120) - Wooster High School

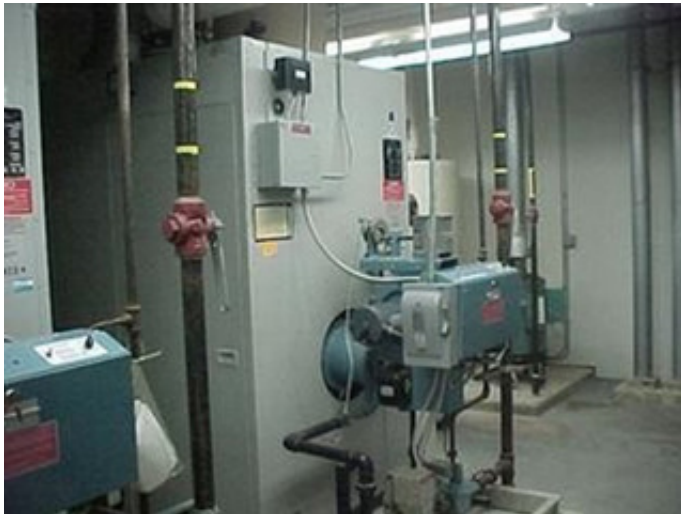
Hot water boilers

Recommendations: Replace the failed exhaust fans and make up air units in Gym and running track. Replace the direct fired units with indirect fired units so fumes no longer accumulate in occupied spaces. Remove abandoned make up air units for Natatorium in Mechanical Room. Replace the two (2) Natatorium rooftop dehumidification units with a system of better quality. Replace the VAV boxes and their controls. Replace the rusted air handling units. Replace the Building Automation System with more user friendly controls and expand with more capability to meet OSDM standards. Much of the existing heating system can remain without replacement. The central duct distribution can remain and the hot water heating piping and pumps can remain.

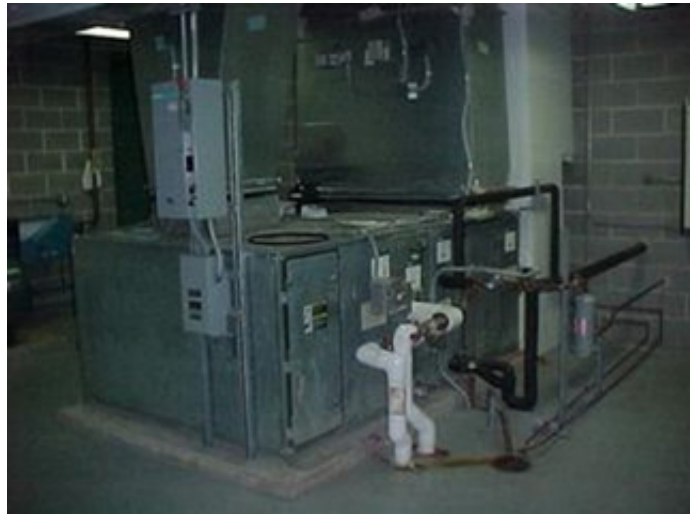
Air handling unit

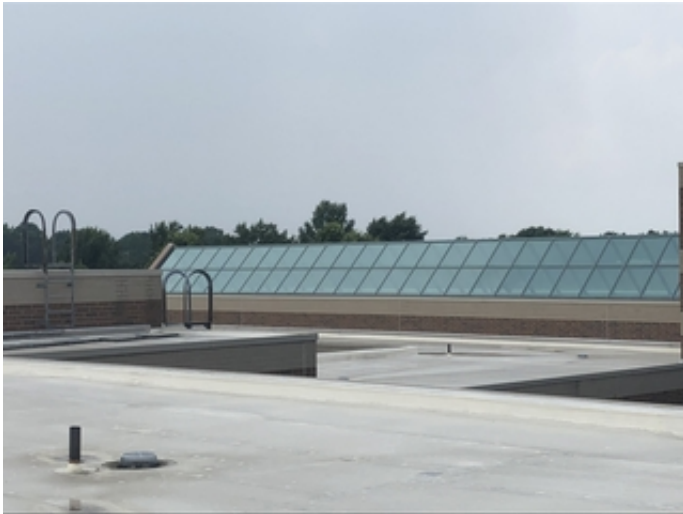
TPO

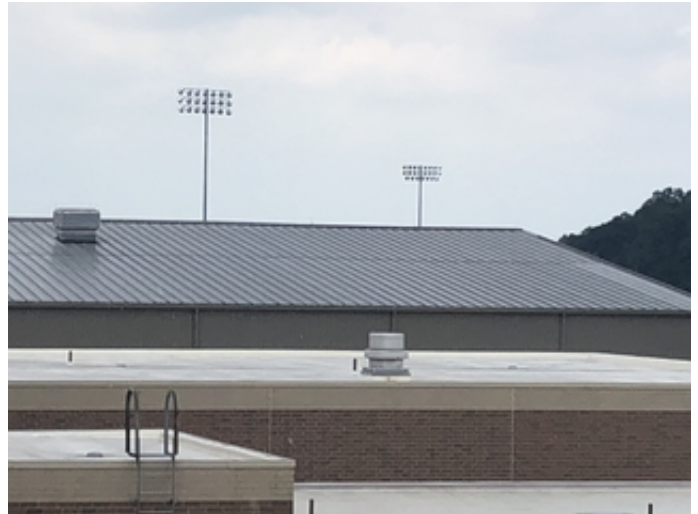
Standing Seam Metal Roofing

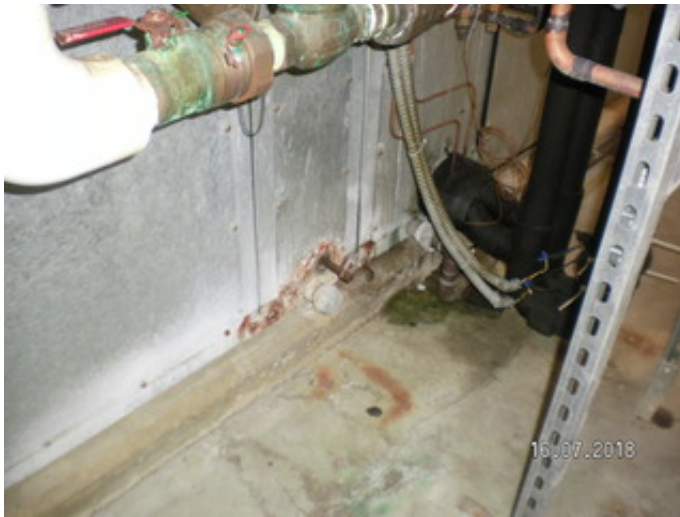
Air handling unit coils

Recommendations: Replace VAV boxes and controllers. Replace Natatorium dehumidification units. Replace running track exhaust fans. Replace remaining direct fired make-up air units with indirect fired units to avoid build-up of gas fumes when exhaust fans fail. Add air conditioning to the replaced make-up air units with refrigerant coils and on grade condensing units. This allows for a reduction in energy costs due to a reduction in fresh air requirements. Replace rusting air handling units while maintaining the recently replaced refrigerant coils.

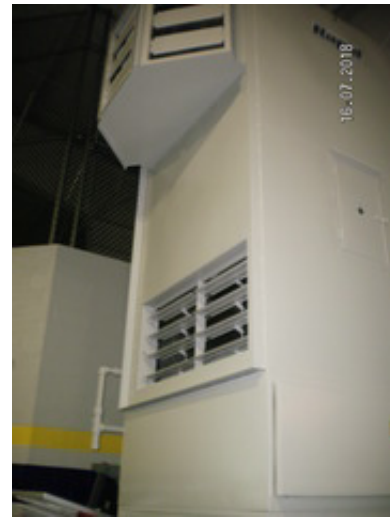
Direct fired unit

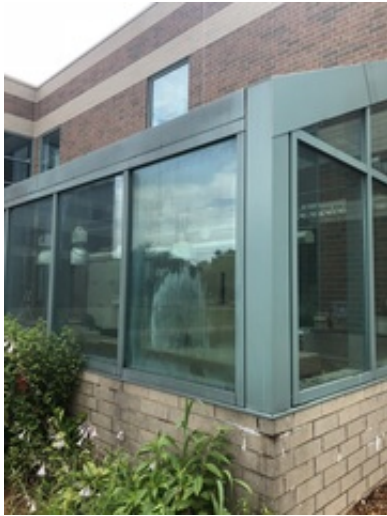
Greenhouse

Recommendations: Replace compromised glazing units and repair damaged trim segment. Replace greenhouse glazing assembly. No additional work is required at this time.

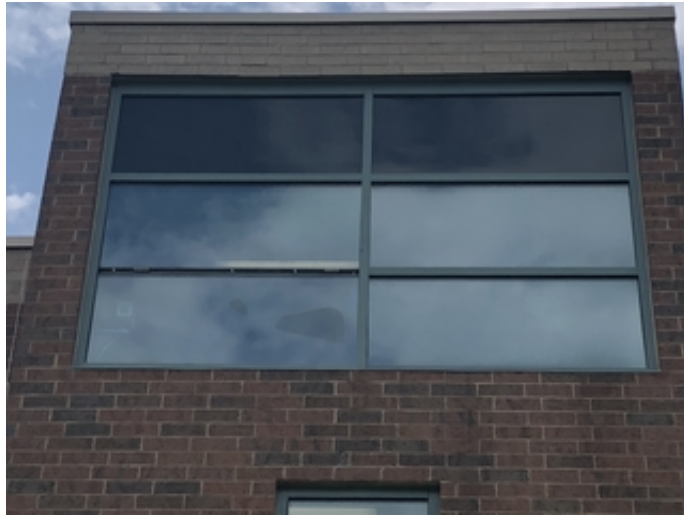
Damaged Trim

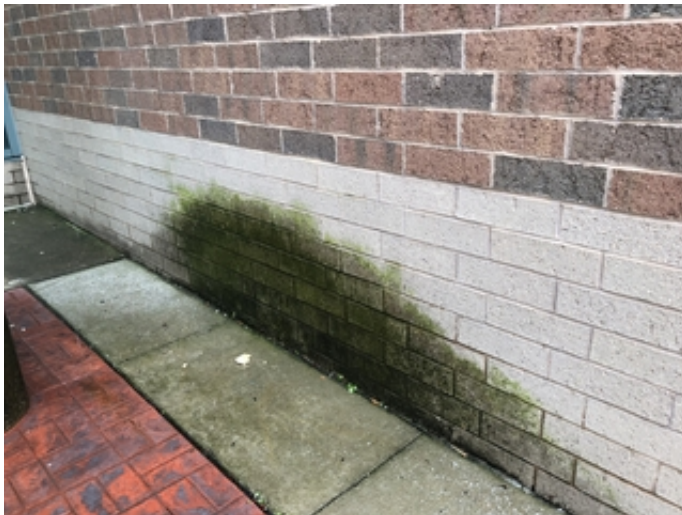
Algae Growth

Recommendations: Provide spot cleaning of areas of algae growth/efflorescence and provide for brick maintenance repair for any area of deterioration.

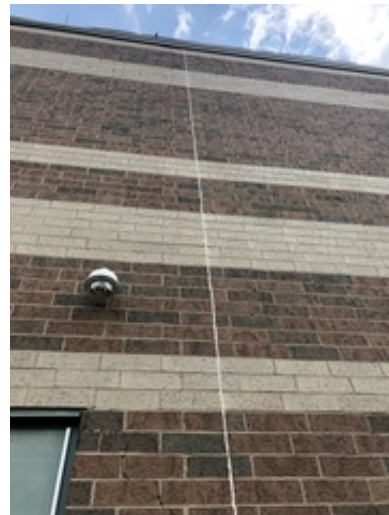
Control Joint

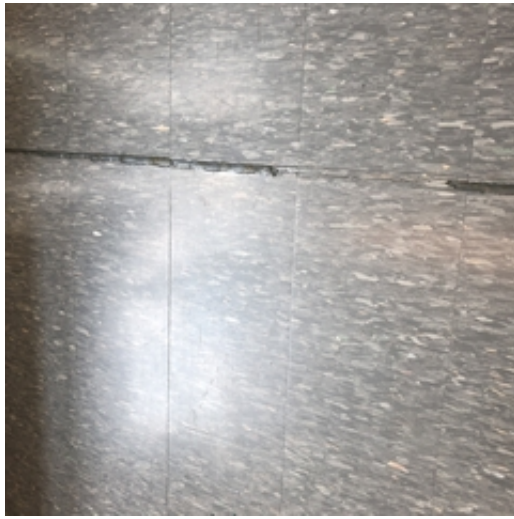
Damaged VCT

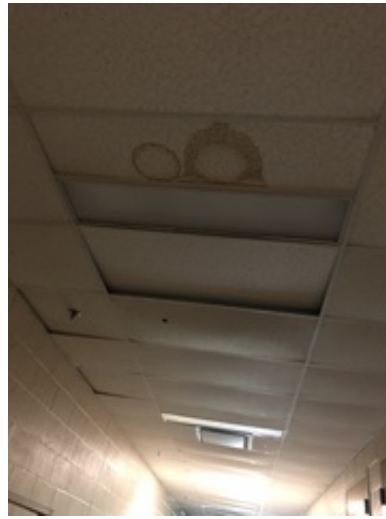
Damaged Acoustical Ceiling

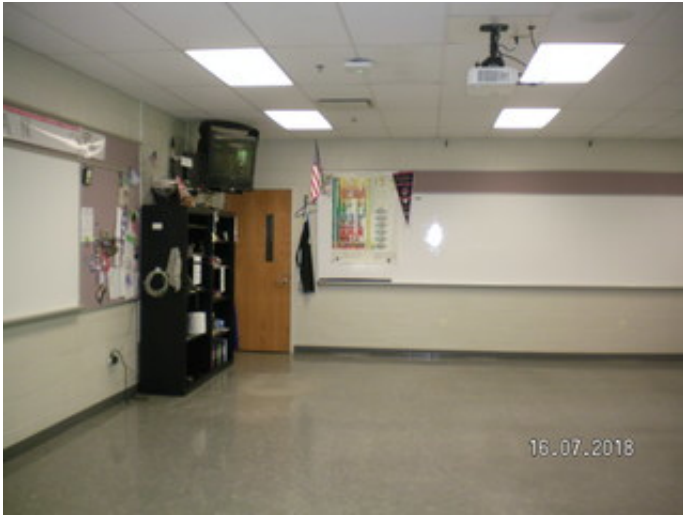
Classroom lighting

Recommendations: Replace light sources with LED lamps to provide longer life systems and reduce energy consumption. Revise classroom lighting to meet 50 footcandle requirement of OSDM. Revise Gymnasium lighting to reach 60 footcandles recommended in OSDM. Provide classrooms lighting with dual level switching and occupancy sensors. Provide added controls in Library and Cafeteria to make use of daylight harvesting.

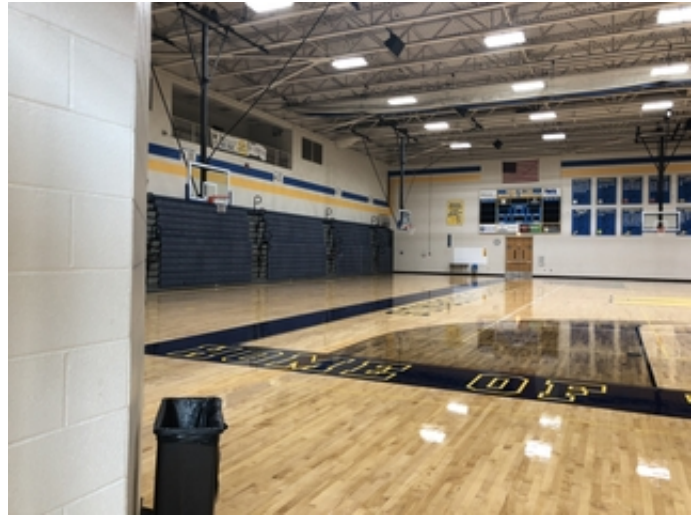
Gym lighting

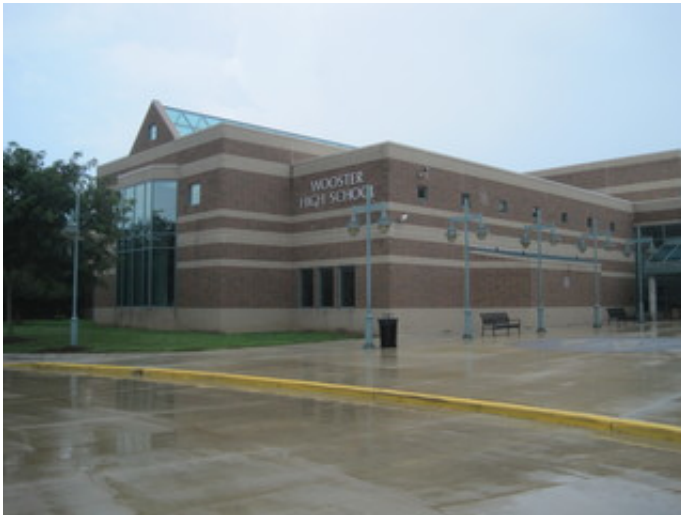
Front entrance cameras

Recommendations: Reconfigure front entrance to allow for a separate public entrance. Provide additional cameras and add motion detectors. Exterior security lighting should have lamp sources changed to LED for prolonged maintenance life. Upgrade security system to meet Ohio School Design Manual guidelines.

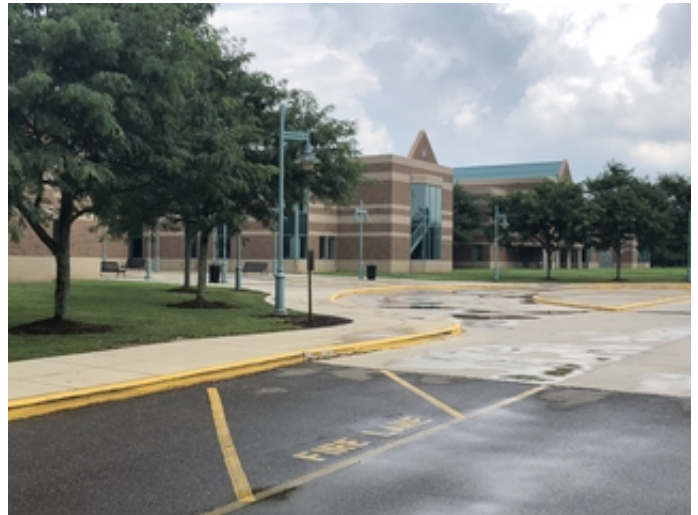
Entrance lighting

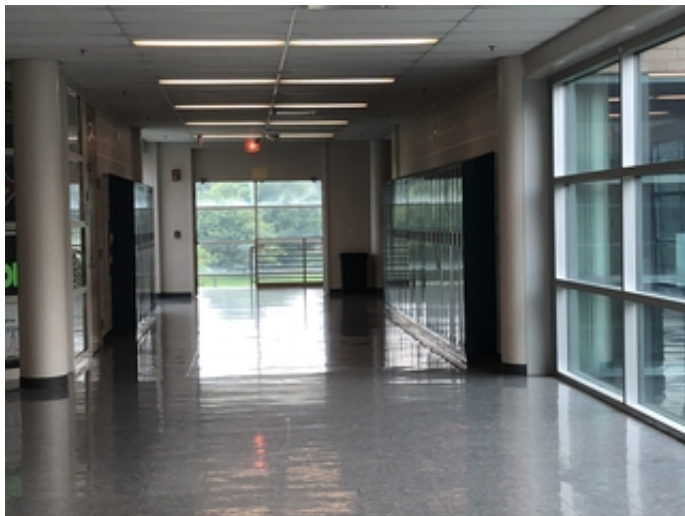
Emergency lighting

Recommendations: The exit lights and egress lights should be changed to LED for longer life.

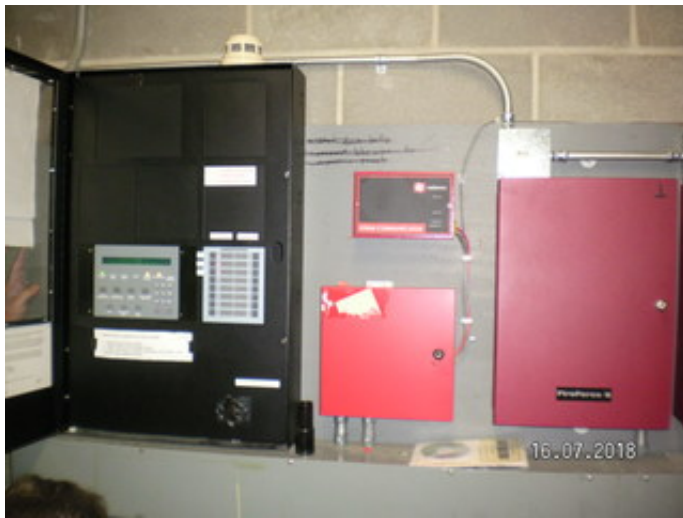
Fire alarm panel

Recommendations: The fire alarm system should be updated with additional A/V devices added to all classrooms and toilet rooms.

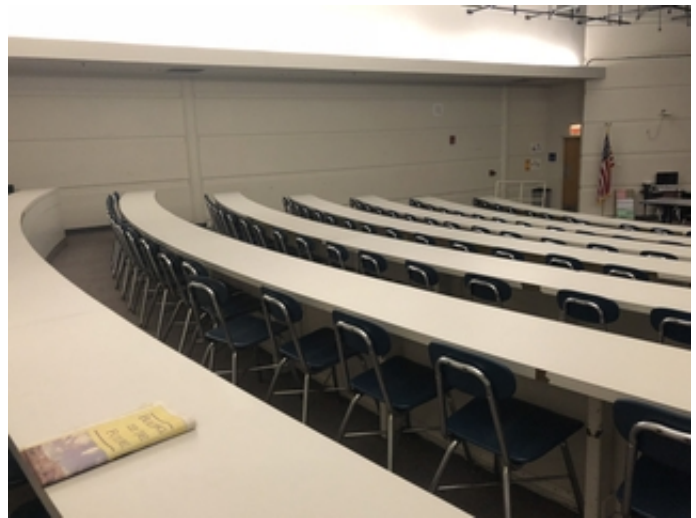
Large classroom A/V

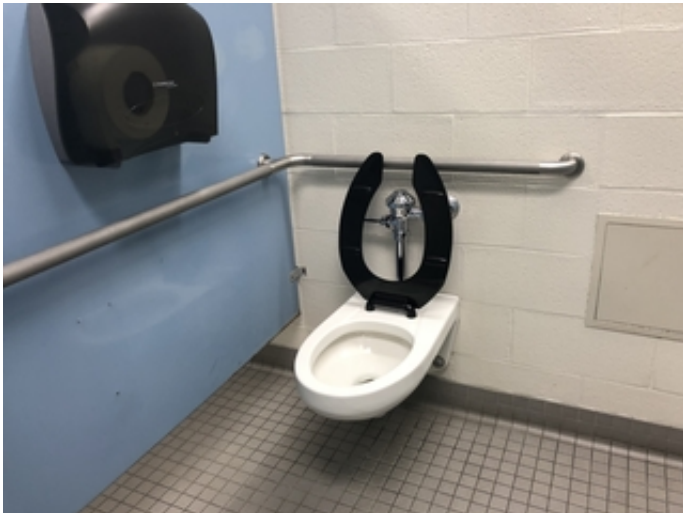
Non-Conforming Grab Bars

Other: Insulate Exposed Piping	\$100.00	per unit		37 Required							\$3,700.00	Insulate exposed piping at sinks
Other: Vertical Grab Bars	\$100.00	per unit		16 Required							\$1,600.00	Add vertical grab bars at HC water closets
Sum:			\$133,803.80	\$128,116.00	\$3,464.00	\$0.00	\$75.00	\$0.00	\$2,148.80	\$0.00

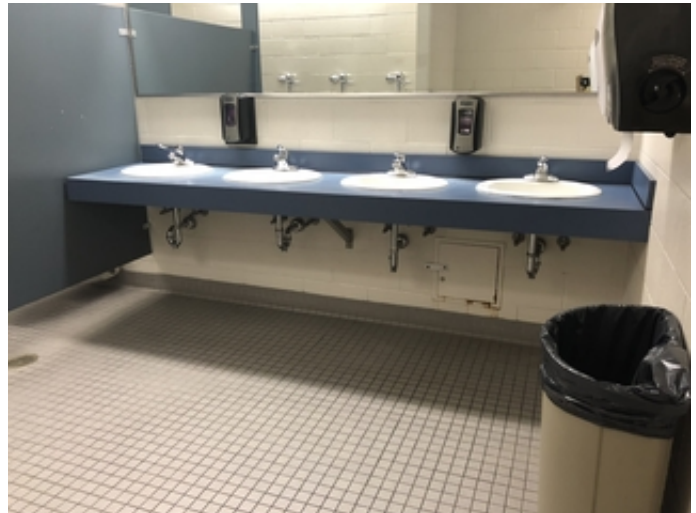
Exposed Piping

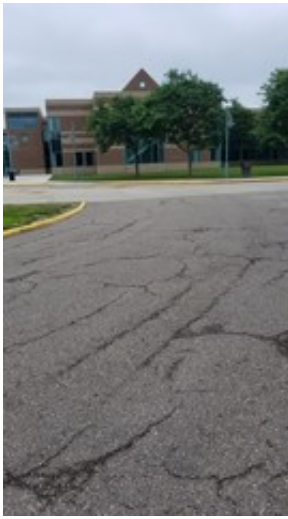
Damaged Bus Loop Pavement

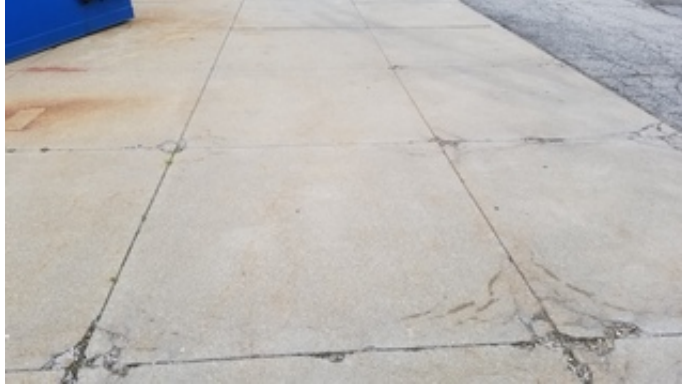
Damaged Concrete

Concrete Sidewalk:	\$4.69	sq.ft. (Qty)		4,906 Required	334 Required	657 Required	7 Required	559 Required	207 Required	159 Required	\$32,028.01	(5 inch exterior slab)
Base Sitework Allowance for Unforeseen Circumstances	\$50,000.00	allowance		Required							\$50,000.00	Include this and one of the next two. (Applies for whole building, so only one addition should have this item)
Sitework Allowance for Unforeseen Circumstances for buildings 100,000 SF or larger	\$150,000.00	allowance		Required							\$150,000.00	Include this one or the previous. (Applies for whole building, so only one addition should have this item)
Other: ADA Ramp	\$1,000.00	each		3 Required							\$3,000.00	ADA Ramp with domes
Other: ADA Signage	\$100.00	each		13 Required				1 Required			\$1,400.00	Updated ADA Signage
Sum:			\$1,236,911.21	\$945,931.54	\$50,552.66	\$99,253.73	\$1,098.43	\$84,656.71	\$31,364.03	\$24,054.11

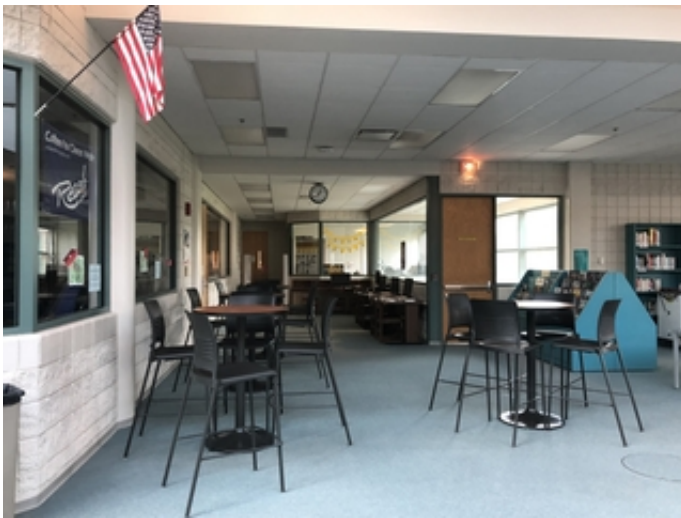
Media Center

Recommendations: Provide for replacement of outdated or inadequate furniture.

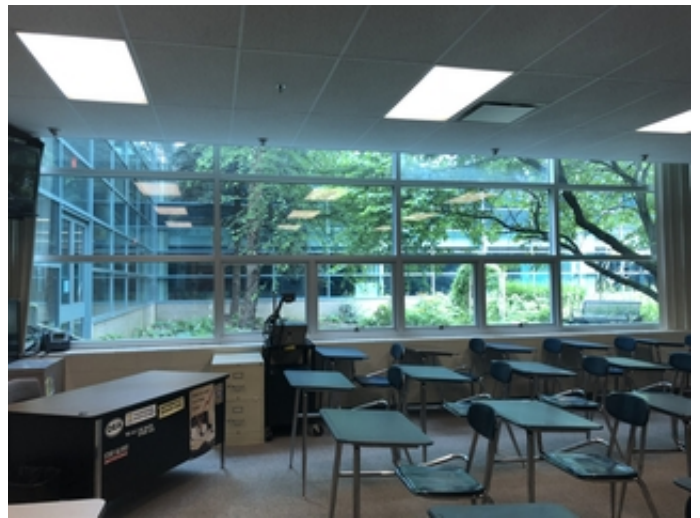
Class Furniture
