# FACILITY CONDITION ASSESSMENT

**Richmond Public Schools**  
301 North Ninth Street  
Richmond, VA 23219

Lucille M. Brown Middle School  
6300 Jahnke Road  
Richmond, VA 23225

*May 21, 2024*

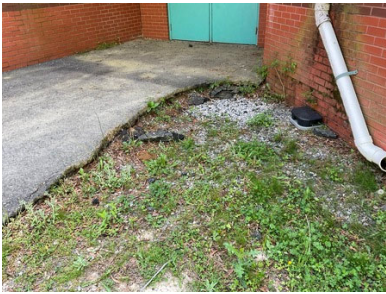
#### Sidewalk in Poor condition.

The sidewalk adjacent to door 9 has fallen away and is a safety tripping hazard if students leave the building in an emergency. - AssetCALC ID: 7563494

Recommendation: **Repair in 2024**

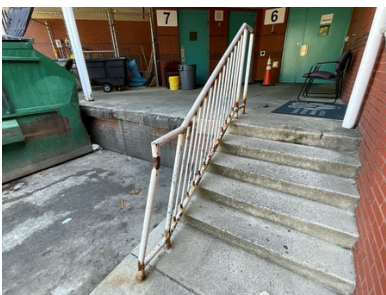
#### Stair/Ramp Rails in Poor condition.

The rail is collision damaged and badly rusted as well. - AssetCALC ID: 7563595

Recommendation: **Repair/Install in 2024**

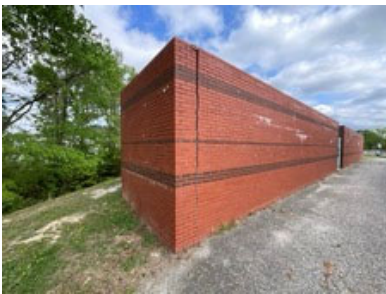
#### Dumpster Enclosure in Poor condition.

There was a 10 foot section of veneer on the enclosure for the chiller that has become detached from the inner CMU. This needs to be repaired or secured to the main wall to prevent the wall from tipping over. Appears to be a safety issue. - AssetCALC ID: 7563585

Recommendation: **Replace/Install in 2024**

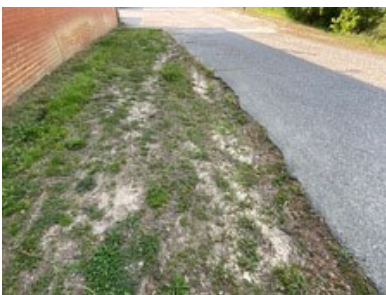
#### Landscaping in Poor condition.

Sod at Eroded Areas  
Site Lucille M. Brown Middle School Site door 9 to loading dock water has eroded the landscaping.

The sod has eroded, causing a depression and a tripping hazard - AssetCALC ID: 7563591

Recommendation: **Repair in 2024**

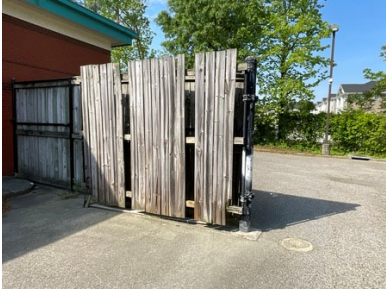
### Fences & Gates in Poor condition.

The wood fence leading to the loading dock is in need of replacement. The wood is missing in some spots, cut, warped and splitting. - AssetCALC ID: 7563505

Uniformat Code: G2060  
Recommendation: **Replace in 2025**

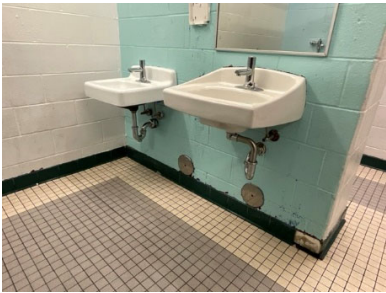
ID	Location Description	UF Code	Description	Condition	Plan Type	Cost
7568859	Restrooms	Y1050	ADA Restrooms, Lavatory, Pipe Wraps/Insulation, Install	NA	Accessibility	\$800
<b>Total (1 items)</b>						<b>\$800</b>

### ADA Restrooms

Uniformat Code: Y1050  
Recommendation: **Install in 2024**
