FACILITY CONDITION ASSESSMENT

Martin L. King, Jr. Preschool
900 Mosby Street
Richmond, VA 23223

166385.24R000-048.468

May 21, 2024

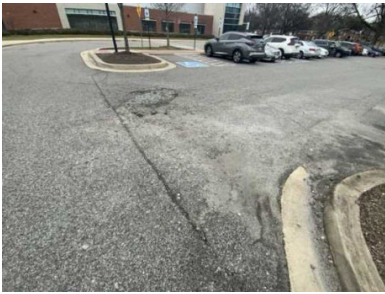
Pavement, Asphalt
Martin L. King, Jr. Preschool Site Parking Lot

Parking Lots in Poor condition.

Potholes and cracks were observed at the parking lot area. Cut and patch will be required as repair method. -
AssetCALC ID: 7415557

Uniformat Code: G2020
Recommendation: **Cut & Patch in 2024**
