# FACILITY CONDITION ASSESSMENT

**Richmond Public Schools**  
301 North Ninth Street  
Richmond, VA 23219

Linwood Holton Elementary School  
1600 West Laburnum Avenue  
Richmond, VA 23227

*April 10, 2024*

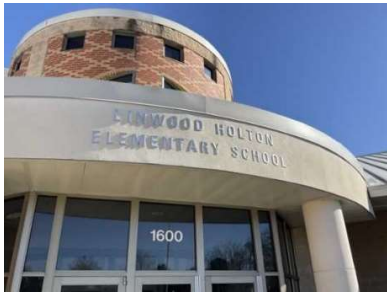
#### Roofing in Poor condition.

Single-Ply Membrane, TPO/PVC  
Linwood Holton Elementary School Rotunda Roof

Reports of roof leaks - AssetCALC ID: 7513330

Uniformat Code: B3010  
Recommendation: **Replace in 2024**

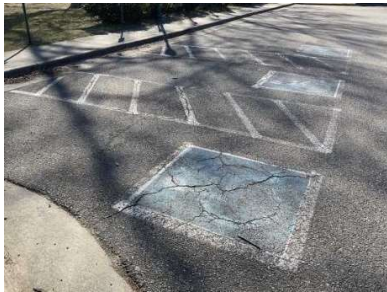
#### Parking Lots in Poor condition.

Pavement, Asphalt  
Site Linwood Holton Elementary School Site

Paint is fading - AssetCALC ID: 7412885

Uniformat Code: G2020  
Recommendation: **Seal & Stripe in 2025**

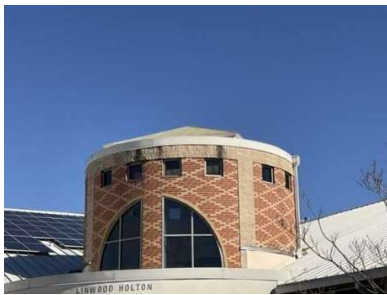
#### Roof Skylight in Poor condition.

per SF of glazing  
Main Building Linwood Holton Elementary School Rotunda Roof

Roof leak reported at skylight - AssetCALC ID: 7412895

Uniformat Code: B3060  
Recommendation: **Replace in 2024**

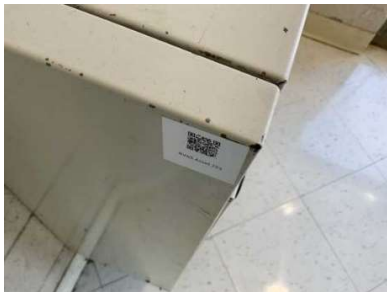
#### Unit Heater in Poor condition.

Electric  
Main Building Linwood Holton Elementary School Building entrances

It was reported that the units require lots of maintenance and poorly function - AssetCALC ID: 7412982

Uniformat Code: D3020  
Recommendation: **Replace in 2025**

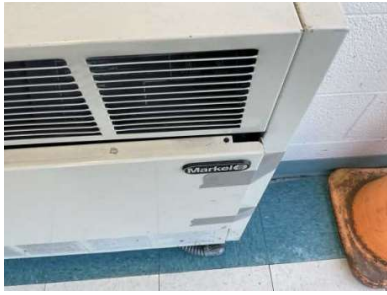
**Unit Heater in Poor condition.**

Electric  
Main Building Linwood Holton Elementary  
School Building entrances

It was reported that the units require lots of maintenance and poorly function - AssetCALC ID: 7412927

Uniformat Code: D3020  
Recommendation: **Replace in 2025**

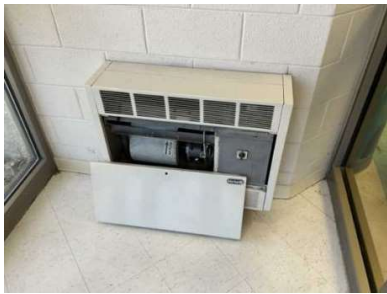
**Unit Heater in Poor condition.**

Electric  
Main Building Linwood Holton Elementary  
School Building entrances

It was reported that the units require lots of maintenance and poorly function - AssetCALC ID: 7412866

Uniformat Code: D3020  
Recommendation: **Replace in 2025**

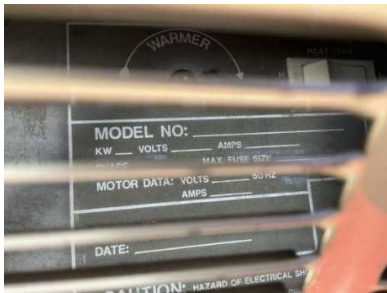
**Unit Heater in Poor condition.**

Electric  
Main Building Linwood Holton Elementary  
School Building entrances

It was reported that the units require lots of maintenance and poorly function - AssetCALC ID: 7412981

Uniformat Code: D3020  
Recommendation: **Replace in 2025**

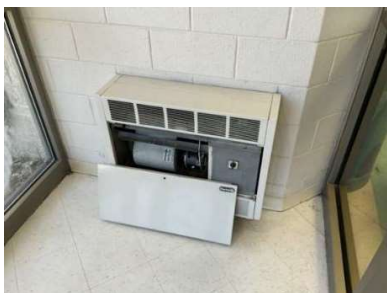
**Unit Heater in Poor condition.**

Electric  
Main Building Linwood Holton Elementary  
School Building entrances

It was reported that the units require lots of maintenance and poorly function - AssetCALC ID: 7412892

Uniformat Code: D3020  
Recommendation: **Replace in 2025**

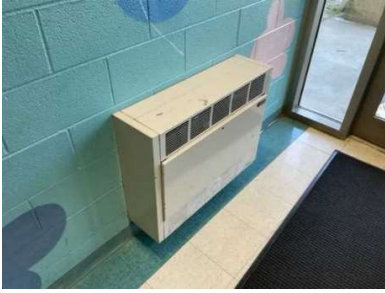
**Unit Heater in Poor condition.**

Electric  
Main Building Linwood Holton Elementary  
School Building entrances

Uniformat Code: D3020  
Recommendation: **Replace in 2025**
