FACILITY CONDITION ASSESSMENT

Richmond Public Schools
301 North Ninth Street
Richmond, VA 23219

Mary Scott Preschool
4011 Moss Side Avenue
Richmond, VA 23222

May 20, 2024

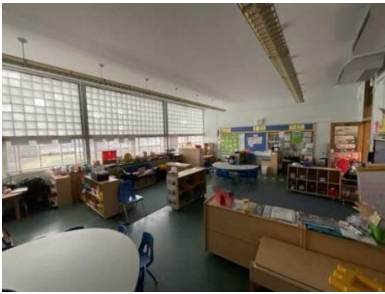
Recommended Follow-up Study: Environmental, Asbestos (ACM) & Lead Base Paint (LBP)

Environmental, Asbestos (ACM) & Lead Base Paint (LBP)
Main Building Mary Scott Preschool
Throughout building

There is some likelihood, the original VCT flooring may contain asbestos; therefore, sampling is required to determine next steps - AssetCALC ID: 7421158

Uniformat Code: P2030
Recommendation: **Evaluate/Report in 2024**

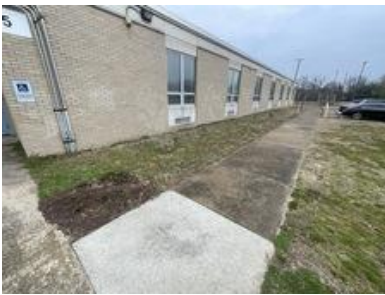
Exterior Walls in Poor condition.

any surface
Main Building Mary Scott Preschool

Clean soiled and mildew stained exterior brick walls. - AssetCALC ID: 7526598

Uniformat Code: B2010
Recommendation: **in 2025**

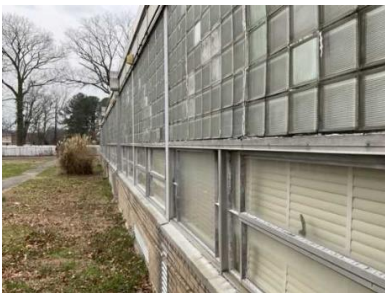
Glazing in Poor condition.

any type by SF
Main Building Mary Scott Preschool Building
Exterior

Leaks, cracked windows, single pane, and outdated glass block - AssetCALC ID: 7421168

Uniformat Code: B2020
Recommendation: **Replace in 2026**

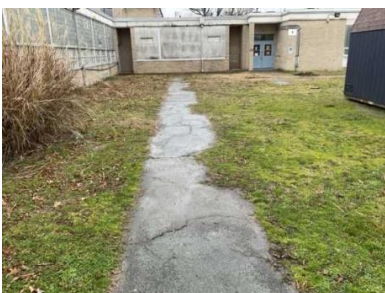
Sidewalk in Poor condition.

Asphalt
Site Mary Scott Preschool Site

Moderate cracking through. Needs overlay - AssetCALC ID: 7421086

Uniformat Code: G2030
Recommendation: **Overlay in 2026**

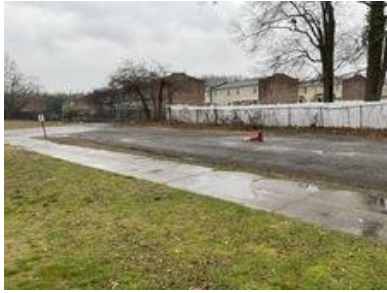
Roadways in Poor condition.

Pavement, Asphalt
Mary Scott Preschool Parent drop off

Extremely broken and loose asphalt pavement lane at south side of building. - AssetCALC ID: 7526862

Uniformat Code: G2010
Recommendation: **Mill & Overlay in 2024**

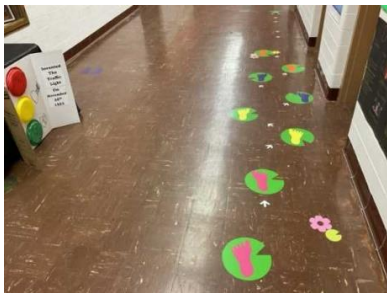
Flooring in Poor condition.

Vinyl Tile (VCT), w/ Asbestos Abatement
Main Building Mary Scott Preschool
Throughout building

Worn, scarred and very outdated tiles are likely ACM. - AssetCALC ID: 7421125

Uniformat Code: C2030
Recommendation: **Replace in 2025**

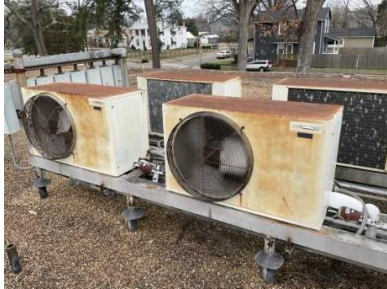
Split System in Poor condition.

Condensing Unit/Heat Pump
Main Building Mary Scott Preschool Roof

To be replaced by central system with chiller in summer of 2024 - AssetCALC ID: 7421117

Uniformat Code: D3030
Recommendation: **Replace in 2025**

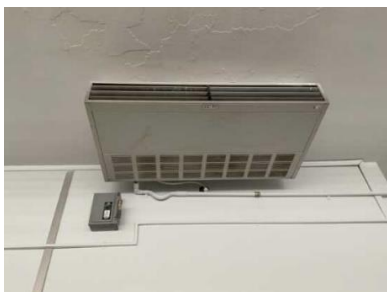
Split System in Poor condition.

Fan Coil Unit, DX
Main Building Mary Scott Preschool
Throughout building

To be removed with install of central cooling system in summer, 2024 - AssetCALC ID: 7421118

Uniformat Code: D3030
Recommendation: **Replace in 2025**

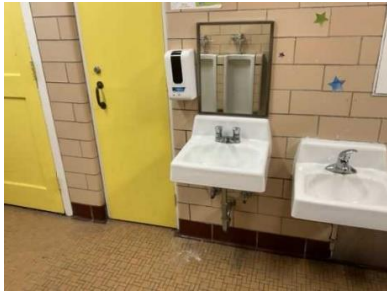
ADA Restrooms

Lavatory, Pipe Wraps/Insulation
Main Building Mary Scott Preschool Restrooms

Uniformat Code: Y1050
Recommendation: **Install in 2024**
