# FACILITY CONDITION ASSESSMENT

**Richmond Public Schools**  
301 North Ninth Street  
Richmond, VA 23219

Lois Harrison-Jones Elementary School  
3021 Maplewood Avenue  
Richmond, VA 23221

*August 15, 2024*

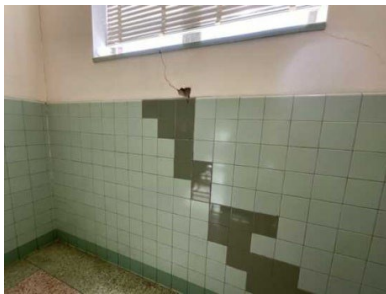
### Exterior Walls in Poor condition.

Concrete  
Main Building Lois Harrison-Jones Elementary School West end stairwell

Severe crack damage to structural wall and ceramic tile. - AssetCALC ID: 7604082

Uniformat Code: B2010  
Recommendation: **Repair in 2024**

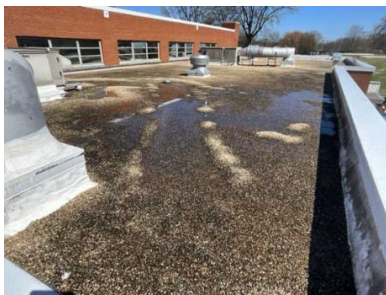
### Recommended Follow-up Study: Building Envelope, Roof

Building Envelope, Roof  
Main Building Lois Harrison-Jones Elementary School Roof

Roof ponding issues, slope and clear drainage - AssetCALC ID: 7476880

Uniformat Code: P2030  
Recommendation: **Evaluate/Report in 2025**

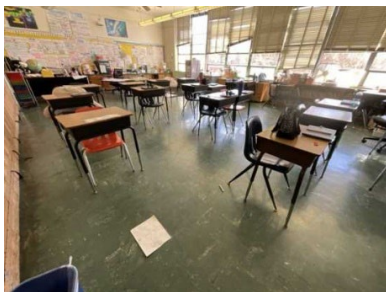
### Flooring in Poor condition.

Vinyl Tile (VCT), w/ Asbestos Abatement  
Main Building Lois Harrison-Jones Elementary School Throughout building

ACM VCT tiles observed - AssetCALC ID: 7473365

Uniformat Code: C2030  
Recommendation: **Replace in 2026**

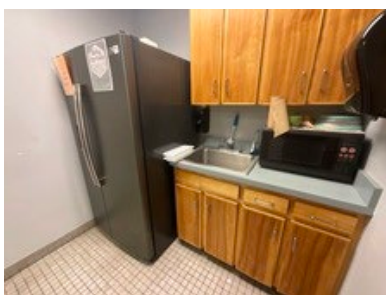
### ADA Kitchen & Laundry Areas

Sink/Counter/Maneuverability, Full Reconfiguration  
Main Building Lois Harrison-Jones Elementary School Staff Lounge

Missing knee clearance - AssetCALC ID: 7529142

Uniformat Code: Y1060  
Recommendation: **Renovate in 2024**

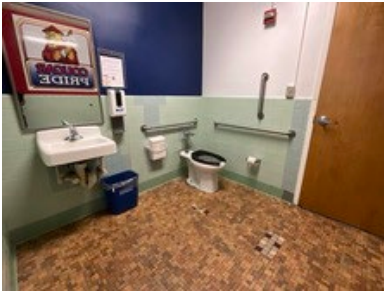
## ADA Restrooms

Lavatory, Pipe Wraps/Insulation  
Main Building Lois Harrison-Jones Elementary  
School Restrooms

Piping insulation missing - AssetCALC ID: 7529143

Uniformat Code: Y1050  
Recommendation: **Install in 2024**
