FACILITY CONDITION ASSESSMENT

Richmond Public Schools
301 North Ninth Street
Richmond, VA 23219

Miles J. Jones Elementary School
200 Beaufont Hill Drive
Richmond VA, 23225

May 24, 2024

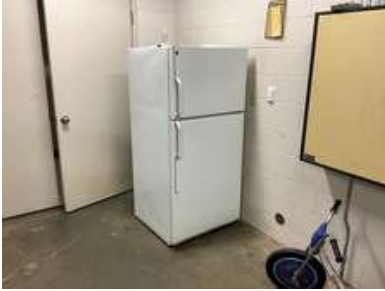
Refrigerator, 14 to 18 CF
Main Building Miles J. Jones Elementary
School Boiler room

Residential Appliances in Poor condition.

Does not provide adequate cooling, replace - AssetCALC ID: 7529011

Uniformat Code: E1060
Recommendation: **Replace in 2026**

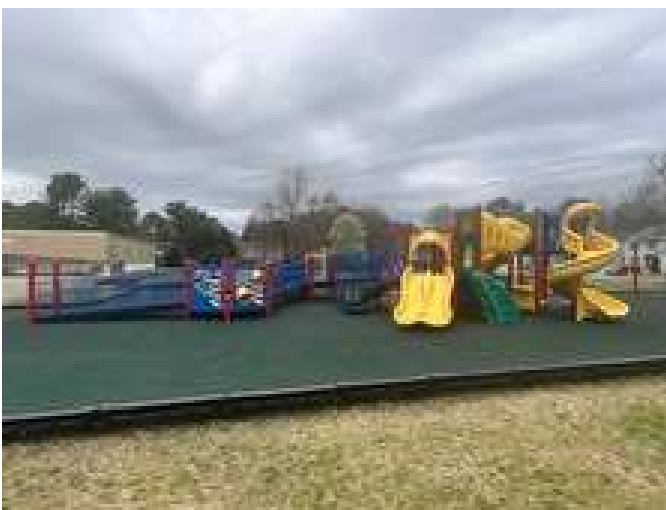
5 - PLAY STRUCTURE

The site is in good condition. No issues were reported or observed. Play structures dating back to the development of the site should be considered for replacement by 2035.
