FACILITY CONDITION ASSESSMENT

Richmond Public Schools
301 North Ninth Street
Richmond, VA 23219

Maymont Preschool
1211 South Allen Street
Richmond, VA 23220

June 29, 2024

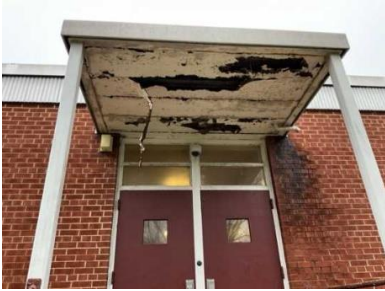
Roof Structure in Failed condition.

Flat, Metal Deck Over Steel Beams
Main Building Maymont Preschool Exit 4
Canopy

Roof framing at the entrance canopy is water damaged and a safety hazard due to falling debris. - AssetCALC ID: 7416229

Uniformat Code: B1020
Recommendation: **Replace in 2024**

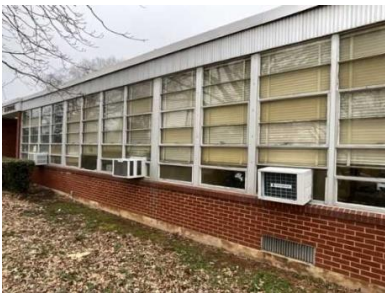
Glazing in Poor condition.

any type, by SF
Main Building Maymont Preschool Building
Exterior

Windows are antiquated and inefficient. - AssetCALC ID: 7416223

Uniformat Code: B2020
Recommendation: **Replace in 2025**

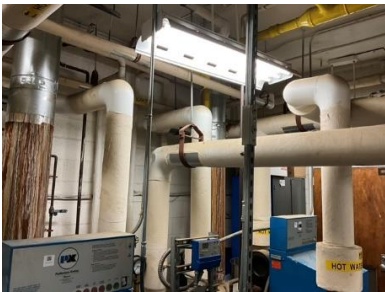
Piping & Valves in Poor condition.

Fiberglass Insulation, Domestic Water
Main Building Maymont Preschool Throughout

Condensation leaks due to damaged pipe insulation - AssetCALC ID: 7649126

Uniformat Code: D2010
Recommendation: **Replace in 2025**

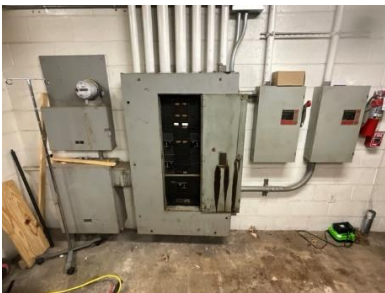
Electrical System in Poor condition.

Full System Renovation/Upgrade, Medium
Density/Complexity
Main Building Maymont Preschool Throughout

Uniformat Code: D5020
Recommendation: **Replace in 2026**
