FACILITY CONDITION ASSESSMENT

Richmond Public Schools
301 North Ninth Street
Richmond, VA 23219

August 15, 2024

Mary Munford Elementary School
211 Westmoreland Avenue
Richmond, VA 23226

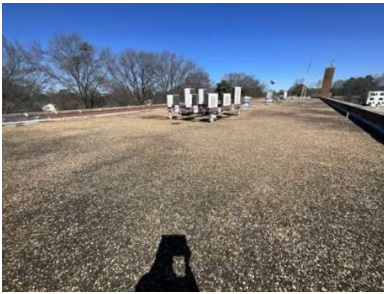
Roofing in Poor condition.

Built-Up
Main Building Mary Munford Elementary
School Classroom wing

Roof system is very old and plagued with recurring leaks. - AssetCALC ID: 7568491

Uniformat Code: B3010
Recommendation: **Replace in 2026**

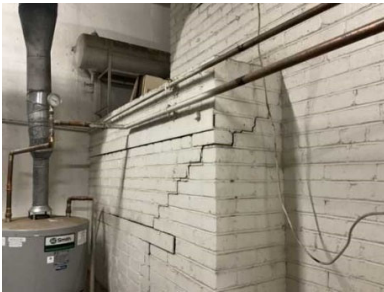
Basement Wall in Poor condition.

any type, Epoxy Injection of Cracks
Main Building Mary Munford Elementary
School Boiler room

Settlement cracks in brick wall require repair in basement boiler room. - AssetCALC ID: 7438976

Uniformat Code: A2010
Recommendation: **Repair in 2025**

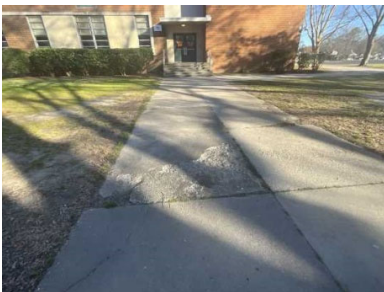
Sidewalk in Poor condition.

Concrete, Small Areas/Sections
Site Mary Munford Elementary School Site

Damaged and ware to concrete pavers - AssetCALC ID: 7442421

Uniformat Code: G2030
Recommendation: **Replace in 2026**

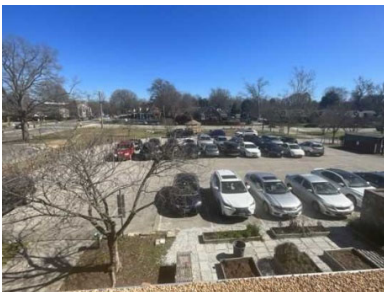
Parking Lots in Poor condition.

Pavement, Asphalt
Site Mary Munford Elementary School Site

Paint is fading, striping needed - AssetCALC ID: 7426991

Uniformat Code: G2020
Recommendation: **Seal & Stripe in 2025**

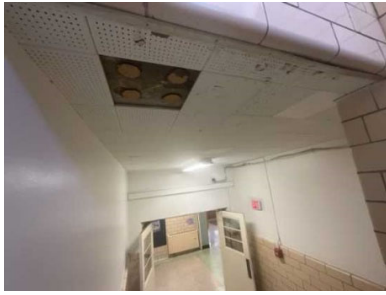
Suspended Ceilings in Poor condition.

Hard Tile, Replacement w/ ACT
Main Building Mary Munford Elementary School Throughout building

Missing tiles - AssetCALC ID: 7472825

Uniformat Code: C1070
Recommendation: **Replace in 2025**

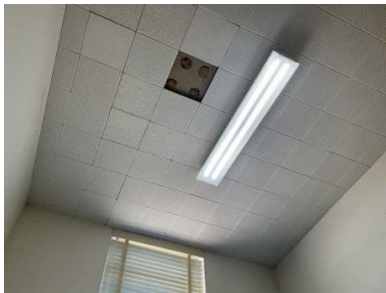
Suspended Ceilings in Poor condition.

Hard Tile, Replacement w/ ACT
Site Mary Munford Elementary School Throughout building

Missing ceiling tiles - AssetCALC ID: 7442418

Uniformat Code: C1070
Recommendation: **Replace in 2025**

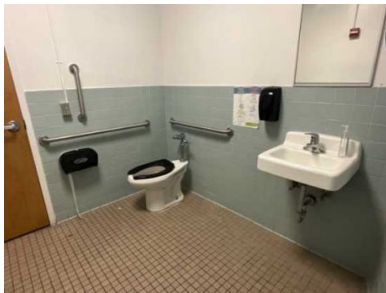
ADA Restrooms

Lavatory, Pipe Wraps/Insulation
Main Building Mary Munford Elementary School Restrooms

Piping insulation missing - AssetCALC ID: 7472827

Uniformat Code: Y1050
Recommendation: **Install in 2024**

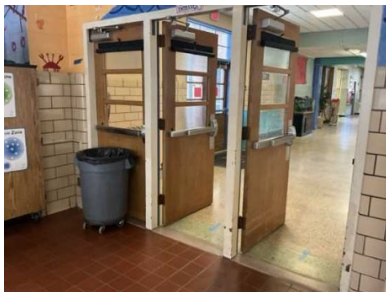
ADA Entrances & Doors

Door Closer, To Less than 5 LB
Main Building Mary Munford Elementary School Throughout building

Uniformat Code: Y1030
Recommendation: **Modify in 2024**

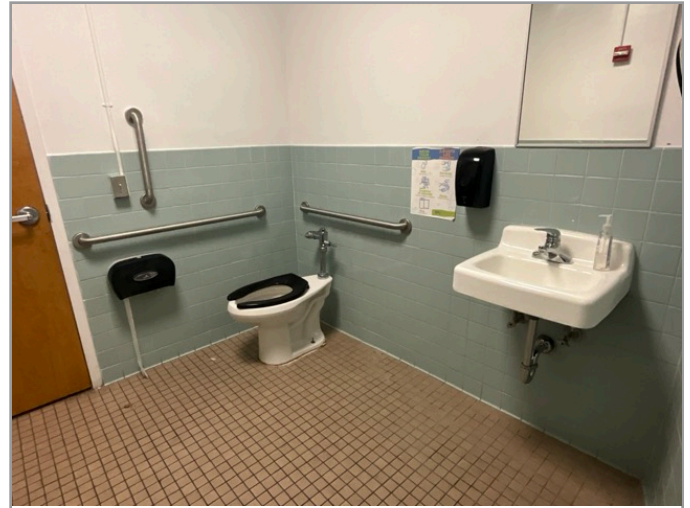
SINK, FAUCET HANDLES AND ACCESSORIES

| Question | | Yes | No | NA | Comments |
|---|---|---|---|---|---|
| 4 | Is the plumbing piping under lavatories configured to protect against contact ? | | ✗ | | Piping insulation missing |
