FACILITY CONDITION ASSESSMENT

Richmond Public Schools
301 North Ninth Street
Richmond, VA 23219

Henry L. Marsh, III Elementary School
813 North 28th Street
Richmond, VA 23223

May 29, 2024

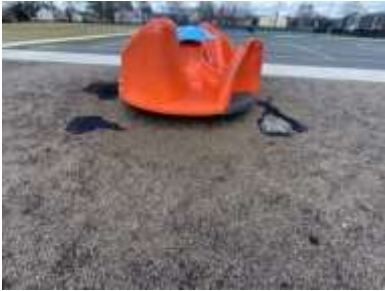
Playfield Surfaces in Failed condition.

Rubber, Small Areas
Site Henry L. Marsh, III Elementary School
Building exterior

Playground surface was observed damaged, with cracks and holes, apparently, due to settlement of the substrate. - AssetCALC ID: 7421968

Uniformat Code: G2050
Recommendation: **Replace in 2024**
