FACILITY CONDITION ASSESSMENT

Richmond Public Schools
301 North Ninth Street
Richmond, VA 23219

George W. Carver Elementary School
1110 West Leigh Street
Richmond, VA 23220

June 21, 2024

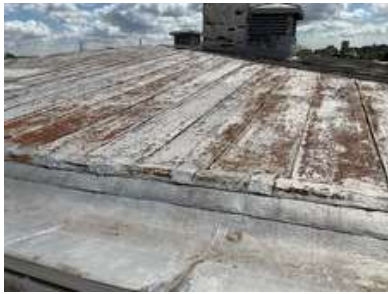
Roofing in Poor condition.

Metal
1915 Addition George W. Carver Elementary
School Roof

The roof was coated with a liquid membrane, which is flaking off and in need of replacement. Rust is a sign that the roof's protective coating is starting to deteriorate, and if left unaddressed, corrosion can cause water to the structure. - AssetCALC ID: 7523584

Uniformat Code: B3010
Recommendation: **Replace in 2024**

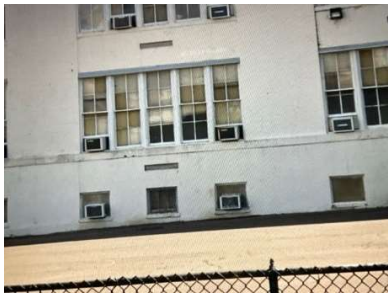
Window in Poor condition.

Wood, 16-25 SF
1915 Addition George W. Carver Elementary
School Building exterior

The windows are single pain, no storms. Single-pane windows are less efficient than double or triple pane windows and can lead to higher energy bills. Replacing single-pane windows can help reduce window condensation, which can damage the window casings, surrounding walls, and floors. Single-pane windows offer poor noise reduction as well. - AssetCALC ID: 7529786

Uniformat Code: B2020
Recommendation: **Replace in 2025**

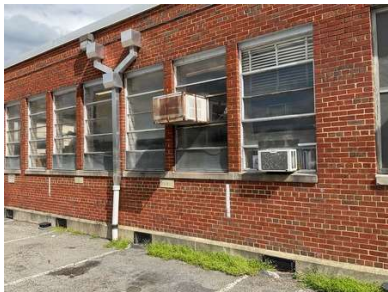
Glazing in Poor condition.

any type by SF
1915 Addition George W. Carver Elementary
School Building Exterior

The windows are single pain, no storms. Single-pane windows are less efficient than double or triple pane windows and can lead to higher energy bills. Replacing single-pane windows can help reduce window condensation, which can damage the window casings, surrounding walls, and floors. Single-pane windows offer poor noise reduction as well. - AssetCALC ID: 7523522

Uniformat Code: B2020
Recommendation: **Replace in 2025**

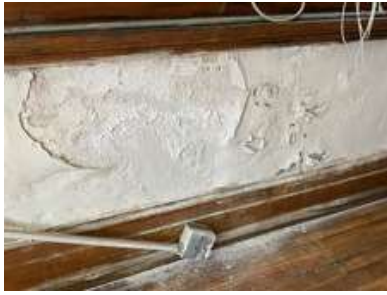
Interior Construction in Poor condition.

any type, Repairs per Man-Day
1915 Addition George W. Carver Elementary School 222

Wall leak room 222 under window that houses an air conditioner. Plaster turning to powder as moisture leaking in through active leak or capillary action. - AssetCALC ID: 7523610

Uniformat Code: C1010
Recommendation: **Repair in 2024**

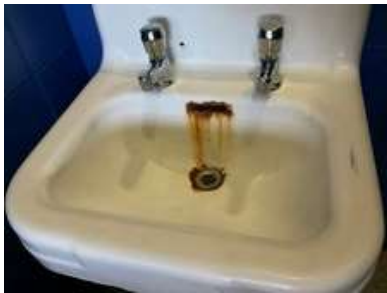
Sink/Lavatory in Poor condition.

Wall-Hung, Enameled Steel
1951 Main Building George W. Carver Elementary School 104

The sink overflow and drain are rusting out. The enamel has worn away. It may be difficult to seal the strainer. - AssetCALC ID: 7523647

Uniformat Code: D2010
Recommendation: **Replace in 2024**

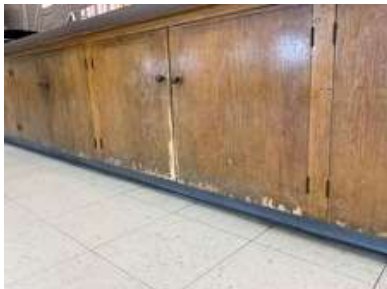
Casework in Poor condition.

Cabinetry, Hardwood Standard
1951 Main Building George W. Carver Elementary School 104

Cabinets in the first floor 1951 wing are delaminating, and veneers are chipping. Replacement in these classrooms is recommended. - AssetCALC ID: 7523621

Uniformat Code: E2010
Recommendation: **Replace in 2024**

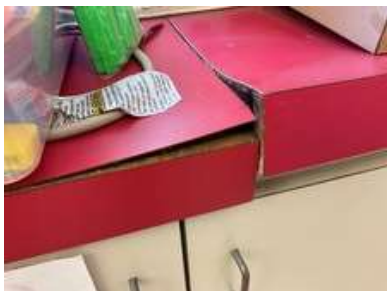
Casework in Poor condition.

Countertop, Plastic Laminate
1951 Main Building George W. Carver Elementary School 102

The counter tops in the first floor of the 1951 center section wing are delaminating. - AssetCALC ID: 7523582

Uniformat Code: E2010
Recommendation: **Replace in 2025**

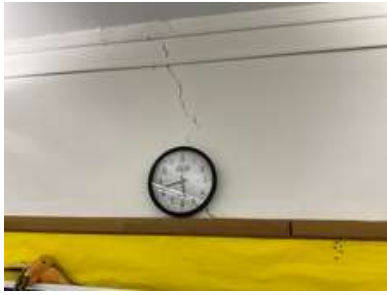
Ceiling Finishes in Poor condition.

There is a crack running through the clock at the head of the class on the wall and also ceiling repair work along the exterior wall ceiling above the windows - AssetCALC ID: 7523541

Uniformat Code: C2050
Recommendation: **Repair in 2024**

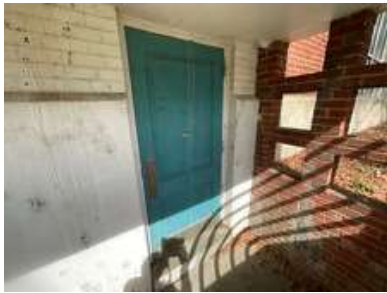
Exterior Door in Poor condition.

The door has splits vertically through the raise panel. - AssetCALC ID: 7523570

Uniformat Code: B2050
Recommendation: **Replace in 2024**

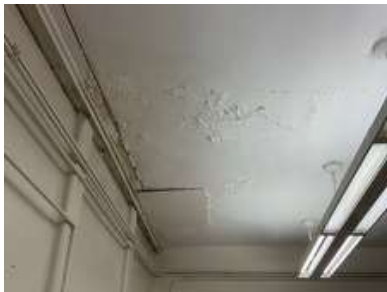
Ceiling Finishes in Poor condition.

Ceiling paint is bubbling and delaminating from substrate. Along window wall ceiling. - AssetCALC ID: 7523561

Uniformat Code: C2050
Recommendation: **Repair in 2024**

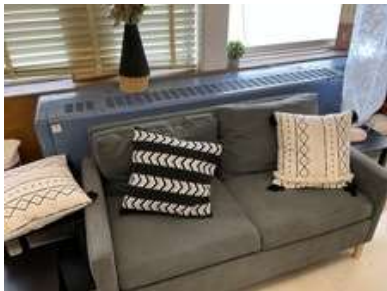
Unit Ventilator in Poor condition.

The heating unit is having a difficult time keeping up with comfort. It has exceeded recommended useful life. - AssetCALC ID: 7523531

Uniformat Code: D3030
Recommendation: **Replace in 2024**

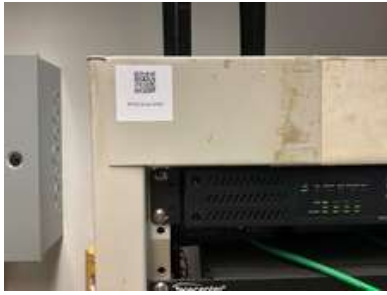
Intercom/PA System in Poor condition.

Public Address Upgrade, Facility-Wide
1951 Main Building George W. Carver
Elementary School Throughout building

The system reportedly does not work - AssetCALC ID: 7523721

Uniformat Code: D6060
Recommendation: **Replace in 2024**

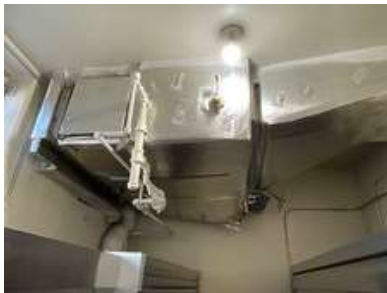
Air Handler in Poor condition.

Interior AHU, Easy/Moderate Access
1951 Main Building George W. Carver
Elementary School Side room off of cafeteria

The the unit motor has been disconnected. It appears the coil is just a pass-through. - AssetCALC ID: 7523512

Uniformat Code: D3050
Recommendation: **Replace in 2024**

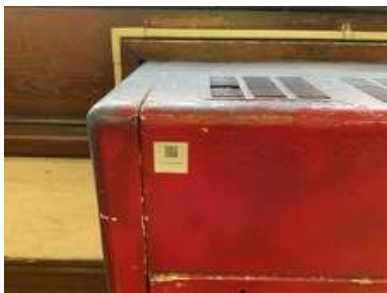
Unit Ventilator in Poor condition.

approx/nominal 2 Ton
1915 Addition George W. Carver Elementary
School Throughout building

The units have exceeded recommended useful life by many years. It is also reported the heat is difficult to control. - AssetCALC ID: 7523717

Uniformat Code: D3030
Recommendation: **Replace in 2024**

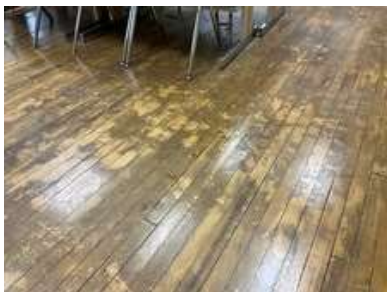
Flooring in Poor condition.

Wood, Strip
1915 Addition George W. Carver Elementary
School 116

The wood floors are in need of replacement. The wood is cracking and splitting and nail holes are visible from the last refinishing. - AssetCALC ID: 7523741

Uniformat Code: C2030
Recommendation: **Replace in 2025**
