FACILITY CONDITION ASSESSMENT

Richmond Public Schools
301 North Ninth Street
Richmond, VA 23219

J. L. Francis Elementary School
5146 Snead Road
Richmond, VA 23224

July 1, 2024

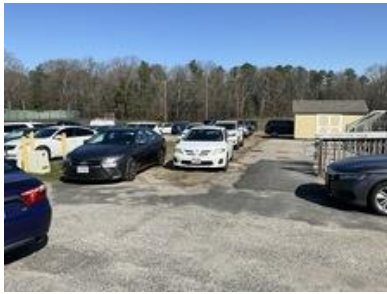
Pavement, Asphalt
J.L. Francis Elementary School

Parking Lots in Poor condition.

Surface cracks and faded striping. - AssetCALC ID: 7666978

Uniformat Code: G2020
Recommendation: **Seal & Stripe in 2026**

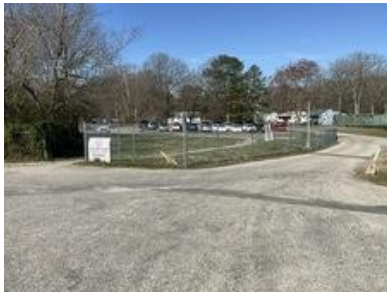
Pavement, Asphalt
Site J.L. Francis Elementary School Site

Parking Lots in Poor condition.

Asphalt pavement is deteriorated and inadequate for all parking. Many cars are parked in grassy areas. - AssetCALC ID: 7516133

Uniformat Code: G2020
Recommendation: **Mill & Overlay in 2026**

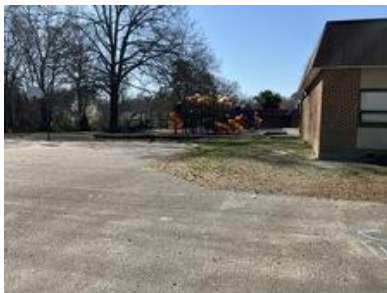
Basketball/General, Asphalt Pavement
J.L. Francis Elementary School Play courts

Athletic Surfaces & Courts in Poor condition.

Seal and repair play courts due to general deterioration. - AssetCALC ID: 7668073

Uniformat Code: G2050
Recommendation: **Seal & Stripe in 2026**

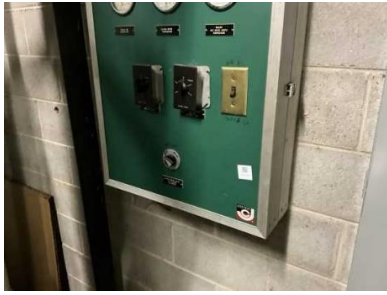
Basic System or Legacy Upgrades
Main Building J.L. Francis Elementary School
Mechanical room

BAS/HVAC Controls in Poor condition.

Uniformat Code: D8010
Recommendation: **Upgrade/Install in 2026**
