# FACILITY CONDITION ASSESSMENT

**Richmond Public Schools**  
301 North Ninth Street  
Richmond, VA 23219

Maury Street Property (Altria)  
2325 Maury Street  
Richmond, VA 23230

*February 29, 2024*

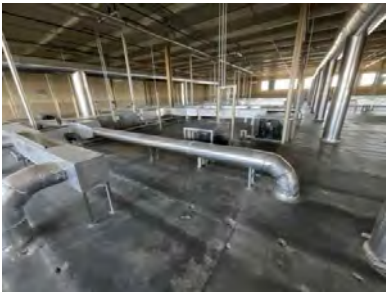
#### Structural Flooring/Decking in Poor condition.

Located in the first bay from east on second floor. Anchor bolts were pulled from concrete which resulted in large spalling. - AssetCALC ID: 7350862

Uniformat Code: B1012  
Recommendation: **Repair in 2024**

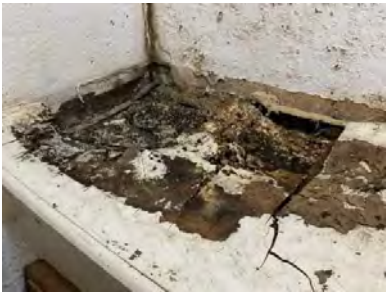
#### Recommended Follow-up Study: Environmental, Mold

Suspected mold in the basement - AssetCALC ID: 7350922

Uniformat Code: P2032  
Recommendation: **Evaluate/Report in 2024**

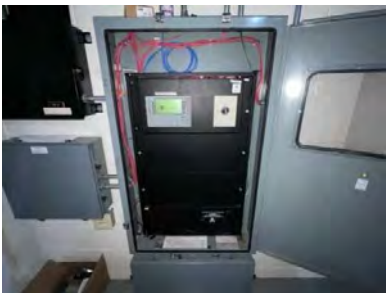
#### Fire Alarm Panel in Poor condition.

Located next to MCC 30A, lots of false alarms. - AssetCALC ID: 7350904

Uniformat Code: D7051  
Recommendation: **Replace in 2025**

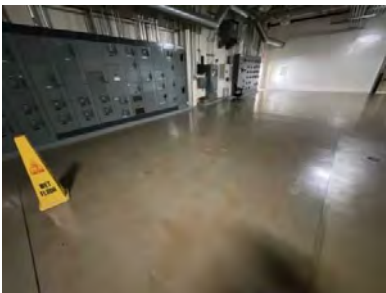
#### Flooring in Poor condition.

Floor coating is extremely slick. - AssetCALC ID: 7350911

Uniformat Code: C2031  
Recommendation: **Prep & Paint in 2025**

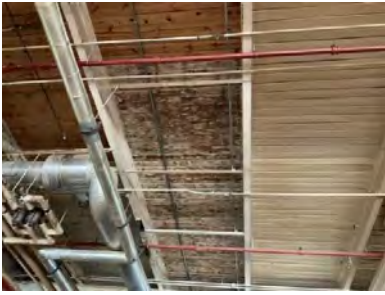
**Structural Flooring/Decking in Poor condition.**

Ceiling and roofing structural flooring/decking is very aged and patched. - AssetCALC ID: 7350859

Uniformat Code: B1012  
Recommendation: **Replace in 2026**

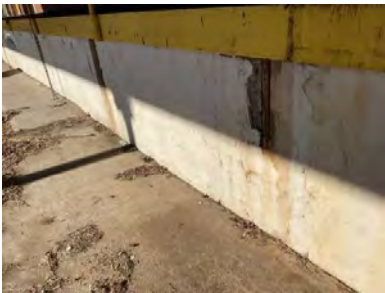
**Exterior Walls in Poor condition.**

Exterior wall paint is very aged and has cracked and flaked - AssetCALC ID: 7350947

Uniformat Code: B2011  
Recommendation: **Prep & Paint in 2025**

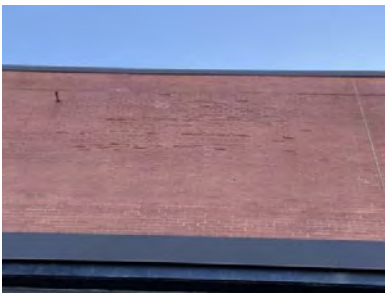
**Exterior Walls in Poor condition.**

Brick is scaling on northeast facade. - AssetCALC ID: 7371725

Uniformat Code: B2012  
Recommendation: **Replace in 2025**

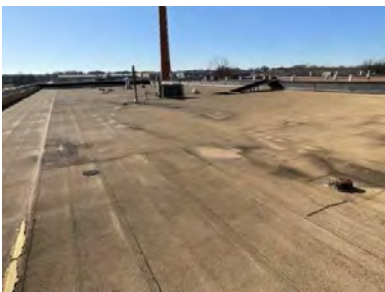
**Roofing in Poor condition.**

Very aged roofing. Evidence of leaking was evident on the northeast roof. - AssetCALC ID: 7350839

Uniformat Code: B3015  
Recommendation: **Replace in 2025**

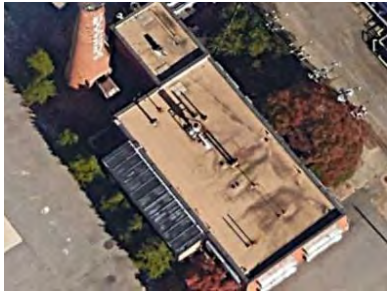
### Roofing in Poor condition.

Very aged roofing - AssetCALC ID: 7356248

Uniformat Code: B3015  
Recommendation: **Replace in 2025**

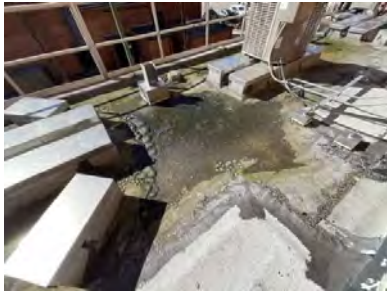
### Roofing in Poor condition.

West and north sides of building have water ponding issues on roofing, very aged with delaminating seams and leak issues. - AssetCALC ID: 7350929

Uniformat Code: B3015  
Recommendation: **Replace in 2025**

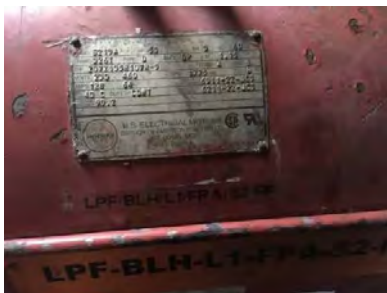
### Pump in Poor condition.

Significantly aged and corroded. - AssetCALC ID: 7348826

Uniformat Code: D4011  
Recommendation: **Replace in 2024**

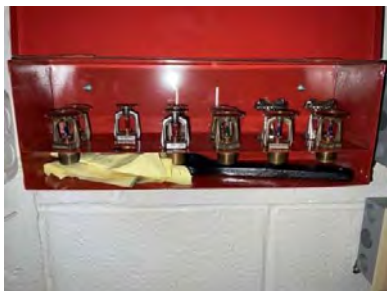
### Fire Suppression System in Poor condition.

Very dated - AssetCALC ID: 7350852

Uniformat Code: D4011  
Recommendation: **Replace in 2025**

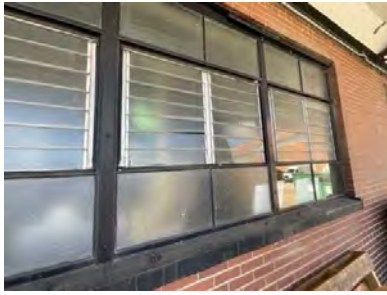
**Glazing in Poor condition.**

Original steel single pain windows vary in age from original construction through 1970s with significant broken glass, missing or ineffective panes, and leaks. - AssetCALC ID: 7350868

Uniformat Code: B2022  
Recommendation: **Replace in 2025**

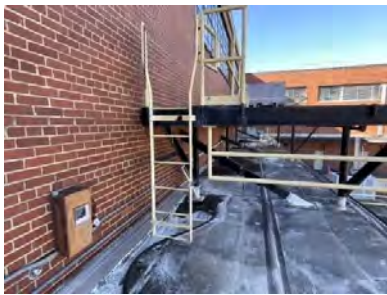
**Roof Appurtenances in Poor condition.**

Ladders are aged and rusting - AssetCALC ID: 7350889

Uniformat Code: B3021  
Recommendation: **Replace in 2025**

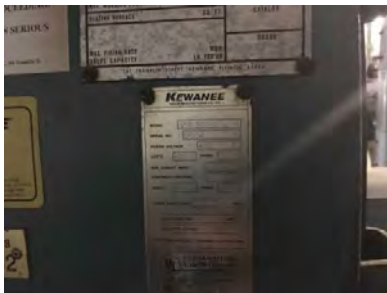
**Steam Boiler in Poor condition.**

Steam leaks and other issues reported - AssetCALC ID: 7348845

Uniformat Code: D3021  
Recommendation: **Replace in 2025**

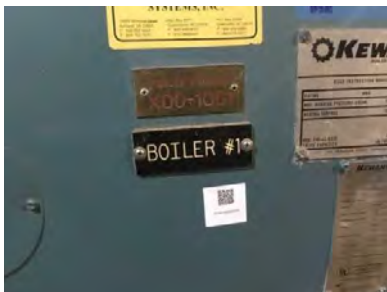
**Steam Boiler in Poor condition.**

Steam leaks and other issues reported - AssetCALC ID: 7348907

Uniformat Code: D3021  
Recommendation: **Replace in 2025**

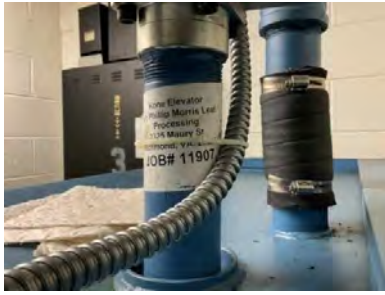
**Elevator Controls, Hydraulic in Poor condition.**

Elevator #3 controls currently not operational and large hydraulic leak - AssetCALC ID: 7350857

Uniformat Code: D1011  
Recommendation: **Replace in 2025**

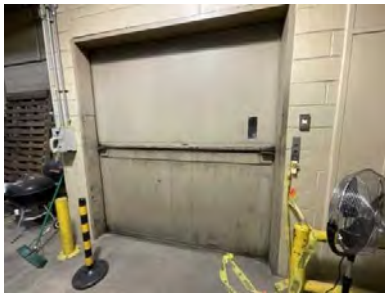
**Freight Elevator in Poor condition.**

Elevator is currently in operable - AssetCALC ID: 7350878

Uniformat Code: D1011  
Recommendation: **Renovate in 2025**

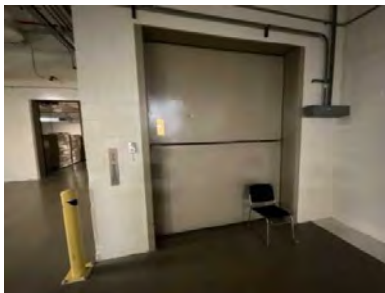
**Freight Elevator in Poor condition.**

Elevator is currently inoperable - AssetCALC ID: 7350880

Uniformat Code: D1011  
Recommendation: **Renovate in 2025**

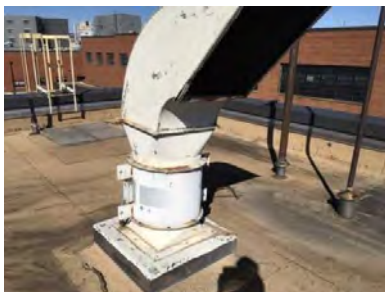
**Exhaust Fan in Poor condition.**

Significantly aged - AssetCALC ID: 7348895

Uniformat Code: D3063  
Recommendation: **Replace in 2025**

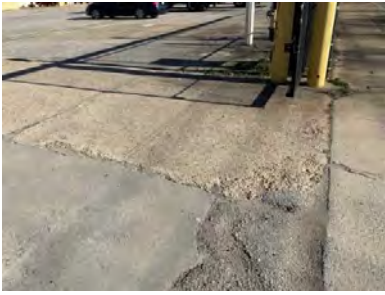
**Roadways in Poor condition.**

Concrete is degraded and spalled - AssetCALC ID: 7350915

Uniformat Code: G2011  
Recommendation: **Replace in 2025**

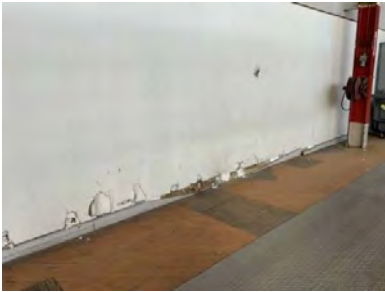
**Interior Wall Construction in Poor condition.**

Damaged gypsum walls - AssetCALC ID: 7350847

Uniformat Code: C1011  
Recommendation: **Replace in 2025**

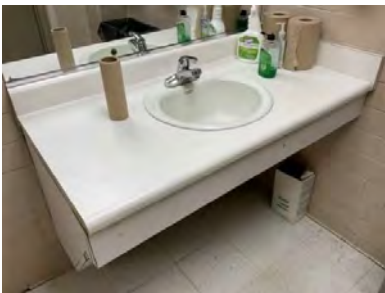
**Casework in Poor condition.**

Delaminating - AssetCALC ID: 7350902

Uniformat Code: E2013  
Recommendation: **Replace in 2025**

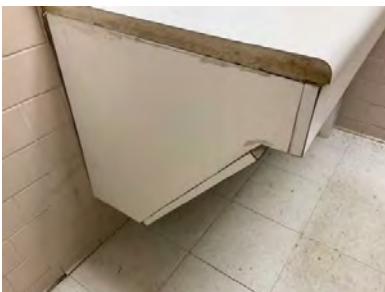
**Casework in Poor condition.**

Delaminating - AssetCALC ID: 7350866

Uniformat Code: E2013  
Recommendation: **Replace in 2025**

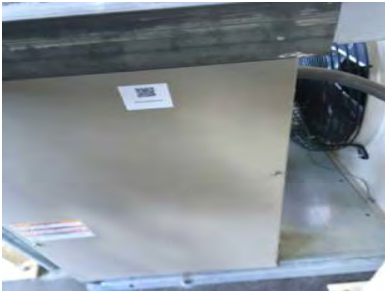
**Split System in Poor condition.**

Past its useful life and outdated refrigerant. - AssetCALC ID: 7348934

Uniformat Code: D3037  
Recommendation: **Replace in 2024**

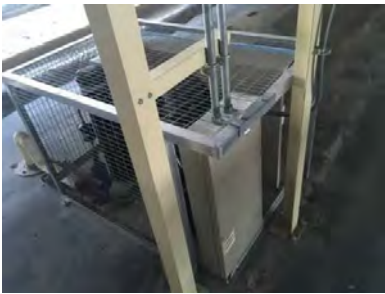
**Split System in Poor condition.**

Past its useful life and outdated refrigerant. - AssetCALC ID: 7348801

Uniformat Code: D3037  
Recommendation: **Replace in 2024**

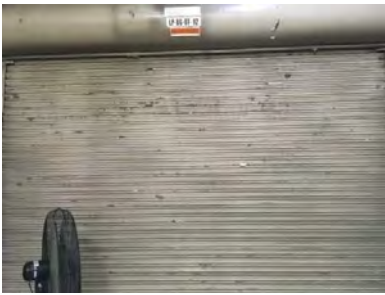
**Overhead/Dock Door in Poor condition.**

Worn and corroded. - AssetCALC ID: 7348837

Uniformat Code: B2053  
Recommendation: **Replace in 2024**

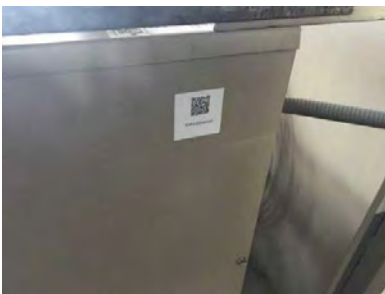
**Split System in Poor condition.**

Beyond useful life and outdated refrigerant. - AssetCALC ID: 7348803

Uniformat Code: D3037  
Recommendation: **Replace in 2024**

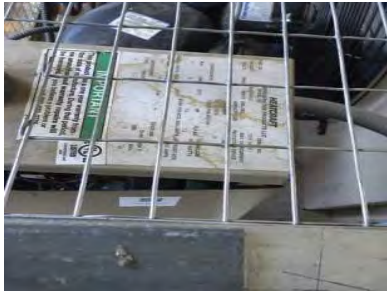
**Split System in Poor condition.**

Past its useful life and outdated refrigerant. - AssetCALC ID: 7348881

Uniformat Code: D3037  
Recommendation: **Replace in 2024**

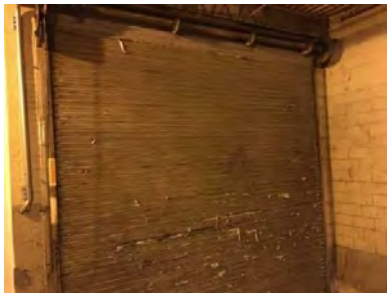
**Overhead/Dock Door in Poor condition.**

Aged, worn, and corroded. - AssetCALC ID: 7348838

Uniformat Code: B2053  
Recommendation: **Replace in 2024**

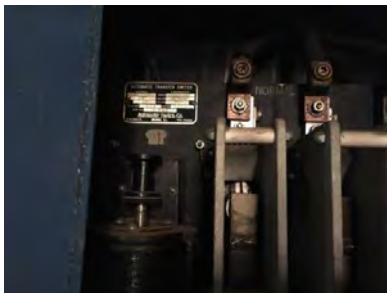
**Automatic Transfer Switch in Poor condition.**

Significantly aged and corroded. - AssetCALC ID: 7348857

Uniformat Code: D5017  
Recommendation: **Replace in 2024**

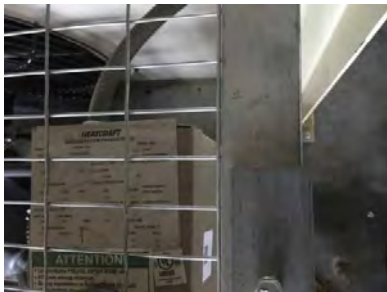
**Split System in Poor condition.**

Past its useful life and outdated refrigerant. - AssetCALC ID: 7348888

Uniformat Code: D3037  
Recommendation: **Replace in 2024**

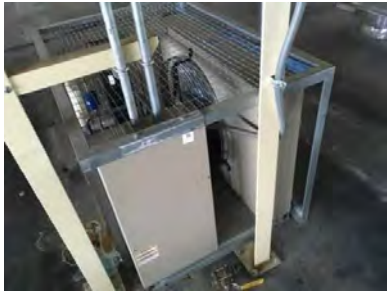
**Split System in Poor condition.**

Past its useful life and outdated refrigerant. - AssetCALC ID: 7348878

Uniformat Code: D3037  
Recommendation: **Replace in 2024**

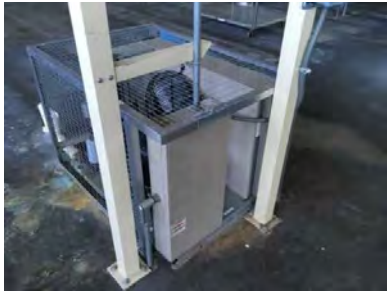
**Split System in Poor condition.**

Past its useful life and outdated refrigerant. - AssetCALC ID: 7348927

Uniformat Code: D3037  
Recommendation: **Replace in 2024**

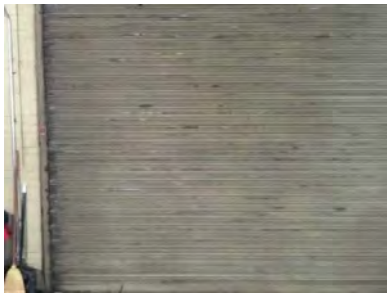
**Overhead/Dock Door in Poor condition.**

Worn and crack damaged - AssetCALC ID: 7348832

Uniformat Code: B2053  
Recommendation: **Replace in 2024**

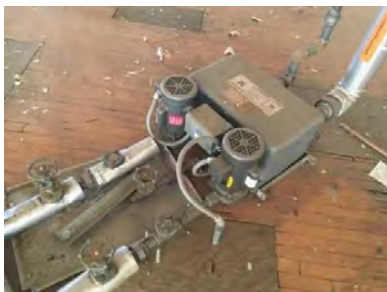
**HVAC Steam Components in Poor condition.**

Aged and corroded - AssetCALC ID: 7348776

Uniformat Code: D3053  
Recommendation: **Replace in 2025**

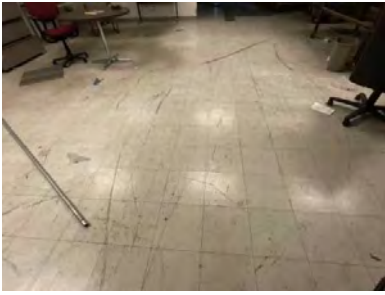
**Flooring in Poor condition.**

VCT is worn and crack damaged - AssetCALC ID: 7350940

Uniformat Code: C2035  
Recommendation: **Replace in 2025**

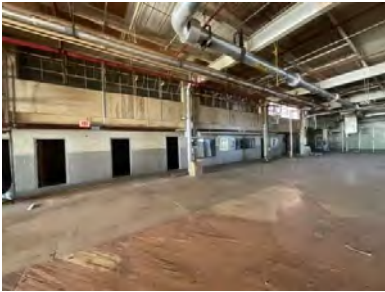
**Flooring in Poor condition.**

Wood flooring appears to be original from 1950's construction and has many patches, loose flooring and decayed sections. - AssetCALC ID: 7350867

Uniformat Code: C2034  
Recommendation: **Replace in 2026**

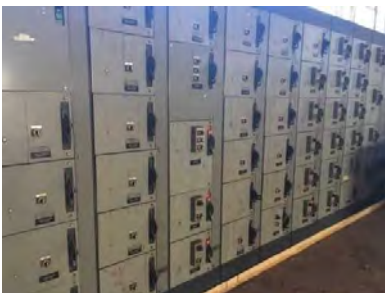
**Motor Control Center in Poor condition.**

Very aged and worn - AssetCALC ID: 7348855

Uniformat Code: D5023  
Recommendation: **Replace in 2026**

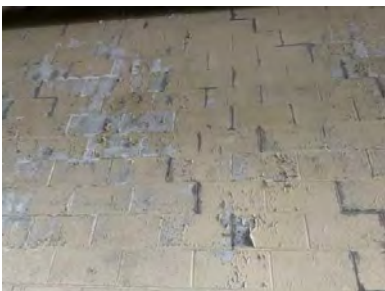
**Wall Finishes in Poor condition.**

Evidence of roof leaking onto eastern wall, and water penetration along north wall in trolley airlock north wall below exterior windows. - AssetCALC ID: 7350872

Uniformat Code: C2017  
Recommendation: **Prep & Paint in 2025**

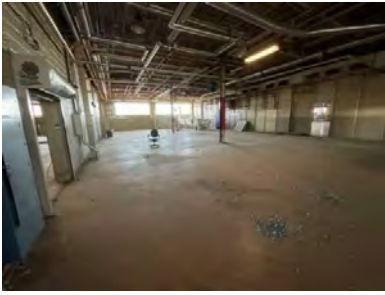
## Interior Lighting System in Poor condition.

Uniformat Code: D5045  
Recommendation: **Replace in 2026**
