FACILITY CONDITION ASSESSMENT

Richmond Public Schools
301 North Ninth Street
Richmond, VA 23219

J.B. Fisher Elementary School
3701 Garden Road
Richmond, VA 23235

May 11, 2024

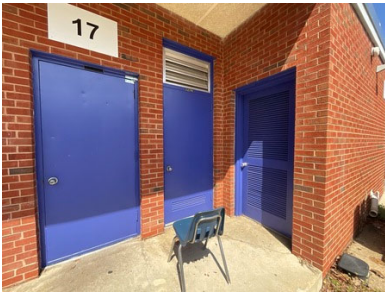
Switchboard in Poor condition.

120/208 V, 1600 AMP
Main Building J.B. Fisher Elementary School
Main Electrical Room

No access to main electrical room due to no key at time of assessment. Switchboard is assumed to be Federal Pacific (safety risk) based on original electrical panels located in the building. - AssetCALC ID: 7505434

Uniformat Code: D5020
Recommendation: **Replace in 2025**

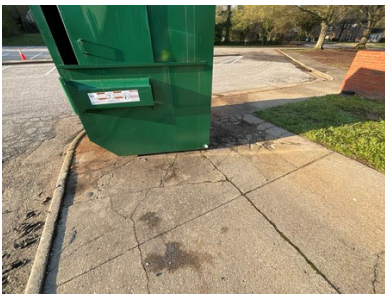
Sidewalk in Poor condition.

Concrete, Large Areas
Site J.B. Fisher Elementary School Parking lot

Severe cracking throughout concrete sidewalks around main parking lot. Some cracking is severe enough to have created tripping hazards. - AssetCALC ID: 7496581

Uniformat Code: G2030
Recommendation: **Replace in 2025**

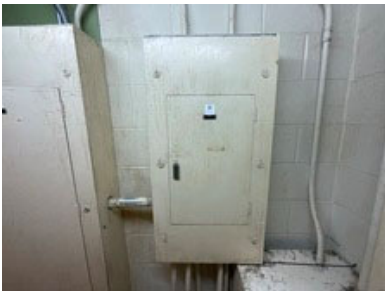
Distribution Panel in Poor condition.

120/240 V, Residential Style
Main Building J.B. Fisher Elementary School K-2 Hall Electrical Room

Replace Federal Pacific panel, poses a safety risk. - AssetCALC ID: 7496593

Uniformat Code: D5020
Recommendation: **Replace in 2025**

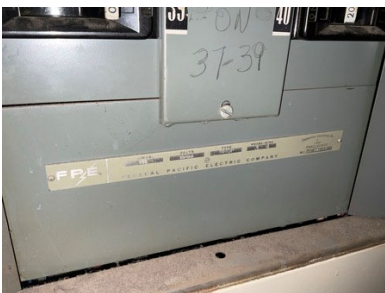
Distribution Panel in Poor condition.

120/240 V
Main Building J.B. Fisher Elementary School Cafetorium Hallway

Replace Federal Pacific panel, poses a safety risk. - AssetCALC ID: 7496591

Uniformat Code: D5020
Recommendation: **Replace in 2025**

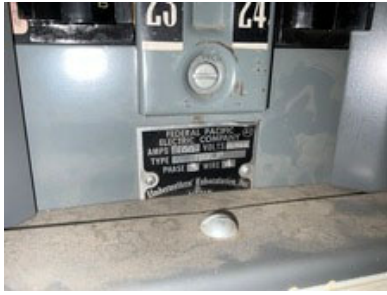
Distribution Panel in Poor condition.

120/240 V, Residential Style
Main Building J.B. Fisher Elementary School
Hallway Electrical Room

Replace Federal Pacific panel, poses a safety risk. - AssetCALC ID: 7496611

Uniformat Code: D5020
Recommendation: **Replace in 2025**

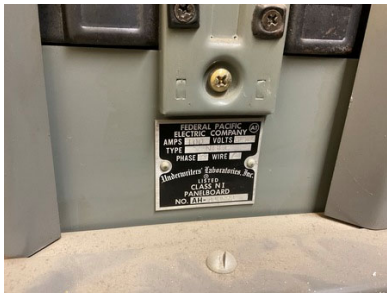
Distribution Panel in Poor condition.

120/240 V, Residential Style
Main Building J.B. Fisher Elementary School K-
2 Hall Electrical Room

Replace Federal Pacific panel, poses a safety risk. - AssetCALC ID: 7496601

Uniformat Code: D5020
Recommendation: **Replace in 2025**

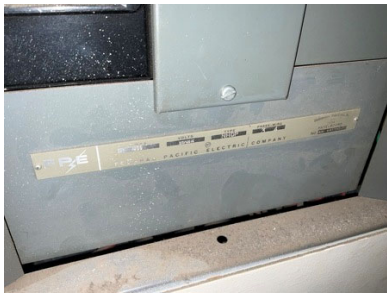
Distribution Panel in Poor condition.

120/240 V, Residential Style
Main Building J.B. Fisher Elementary School
Hallway Electrical Room

Replace Federal Pacific panel, poses a safety risk. - AssetCALC ID: 7496629

Uniformat Code: D5020
Recommendation: **Replace in 2025**

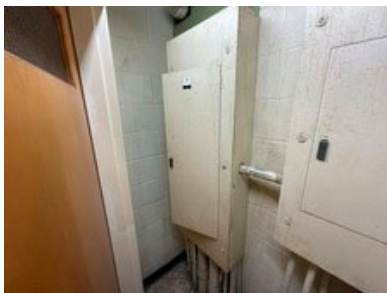
Distribution Panel in Poor condition.

120/240 V, Residential Style
Main Building J.B. Fisher Elementary School K-
2 Hall Electrical Room

Replace Federal Pacific panel, poses a safety risk. - AssetCALC ID: 7496588

Uniformat Code: D5020
Recommendation: **Replace in 2025**

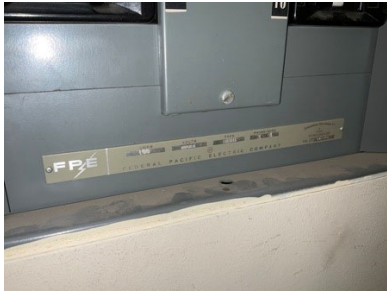
Distribution Panel in Poor condition.

120/240 V, Residential Style
Main Building J.B. Fisher Elementary School
Hallway Electrical Room

Replace Federal Pacific panel, poses a safety risk. - AssetCALC ID: 7496704

Uniformat Code: D5020
Recommendation: **Replace in 2025**

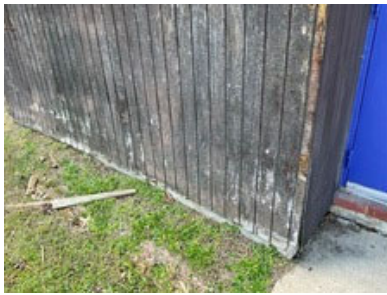
Exterior Walls in Poor condition.

Wood Siding
Annex Building J.B. Fisher Elementary School
Building Exterior

Rotting and deteriorating wood finish throughout exteriors. - AssetCALC ID: 7497038

Uniformat Code: B2010
Recommendation: **Replace in 2025**

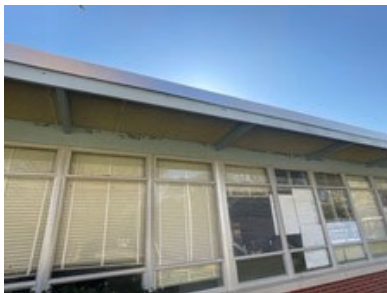
Exterior Walls in Poor condition.

any painted surface, 1-2 Story Building
Main Building J.B. Fisher Elementary School
Building Exterior

Chipping paint on front exterior of building. - AssetCALC ID: 7496682

Uniformat Code: B2010
Recommendation: **Prep & Paint in 2026**

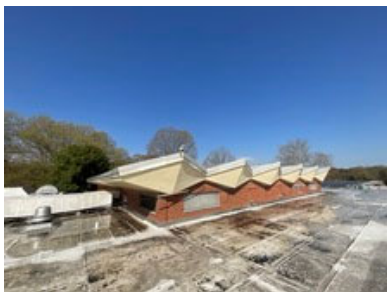
Roofing in Poor condition.

Single-Ply Membrane, TPO/PVC
Main Building J.B. Fisher Elementary School
Roof

Roof membrane has far exceeded its EUL and show signs of eminent failure. - AssetCALC ID: 7496606

Uniformat Code: B3010
Recommendation: **Replace in 2025**

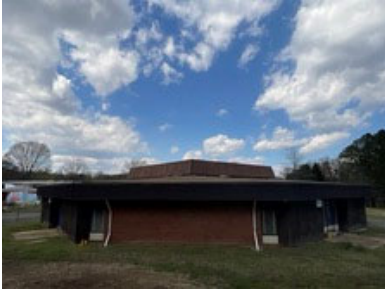
Roofing in Poor condition.

Exceedingly aged and showing general deterioration. - AssetCALC ID: 7497066

Uniformat Code: B3010
Recommendation: **Replace in 2025**

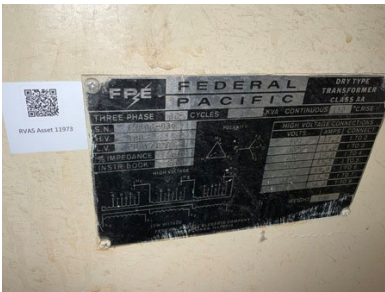
Secondary Transformer in Poor condition.

Replace Federal Pacific transformer - AssetCALC ID: 7496580

Uniformat Code: D5020
Recommendation: **Replace in 2025**

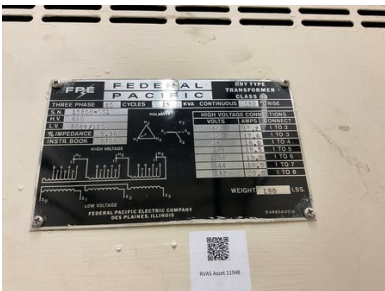
Secondary Transformer in Poor condition.

Original Federal Pacific transformer - AssetCALC ID: 7496635

Uniformat Code: D5020
Recommendation: **Replace in 2025**

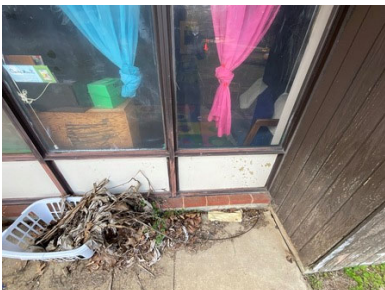
Window in Poor condition.

Significantly aged windows throughout - AssetCALC ID: 7497046

Uniformat Code: B2020
Recommendation: **Replace in 2026**

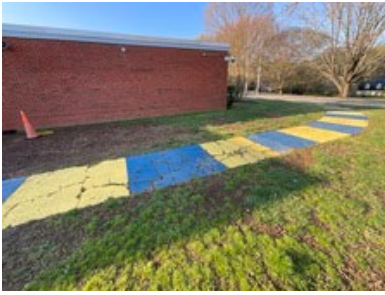
Sidewalk in Poor condition.

Concrete, Small Areas/Sections
Site J.B. Fisher Elementary School Site

Replace small sections of concrete slabs that have cracked elsewhere throughout site. - AssetCALC ID: 7496547

Uniformat Code: G2030
Recommendation: **Replace in 2026**

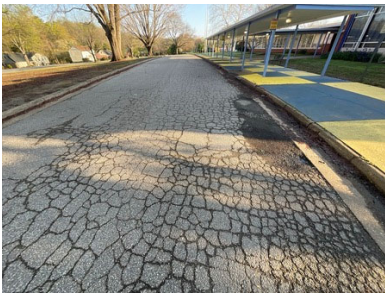
Parking Lots in Poor condition.

Pavement, Asphalt
Site J.B. Fisher Elementary School Site

Severe alligator cracking in various areas on asphalt surfaces. - AssetCALC ID: 7496594

Uniformat Code: G2020
Recommendation: **Mill & Overlay in 2025**

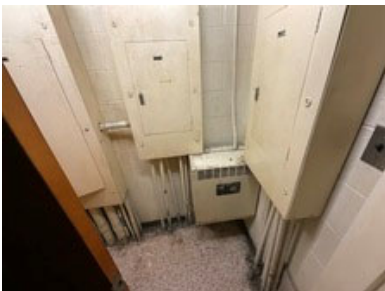
Electrical System in Poor condition.

Wiring & Switches, Average or Low Density/Complexity
Main Building J.B. Fisher Elementary School
Throughout building

Electrical is original to the building with outdated components. - AssetCALC ID: 7496657

Uniformat Code: D5030
Recommendation: **Replace in 2026**

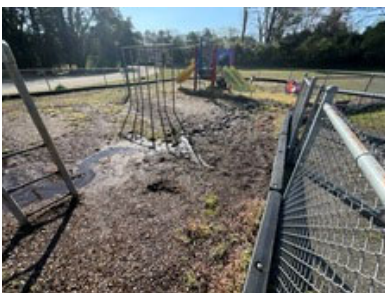
Playfield Surfaces in Poor condition.

Chips Wood, 3" Depth
Site J.B. Fisher Elementary School Site

Playground is flooded with vegetation growing above surface. - AssetCALC ID: 7496579

Uniformat Code: G2050
Recommendation: **Replace in 2025**

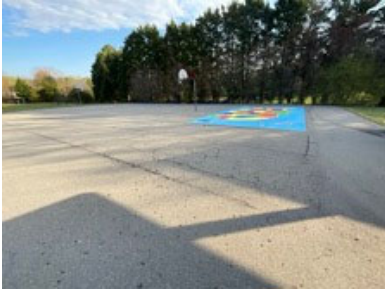
Athletic Surfaces & Courts in Poor condition.

Basketball/General, Asphalt Pavement
Site J.B. Fisher Elementary School Basketball Court

Basketball court transverse cracking needs to be sealed to maintain integrity of pavement system. - AssetCALC ID: 7496662

Uniformat Code: G2050
Recommendation: **Seal & Stripe in 2025**

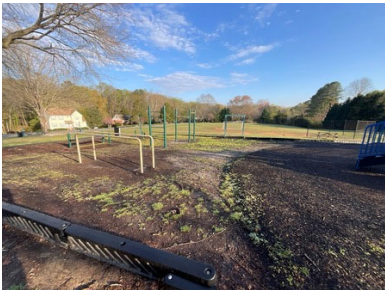
Playfield Surfaces in Poor condition.

Chips Rubber, 6" Depth
Site J.B. Fisher Elementary School Playground Main

Playground surface chips are depleted on main playground. - AssetCALC ID: 7496618

Uniformat Code: G2050
Recommendation: **Replace in 2026**

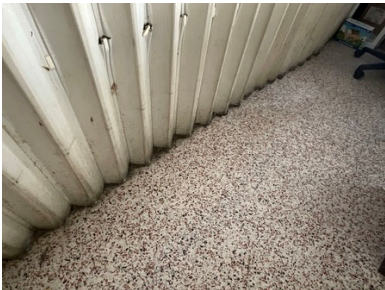
Interior Wall in Poor condition.

Movable Partitions, Fabric 8 to 10' Height
Main Building J.B. Fisher Elementary School Room 101-110

Wall partitions between classrooms are damaged at bottom of wall. - AssetCALC ID: 7496681

Uniformat Code: C1010
Recommendation: **Replace in 2026**

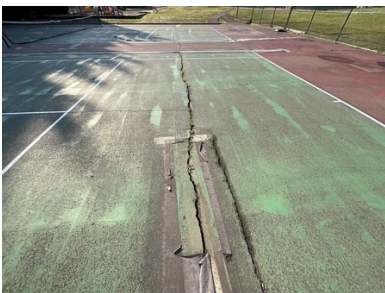
Athletic Surfaces & Courts in Poor condition.

Tennis/Volleyball, Rubber-Acrylic w/ Integral Color
Site J.B. Fisher Elementary School Tennis Court

Severe surface cracking that has allowed vegetation to grow onto surface. Resurface recommended. - AssetCALC ID: 7496694

Uniformat Code: G2050
Recommendation: **Resurface in 2026**

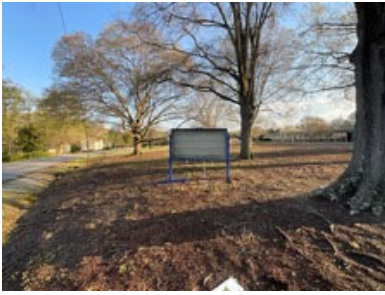
Signage in Failed condition.

Property, Monument
Site J.B. Fisher Elementary School Site

Property signage is nonfunctional and needs to be replaced. - AssetCALC ID: 7496577

Uniformat Code: G2060
Recommendation: **Replace/Install in 2025**

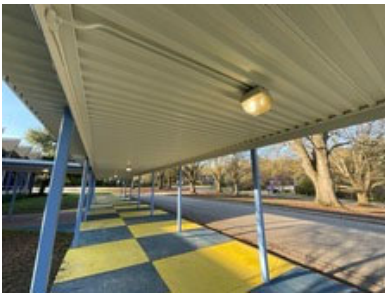
Exterior Fixture w/ Lamp in Poor condition.

any type, w/ LED Replacement
Main Building J.B. Fisher Elementary School
Main Entrance

CFL fixtures, replace with LED - AssetCALC ID: 7496644

Uniformat Code: G4050
Recommendation: **Replace in 2026**

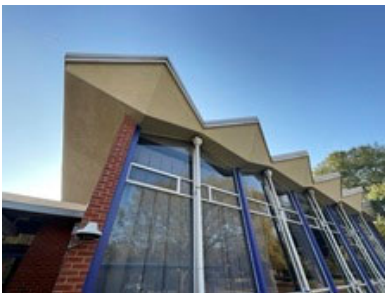
Exterior Walls in Poor condition.

any type, Repairs per Man-Day
Main Building J.B. Fisher Elementary School
Main Entrance (Facade at top of Cafetorium)

Birds appear to be entering structure above windows of cafetorium. Façade repairs required to remedy the issue. - AssetCALC ID: 7496564

Uniformat Code: B2010
Recommendation: **Repair in 2024**
