# FACILITY CONDITION ASSESSMENT

**Richmond Public Schools**  
301 North Ninth Street  
Richmond, VA 23219

Chimborazo Elementary School  
3000 East Marshall Street  
Richmond, VA 23223

*May 21, 2024*

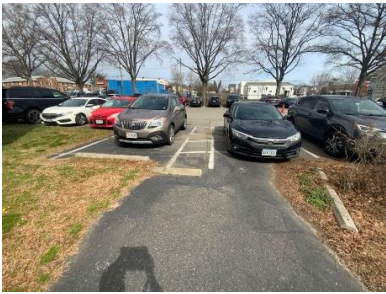
#### ADA Parking

Designated Stall, Pavement Markings & Signage  
Main Building Chimborazo Elementary School

Parking lot lacks accessible parking spaces. - AssetCALC ID: 7415478

Uniformat Code: Y1010  
Recommendation: **Install in 2024**

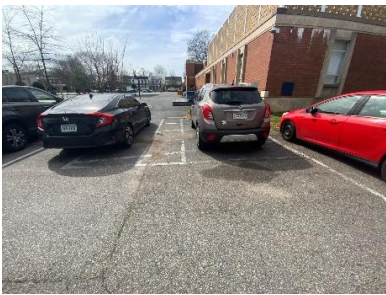
#### ADA Parking

Signage, Pole-Mounted  
Main Building Chimborazo Elementary School  
Throughout

Parking lot lacks accessible parking spaces. - AssetCALC ID: 7415549

Uniformat Code: Y1010  
Recommendation: **Install in 2024**

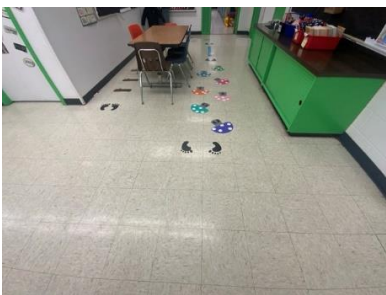
#### ADA Miscellaneous

Level III Study, Includes Measurements  
Main Building Chimborazo Elementary School  
Throughout building

Some areas of the facility were identified as having major or moderate accessibility issues. Bureau Veritas recommends a study be performed to take measurements, provide additional itemized details, research local requirements, and, if necessary, estimate the scope and cost of any required improvements. - AssetCALC ID: 7441117

Uniformat Code: Y1090  
Recommendation: **Evaluate/Report in 2024**

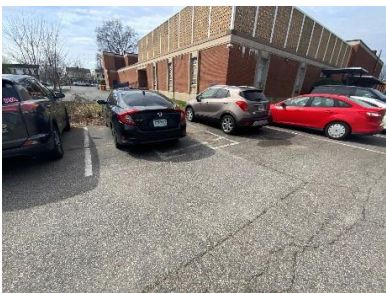
#### ADA Parking

Access Aisle, Striping  
Main Building Chimborazo Elementary School  
Parking lot

Uniformat Code: Y1010  
Recommendation: **Install in 2024**

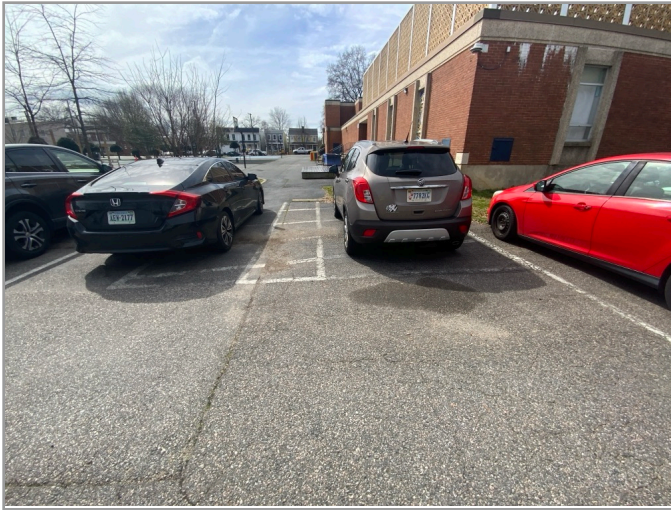
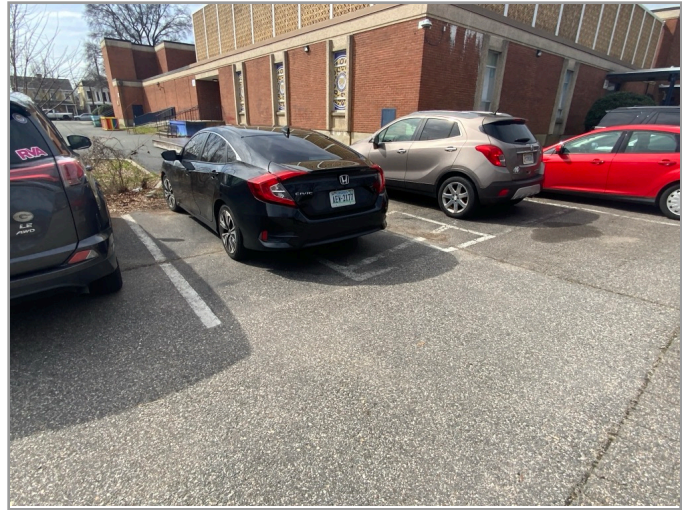
OVERVIEW OF ACCESSIBLE PARKING AREA

Question		Yes	No	NA	Comments
1	Does the required number of standard ADA designated spaces appear to be provided ?		✗		
2	Does the required number of van-accessible designated spaces appear to be provided ?		✗		
3	Are accessible spaces on the shortest accessible route to an accessible building entrance ?		✗		
4	Does parking signage include the International Symbol of Accessibility ?		✗		
5	Does each accessible space have an adjacent access aisle ?		✗		
6	Do parking spaces and access aisles appear to be relatively level and without obstruction ?		✗
