FACILITY CONDITION ASSESSMENT

Richmond Public Schools
301 North Ninth Street
Richmond, VA 23219

John Marshall High School
4225 Old Brook Road
Richmond, VA 23227

May 23, 2024

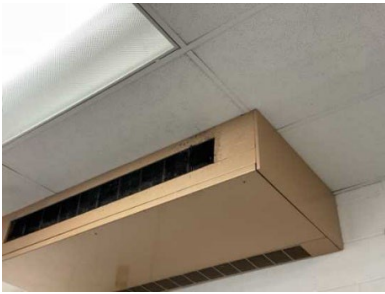
**Recommended Follow-up Study:
Environmental, Analysis of
Suspect Fungal Growth**

Suspected fungal growth present on fan coil units in several classrooms - AssetCALC ID: 7414943

Uniformat Code: P2030
Recommendation: **Evaluate/Report in 2024**

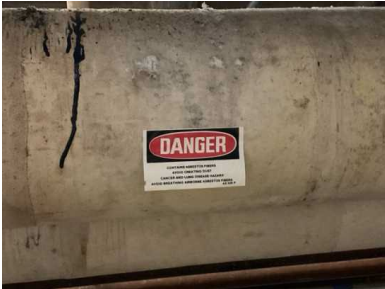
**Recommended Follow-up Study:
Environmental, Asbestos (ACM) &
Lead Base Paint (LBP)**

Asbestos has been reported to be present in pipe insulation, window framing, and flooring. These items will need to be abated. - AssetCALC ID: 7415150

Uniformat Code: P2030
Recommendation: **Evaluate/Report in 2024**

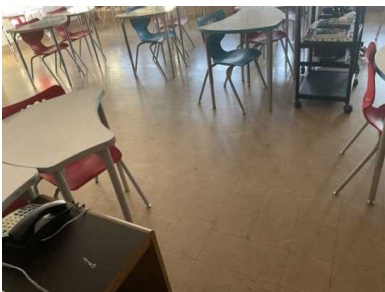
Flooring in Poor condition.

There is some likelihood the flooring present in most of the classrooms contains asbestos. A consultant should be hired to either affirm or deny this possibility, and then abatement is recommended if the presence of asbestosis is confirmed. - AssetCALC ID: 7415033

Uniformat Code: C2030
Recommendation: **Replace in 2025**

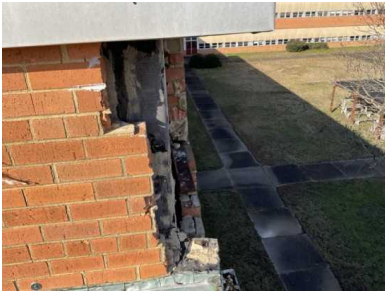
Exterior Walls in Poor condition.

Numerous sections of failed exterior brick veneer wall and bulging walls. - AssetCALC ID: 7415012

Uniformat Code: B2010
Recommendation: **Replace in 2024**

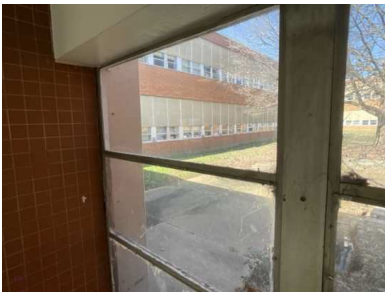
Glazing in Poor condition.

Vast majority of windows are original single pane aluminum with issues. - AssetCALC ID: 7415152

Uniformat Code: B2020
Recommendation: **Replace in 2025**

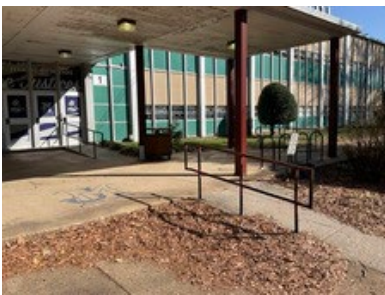
Curtain Wall in Poor condition.

Single pane glazing, cracked panels, and poorly insulated panels. - AssetCALC ID: 7523202

Uniformat Code: B2010
Recommendation: **Replace in 2025**

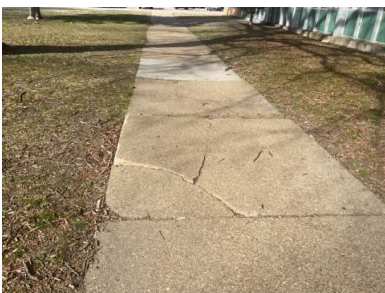
Sidewalk in Poor condition.

There are several large cracks and raised portions of concrete walkways around the site, some present serious, tripping hazards - AssetCALC ID: 7415023

Uniformat Code: G2030
Recommendation: **Repair in 2024**

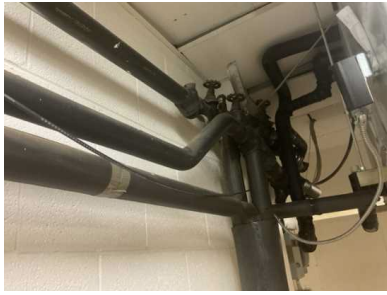
HVAC System in Poor condition.

Many leaks throughout the system. There is evidence of asbestos in original piping. - AssetCALC ID: 7415117

Uniformat Code: D3050
Recommendation: **Replace in 2025**

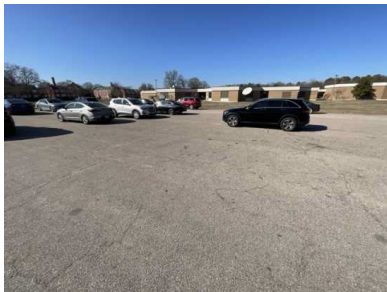
Parking Lots in Poor condition.

Striping is nonexistent throughout the majority of the lot and surface cracks require sealing. - AssetCALC ID: 7415007

Uniformat Code: G2020
Recommendation: **Seal & Stripe in 2024**

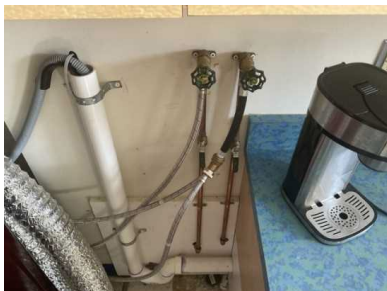
Plumbing System in Poor condition.

Frequent leaks and backups have been reported. Much of the piping is original to build. Full replacement is highly recommended. - AssetCALC ID: 7414995

Uniformat Code: D2010
Recommendation: **Replace in 2026**

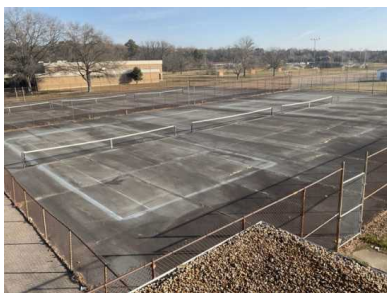
Athletic Surfaces & Courts in Poor condition.

Faded and cracked surfaces - AssetCALC ID: 7415139

Uniformat Code: G2050
Recommendation: **Seal & Stripe in 2025**

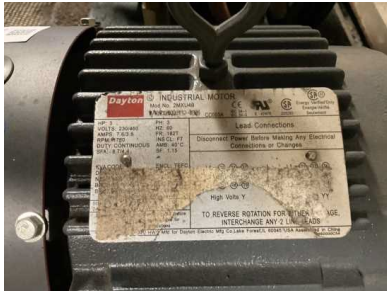
Air Compressor in Failed condition.

Drive belt has snapped - AssetCALC ID: 7415095

Unifomat Code: D2060
Recommendation: **Replace in 2024**

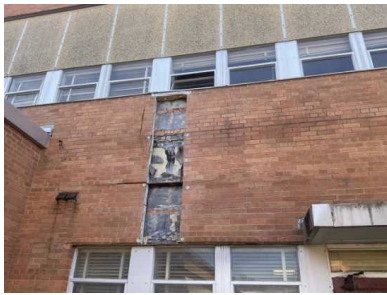
Recommended Follow-up Study: Structural, General Design

There appears to be major settling occurring along the brick veneer in the north courtyard. Some sections of bowed out brick have been cut out and removed, likely for investigating cause. - AssetCALC ID: 7414999

Unifomat Code: P2030
Recommendation: **Design in 2024**

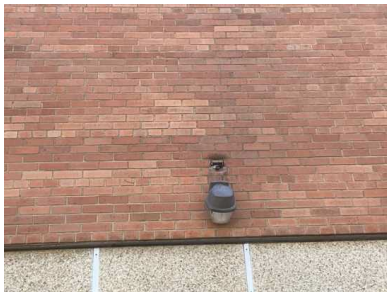
Exterior Fixture with Lamp in Poor condition.

Many lights do not work, and/or are broken - AssetCALC ID: 7414916

Unifomat Code: G4050
Recommendation: **Replace in 2025**

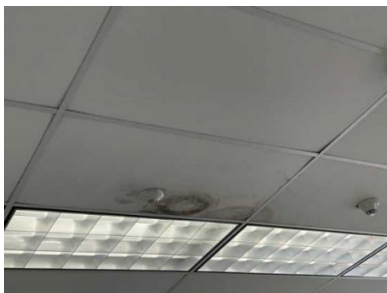
Suspended Ceilings in Poor condition.

Several damaged ACT present throughout the building, particularly in classroom 119 - AssetCALC ID: 7414927

Unifomat Code: C1070
Recommendation: **Replace in 2025**

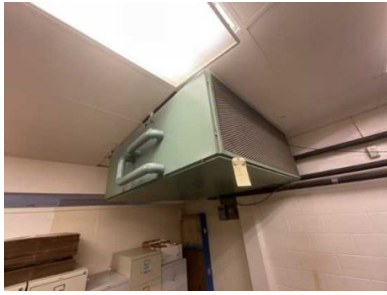
Fan Coil Unit in Poor condition.

Antiquated. Leaks evident. Some units have suspected fungal growth. - AssetCALC ID: 7414933

Uniformat Code: D3050
Recommendation: **Replace in 2025**

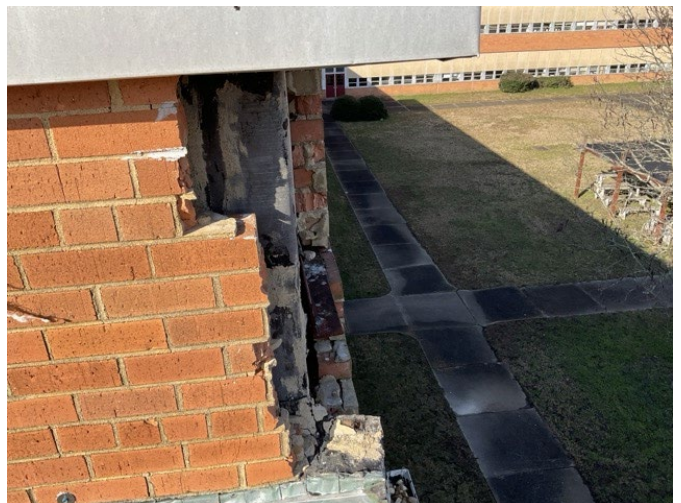
6 - BRICK FACADE

<p>Additional Studies</p>	<p>The brick facade is in poor (and in some areas failed) condition. The north courtyard has areas of bricks bowing out from the building, several sections appear to have been cut out some time ago. There is also potential settlement cracking present throughout the façade. A professional engineer must be retained to analyze the existing condition, provide recommendations and, if necessary, estimate the scope and cost of any required repairs, including finishing the repairs in progress. The cost of this study is included in the cost tables. A budgetary cost allowance to replace the brick is also included, however due to the ambiguity of the problem, this estimated cost may not be accurate.</p> <p>There is suspected fungal growth present in ceiling tiles and on fan coil units throughout the facility. This can pose a safety and health concern. A professional consultant must be retained to analyze the existing condition, provide recommendations and, if necessary, estimate the scope and cost of any required remediation. The cost of the study is included in the cost tables.</p> <p>It was brought to attention that there is a high probability of asbestos located in numerous areas of the building to include but not exclusively: the frame sealing components of exterior glazing, insulation of plumbing and HVAC piping, and classroom VCT flooring. A professional consultant must be retained to analyze the existing condition, provide recommendations and, if necessary, estimate the scope and cost of any required abatement. The cost of the study is included in the cost tables. Due to the ambiguity of which assets end up returning positive for asbestos particles, cost for abatement can widely vary and current costs only represent the amount needed for replacement of classroom VCT flooring.</p>
