FACILITY CONDITION ASSESSMENT

Richmond Public Schools
301 North Ninth Street
Richmond, VA 23219

Franklin Military Academy
701 North 37th Street
Richmond, VA 23223

May 13, 2024

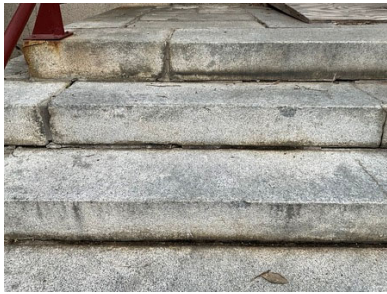
Exterior Stairs in Poor condition.

Stone
Site Franklin Military Academy Site

Mortar joints are cracked and missing. - AssetCALC ID: 7511105

Uniformat Code: B2010
Recommendation: **Repoint in 2025**

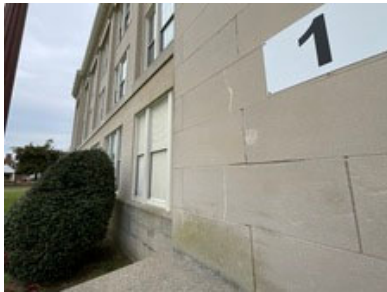
Exterior Walls in Poor condition.

Stone
Main Building Franklin Military Academy
Building Exterior

The mortar joints of the stonework surrounding the building have become loose or missing. - AssetCALC ID: 7510867

Uniformat Code: B2010
Recommendation: **Repoint in 2025**

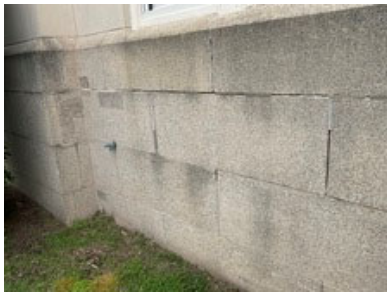
Exterior Walls in Poor condition.

Stone
Main Building Franklin Military Academy
Foundation

Mortar joints are cracked and falling out. - AssetCALC ID: 7511027

Uniformat Code: B2010
Recommendation: **Repoint in 2025**

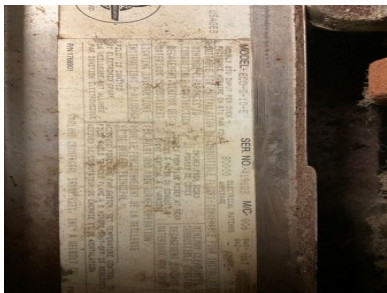
Foodservice Equipment in Poor condition.

Convection Oven, Double
Main Building Franklin Military Academy
Kitchen

Unit has a sign on it out of service. - AssetCALC ID: 7510980

Uniformat Code: E1030
Recommendation: **Replace in 2024**

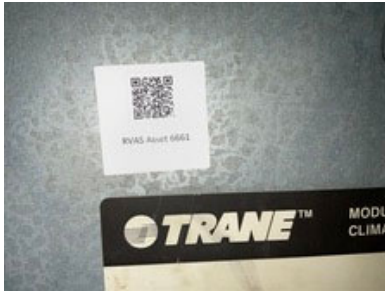
Air Handler in Poor condition.

Interior AHU, Easy/Moderate Access
Main Building Franklin Military Academy
Mechanical room

There are significant water, stains, and drip marks from supply in return piping from coil. There is also an active leak in the return pipe going into the coil. Significant rust along the top of the sheet metal. - AssetCALC ID: 7511068

Recommendation: **Replace in 2025**
