# FACILITY CONDITION ASSESSMENT

**Richmond Public Schools**  
301 North Ninth Street  
Richmond, VA 23219

Frances W. McClenney Elementary School  
3817 Chamberlayne Avenue  
Richmond, VA 23227

*May 22, 2024*

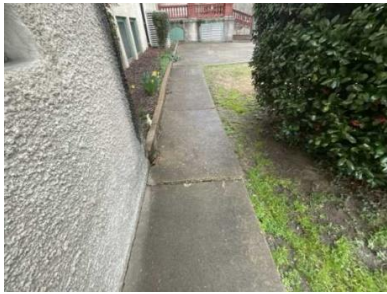
### Sidewalk in Poor condition.

any pavement type, Sectional Repairs (per Man-Day)  
 Site Frances W. McClenney Elementary School Site

Trip hazards are present on walkways and require resurfacing - AssetCALC ID: 7424952

Uniformat Code: G2030  
 Recommendation: **Repair in 2024**

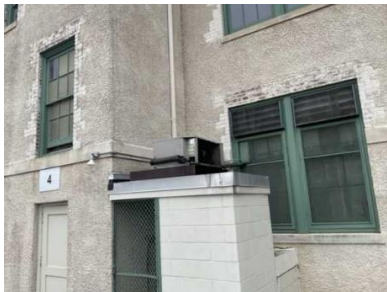
### Exterior Walls in Poor condition.

any painted surface  
 Main Building Frances W. McClenney Elementary School Building Exterior

Faded and chipped - AssetCALC ID: 7424936

Uniformat Code: B2010  
 Recommendation: **Prep & Paint in 2025**

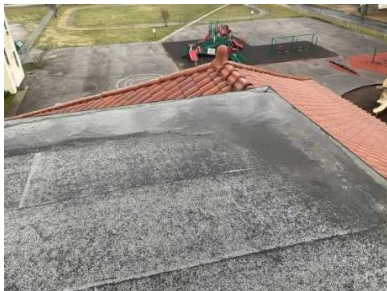
### Roofing in Poor condition.

Modified Bitumen  
 Main Building Frances W. McClenney Elementary School Roof

Multiple leaks reported, some soft spots - AssetCALC ID: 7424904

Uniformat Code: B3010  
 Recommendation: **Replace in 2026**

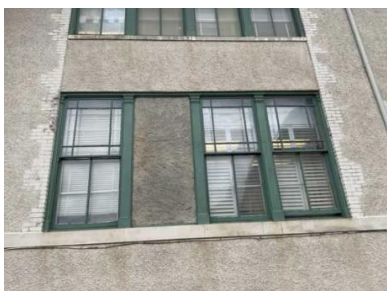
### Glazing in Poor condition.

any type by SF  
 Main Building Frances W. McClenney Elementary School Building Exterior

Leaking, many panes have been replaced to plexiglass. - AssetCALC ID: 7424888

Uniformat Code: B2020  
 Recommendation: **Replace in 2025**

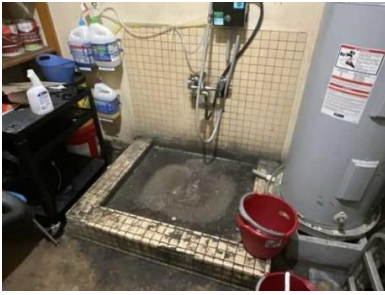
**Sink/Lavatory in Poor condition.**

Service Sink, Floor  
Main Building Frances W. McClenney  
Elementary School Utility closet

Drain has massive amount of buildup - AssetCALC ID: 7424883

Uniformat Code: D2010  
Recommendation: **Replace in 2025**

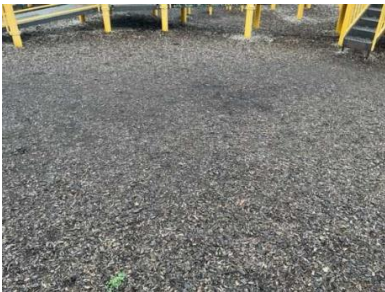
**Playfield Surfaces in Poor condition.**

Chips Wood, 6" Depth  
Site Frances W. McClenney Elementary School  
Playground

Woodchip areas need to be refilled - AssetCALC ID: 7424871

Uniformat Code: G2050  
Recommendation: **Replace in 2025**

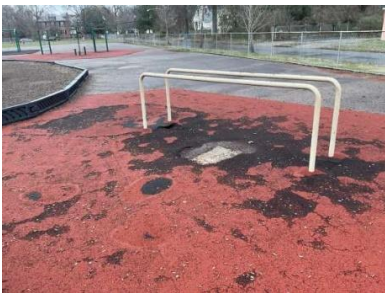
**Playfield Surfaces in Poor condition.**

Rubber, Small Areas  
Site Frances W. McClenney Elementary School  
Playground

Erosion and broken sections - AssetCALC ID: 7424914

Uniformat Code: G2050  
Recommendation: **Replace in 2025**

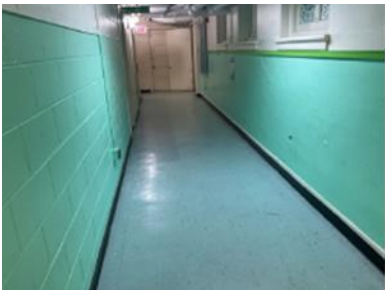
**HVAC System**

Full System Renovation/Upgrade, Low  
Complexity  
Main Building Frances W. McClenney  
Elementary School Hallways

According to management, the hallways are not air conditioned and dual temperature system creates challenges on mild days. - AssetCALC ID: 7541225

Uniformat Code: D3050  
Recommendation: **Upgrade in 2025**
