FACILITY CONDITION ASSESSMENT

Richmond Public Schools
301 North Ninth Street
Richmond, VA 23219

Elizabeth D. Redd Elementary School
5601 Jahkne Road
Richmond, VA 23225

May 15, 2024

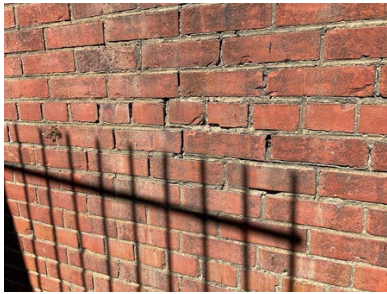
Exterior Walls in Poor condition.

Brick
Elizabeth D. Redd Elementary School Main Building Exterior

It was reported that mold was an issue in the school. A possible area of moisture infiltration is through brick and into the wall system. - AssetCALC ID: 7544924

Uniformat Code: B2010
Recommendation: **Repair/Repoint in 2024**

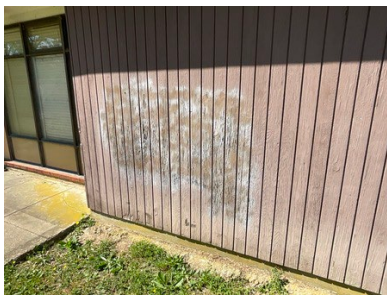
Exterior Walls in Poor condition.

Plywood/OSB
Elizabeth D. Redd Elementary School Kindergarten Round

T1-11 is weathered and delaminating. - AssetCALC ID: 7544822

Uniformat Code: B2010
Recommendation: **Replace in 2024**

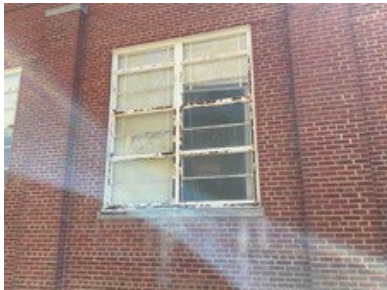
Glazing in Poor condition.

Any Type by SF
Elizabeth D. Redd Elementary School Main Building Exterior

The windows are steel frame, single pane with no storms. Some of the windows have difficulty closing. Additionally, the window caulking may contain asbestos. - AssetCALC ID: 7544755

Uniformat Code: B2020
Recommendation: **Replace in 2024**

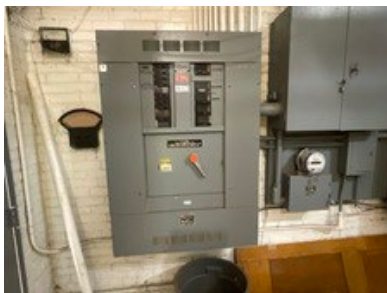
Switchboard in Poor condition.

120/208 V
Elizabeth D. Redd Elementary School Main Building Boiler Room

FPE panelboards circuit breakers may not trip properly when there is an overload or short circuit. This can lead to dangerous wiring, heat levels and potential fire. - AssetCALC ID: 7544867

Uniformat Code: D5020
Recommendation: **Replace in 2024**

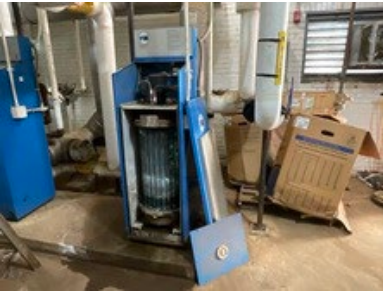
Boiler in Poor condition.

Gas, HVAC
Elizabeth D. Redd Elementary School Main Building Boiler Room

Unit is down for repairs - AssetCALC ID: 7544858

Uniformat Code: D3020
Recommendation: **Replace in 2026**

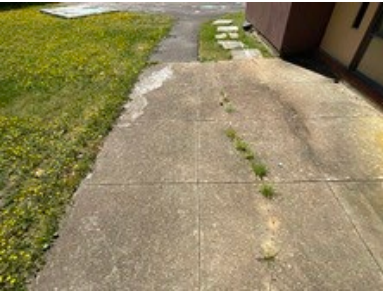
Sidewalk in Poor condition.

Concrete, Large Areas
Elizabeth D. Redd Elementary School Kindergarten Round

Small section in front of exterior door, number five the concrete has chipped and spalled away. Replacement of pad is necessary. - AssetCALC ID: 7544868

Uniformat Code: G2030
Recommendation: **Replace in 2024**

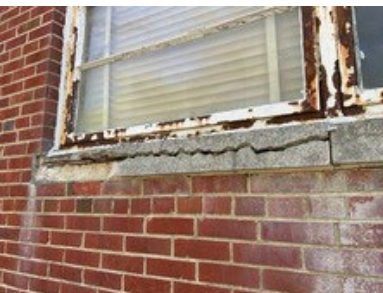
Edging in Poor condition.

Concrete
Elizabeth D. Redd Elementary School Main Building Exterior Windowsill

All of the exterior concrete windowsills of the original building are cracking and some have exposed rebar. They all need to be chipped out and replaced. - AssetCALC ID: 7544754

Uniformat Code: G2030
Recommendation: **Replace in 2024**

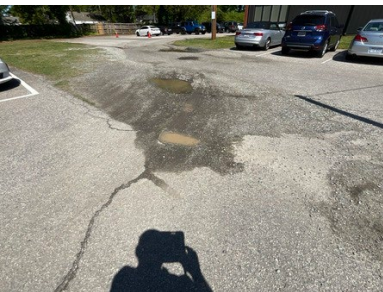
Parking Lots in Poor condition.

Pavement, Asphalt
Elizabeth D. Redd Elementary School Site

The pavement behind the rear handicap parking is very worn with alligator cracks and potholes. - AssetCALC ID: 7544888

Uniformat Code: G2020
Recommendation: **Mill & Overlay in 2025**

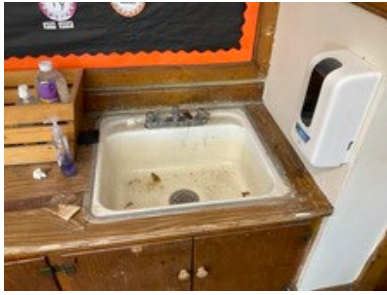
Sink/Lavatory in Poor condition.

Vanity Top, Enameled Steel
Elizabeth D. Redd Elementary School Main
Building Room 101

Hot and cold faucet will not shut off water completely. Handles just spin. - AssetCALC ID: 7544988

Uniformat Code: D2010
Recommendation: **Replace in 2024**

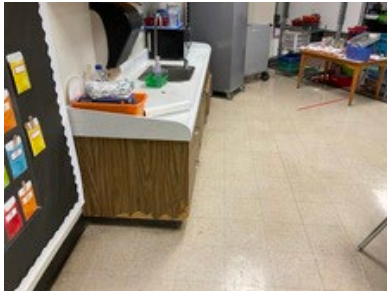
Casework in Poor condition.

Cabinetry Economy
Elizabeth D. Redd Elementary School
Kindergarten Round

The cabinetry is chipped along the bottom edges on the front sides. - AssetCALC ID: 7544771

Uniformat Code: E2010
Recommendation: **Replace in 2024**

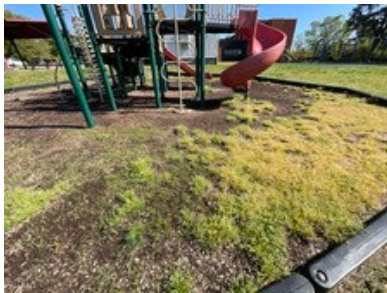
Playground Surfaces in Poor condition.

Chips Wood, 6" Depth
Elizabeth D. Redd Elementary School Site

Wood chips in the smaller play structure are missing and existing wood chips has turned to dirt. - AssetCALC ID: 7544990

Uniformat Code: G2050
Recommendation: **Replace in 2024**

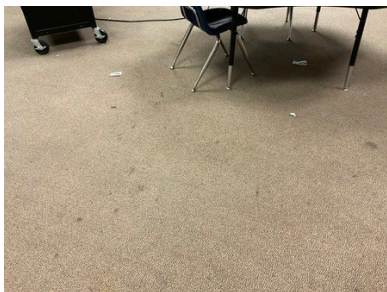
Flooring in Poor condition.

Carpet, Commercial Standard
Elizabeth D. Redd Elementary School
Kindergarten Round

The Carpet is original to the 1970 build and is stained and worn. - AssetCALC ID: 7544979

Uniformat Code: C2030
Recommendation: **Replace in 2024**

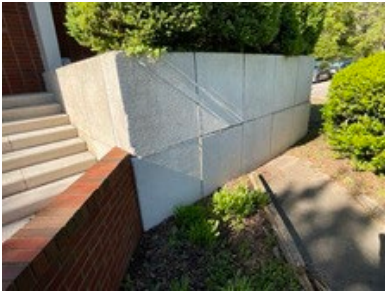
Retaining Wall in Poor condition.

Brick/Stone
Elizabeth D. Redd Elementary School Site

The front portion looks like it is pulling away from the side portion of retaining wall. - AssetCALC ID: 7544914

Uniformat Code: G2060
Recommendation: **Replace in 2024**

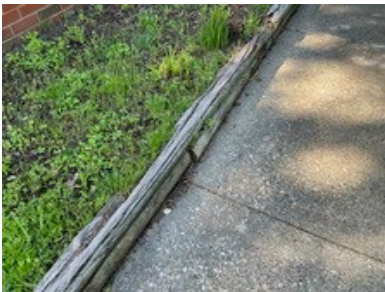
Planter Boxes in Poor condition.

Basic or Wood Built-In Place
Elizabeth D. Redd Elementary School Site

Edge material to the grassy area and planter boxes are decayed at school front. - AssetCALC ID: 7544869

Uniformat Code: G2080
Recommendation: **Replace in 2024**

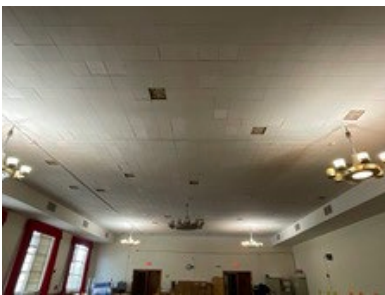
Suspended Ceilings in Poor condition.

Hard Tile, ACM Abatement & Replacement with ACT
Elizabeth D. Redd Elementary School Main Building School Auditorium

Ceiling tiles in the auditorium reportedly contain asbestos. - AssetCALC ID: 7544852

Uniformat Code: C1070
Recommendation: **Replace in 2024**

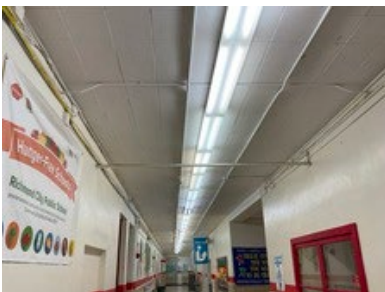
Suspended Ceilings in Poor condition.

Hard Tile, ACM Abatement & Replacement with ACT
Elizabeth D. Redd Elementary School Main Building School Throughout Building

Uniformat Code: C1070
Recommendation: **Replace in 2024**
