# FACILITY CONDITION ASSESSMENT

J.H. Blackwell Elementary School  
300 East 15th Street  
Richmond, VA 23224

*166385.24R000-002.468*

*May 28, 2024*

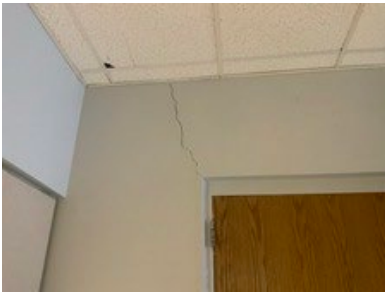
#### Structural Elements in Poor condition.

Any Type, Repairs per Man-Day  
Main Building J.H. Blackwell Elementary  
School Conference Room

Repair large noticeable crack along the door frame of the conference room. - AssetCALC ID: 7518660

Uniformat Code: B1010  
Recommendation: **Repair in 2024**

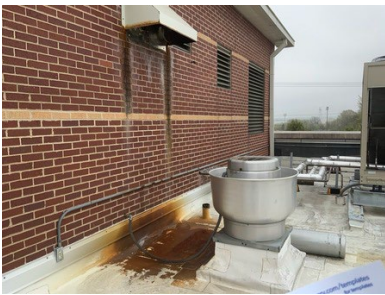
#### Roofing in Poor condition.

Single-Ply Membrane, TPO/PVC  
Main Building J.H. Blackwell Elementary  
School Roof

Pooling everywhere and uneven. - AssetCALC ID: 7499894

Uniformat Code: B3010  
Recommendation: **Replace in 2026**

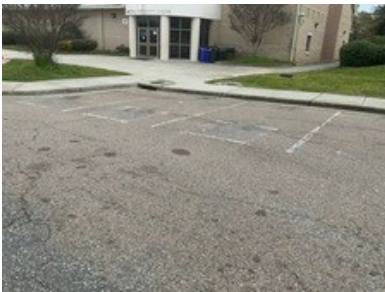
#### Parking Lots in Poor condition.

Pavement, Asphalt  
Site J.H. Blackwell Elementary School Site

Faded stripes - AssetCALC ID: 7508850

Uniformat Code: G2020  
Recommendation: **Seal & Stripe in 2025**

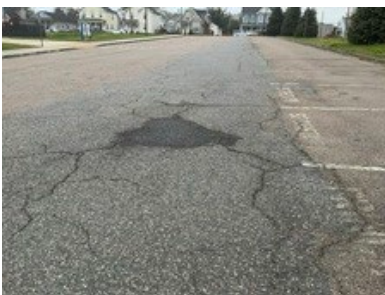
#### Parking Lots in Poor condition.

Pavement, Asphalt  
Main Building J.H. Blackwell Elementary  
School Site

Cracks throughout - AssetCALC ID: 7508849

Uniformat Code: G2020  
Recommendation: **Mill & Overlay in 2025**

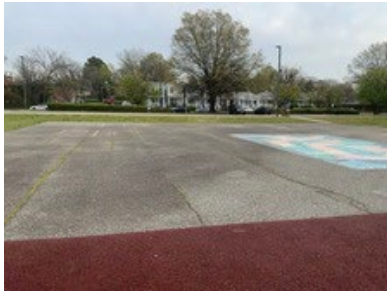
There is a playground consisting of a swing set and large playground structure. The asphalt athletic court has grass growing in between the cracks and needs a mill and overlay. The parking lot has cracks throughout and faded stripes.

### Athletic Surfaces & Courts in Poor condition.

Basketball/General, Asphalt Pavement  
Site J.H. Blackwell Elementary School Site

Many cracks with grass growing in between - AssetCALC ID: 7499856

Unifomat Code: G2050  
Recommendation: **Mill & Overlay in 2025**

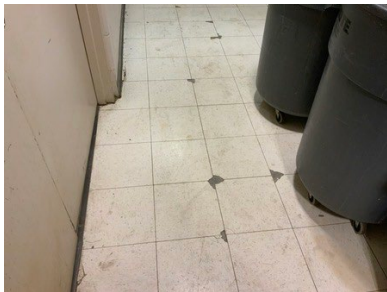
The interior consists mostly of painted CMU walls, ACT ceilings, and VCT flooring. The VCT flooring in the back hallway of the boiler room is chipped and stained, also, the ACT ceiling is discolored and old. There is a large crack that runs from the door frame to the ceiling in the conference room. A cost for repair is provided.

### Flooring in Poor condition.

Vinyl Tile (VCT)  
Main Building J.H. Blackwell Elementary  
School Facilities Back Hallway

Cracks and chipped VCT flooring. - AssetCALC ID: 7499778

Unifomat Code: C2030  
Recommendation: **Replace in 2024**

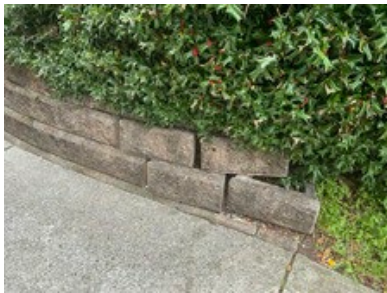
The retaining wall that separates the public pool from the school property line has a few broken off bricks that need repair.

### Retaining Wall in Poor condition.

Brick/Stone  
Site J.H. Blackwell Elementary School Site

Bricks are falling apart at one end - AssetCALC ID: 7499868

Unifomat Code: G2060  
Recommendation: **Replace in 2025**

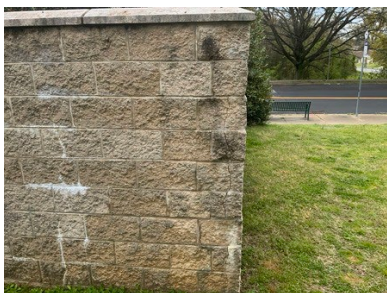
There are two public parking lots that serve the elementary school, but both are shared with the public pool building and J.H. Blackwell Preschool. A private lot on the right-hand side of the building has limited parking and contains the dumpster enclosure, which has vertical cracks on both sides of the rear.

### Dumpster Enclosure in Poor condition.

Masonry (CMU) Walls, 8' High (per LF)  
Site J.H. Blackwell Elementary School Site

Wall is crack on both sides - AssetCALC ID: 7499853

Unifomat Code: G2060  
Recommendation: **Replace/Install in 2026**

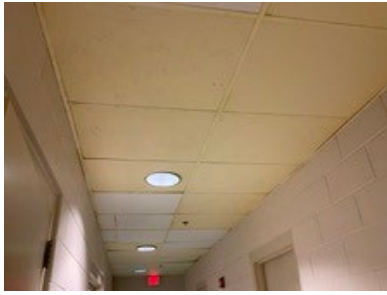
### Suspended Ceilings in Poor condition.

Acoustical Tile (ACT)  
Main Building J.H. Blackwell Elementary  
School Facilities Back Hallway

Unifomat Code: C1070  
Recommendation: **Replace in 2026**
