FACILITY CONDITION ASSESSMENT

Richmond Public Schools
301 North Ninth Street
Richmond, VA 23219

Clark Springs Elementary School
1101 Dance Street
Richmond, VA 23220

October 10, 2024

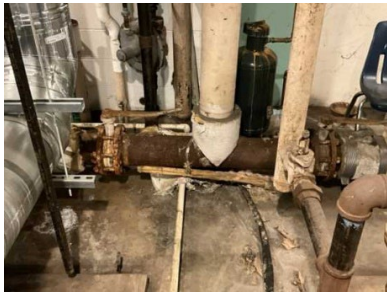
HVAC System in Poor condition.

Hydronic Piping, 2-Pipe
Main Building Clark Springs Elementary School
Boiler Room

Corrosion and deterioration was observed at the hydronic piping. - AssetCALC ID: 7416183

Uniformat Code: D3050
Recommendation: **Replace in 2026**

Cost Estimate: \$251,900

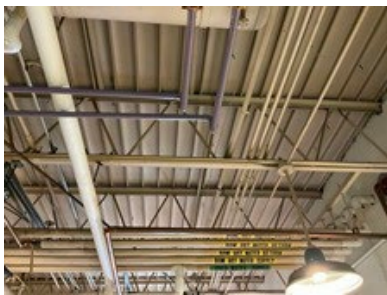
Piping and Valves in Poor condition.

Fiberglass Insulation, Domestic Water
Main Building Clark Springs Elementary School
Throughout

Pipe insulation failing in building is staining ceiling tiles. - AssetCALC ID: 7649132

Uniformat Code: D2010
Recommendation: **Replace in 2025**

Cost Estimate: \$60,000

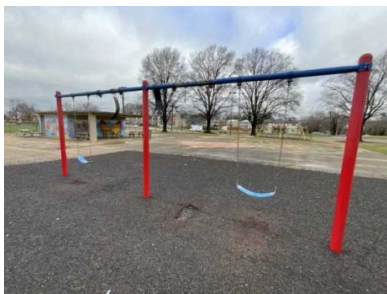
Play Structure in Poor condition.

Swing Set, 4 Seats
Main Building Clark Springs Elementary School
Site

Damage and deterioration were observed at the swing sets. - AssetCALC ID: 7416170

Uniformat Code: G2050
Recommendation: **Replace in 2026**

Cost Estimate: \$7,500
