# FACILITY CONDITION ASSESSMENT

**Richmond Public Schools**  
301 North Ninth Street  
Richmond, VA 23219

Barack Obama Elementary School  
3101 Fendall Avenue  
Richmond, VA 23222

*May 28, 2024*

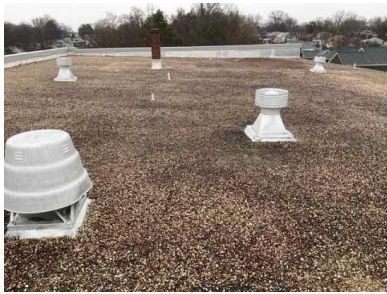
#### Roofing in Poor condition.

Built-Up  
Main Building Barack Obama Elementary  
School Roof

Roof leaks reported throughout - AssetCALC ID: 7450431

Uniformat Code: B3010  
Recommendation: **Replace in 2025**

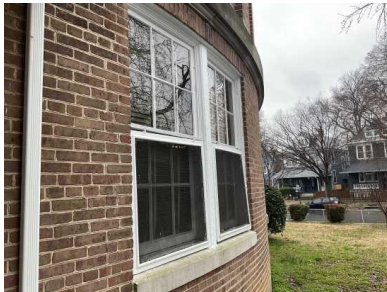
#### Window in Poor condition.

Wood Historical, 16-25 SF  
Main Building Barack Obama Elementary  
School Building Exterior

Drafty and significantly aged, water damaged and rotted in areas - AssetCALC ID: 7450403

Uniformat Code: B2020  
Recommendation: **Restore in 2025**

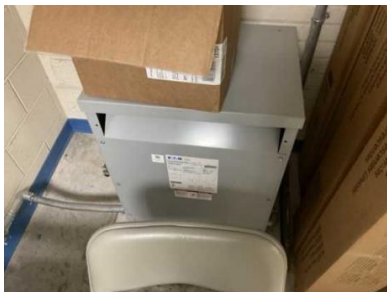
#### Recommended Follow-up Study: Electrical, General Design

Electrical, General Design  
Barack Obama Elementary School Throughout  
Building

It was reported that the electrical system is undersized for the building. - AssetCALC ID: 7530633

Uniformat Code: P2030  
Recommendation: **Study in 2024**

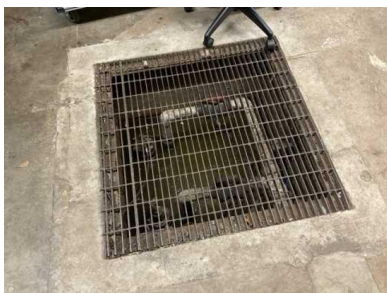
#### Recommended Follow-up Study: Plumbing, Domestic Water Supply System

Plumbing, Domestic Water Supply System  
Main Building Barack Obama Elementary  
School Throughout building

Storm water drainage backed up and clogged - AssetCALC ID: 7450372

Uniformat Code: P2030  
Recommendation: **Evaluate/Report in 2024**

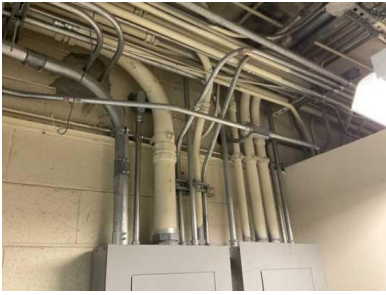
**Electrical System in Poor condition.**

Full System Renovation/Upgrade, Low Density/Complexity  
Main Building Barack Obama Elementary School Throughout building

It was reported that the electrical system is undersized for the building. - AssetCALC ID: 7450420

Uniformat Code: D5020  
Recommendation: **Replace in 2025**

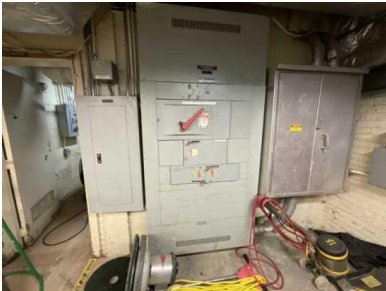
**Distribution Panel in Poor condition.**

120/208 V, 800 AMP  
Main Building Barack Obama Elementary School Mechanical room

Electrical is undersized and aged - AssetCALC ID: 7450448

Uniformat Code: D5020  
Recommendation: **Replace in 2025**

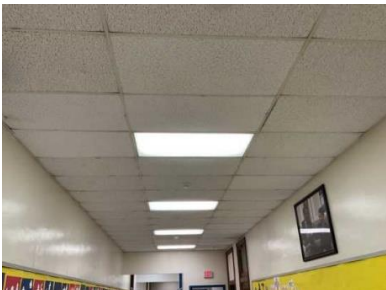
**Suspended Ceilings in Poor condition.**

Acoustical Tile (ACT)  
Main Building Barack Obama Elementary School Throughout building

Ceiling tiles have aged, discolored, and deteriorated - AssetCALC ID: 7450453

Uniformat Code: C1070  
Recommendation: **Replace in 2025**

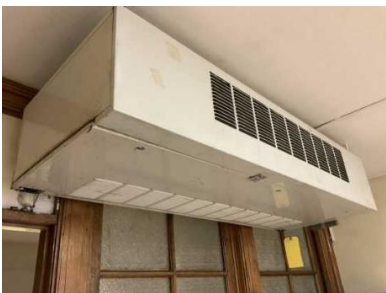
**Unit Ventilator in Poor condition.**

Approx/nominal 2 Ton  
Main Building Barack Obama Elementary School Classrooms

Uniformat Code: D3030  
Recommendation: **Replace in 2025**
