FACILITY CONDITION ASSESSMENT

Richmond Public Schools
301 North Ninth Street
Richmond, VA 23219

Fairfield Court Elementary School
2510 Phaup Street
Richmond, VA 23223

May 23, 2024

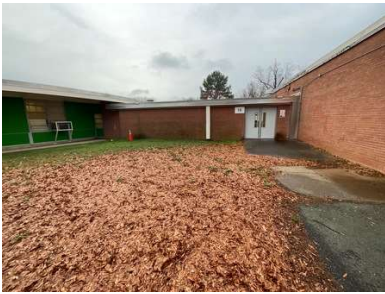
Sidewalk in Poor condition.

Concrete, Large Areas
Site Fairfield Court Elementary School Site

concrete is settled and lifted causing trip hazards. - AssetCALC ID: 7453170

Uniformat Code: G2030
Recommendation: **Replace in 2025**

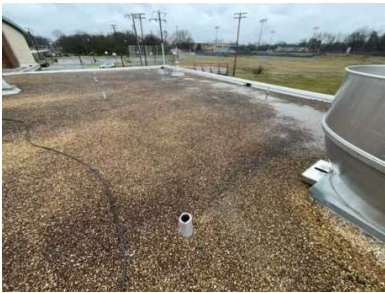
Roofing in Poor condition.

Built-Up
Main Building Fairfield Court Elementary
School Roof

Roofing is aged it has reported leaks and lots of standing water - AssetCALC ID: 7386464

Uniformat Code: B3010
Recommendation: **Replace in 2025**

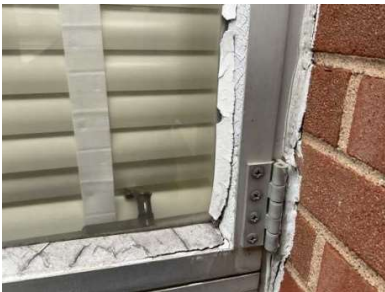
Glazing in Poor condition.

any type by SF
Main Building Fairfield Court Elementary
School Building Exterior

Original single pane, aluminum windows, have lots of corrosion, loose and missing caulking. Reported by staff that the windows leak. - AssetCALC ID: 7386598

Uniformat Code: B2020
Recommendation: **Replace in 2025**

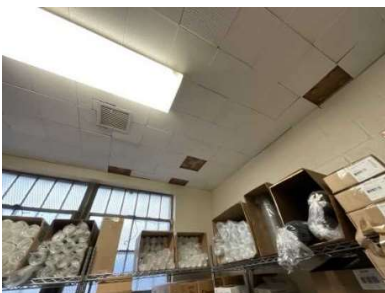
Suspended Ceilings in Poor condition.

Hard Tile, Replacement w/ ACT
Main Building Fairfield Court Elementary
School Throughout building

Lots of missing/loose tiles - AssetCALC ID: 7386489

Uniformat Code: C1070
Recommendation: **Replace in 2025**

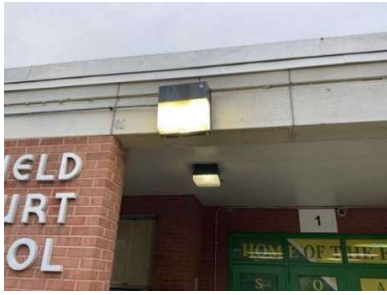
Exterior Fixture w/ Lamp in Poor condition.

any type, w/ LED Replacement
Main Building Fairfield Court Elementary School Building exterior

Reported in PSQ that exterior lighting is insufficient - AssetCALC ID: 7386532

Uniformat Code: G4050
Recommendation: **Replace in 2025**

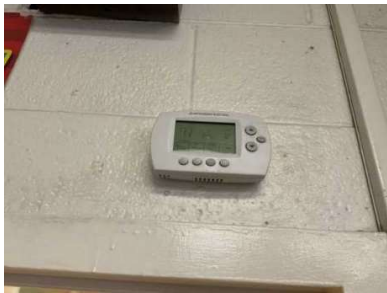
BAS/HVAC Controls in Poor condition.

Basic System or Legacy Upgrades
Main Building Fairfield Court Elementary School Throughout building

Reported in PSQ that the BAS system is problematic. - AssetCALC ID: 7386611

Uniformat Code: D8010
Recommendation: **Upgrade/Install in 2025**

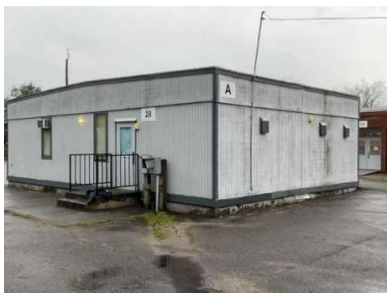
Ancillary Building in Poor condition.

Classroom/Office Module, Standard/Permanent
Site Fairfield Court Elementary School Site

Siding and roofing are in poor condition - AssetCALC ID: 7386468

Uniformat Code: F1020
Recommendation: **Replace in 2025**

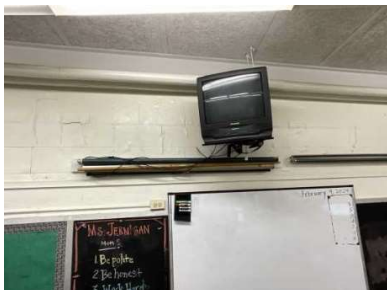
Wall Finishes in Poor condition.

any surface
Main Building Fairfield Court Elementary School Throughout building

Uniformat Code: C2010
Recommendation: **Prep & Paint in 2025**
