# FACILITY CONDITION ASSESSMENT

G.H. Reid Elementary School  
1301 Whitehead Road  
Richmond, VA 23225

*166385.24R000-021.468*

*May 12, 2024*

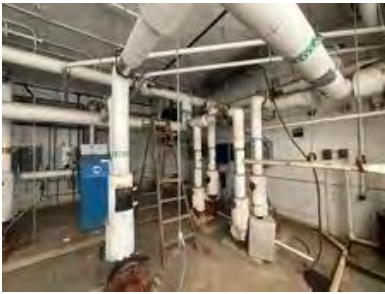
### HVAC System in Poor condition.

Hydronic Piping, 4-Pipe  
Main Building G.H. Reid Elementary School  
Throughout building

2-pipe system needs to be upgraded to 4-pipe for efficiency purposes. - AssetCALC ID: 7524641

Uniformat Code: D3050  
Recommendation: **Replace in 2026**

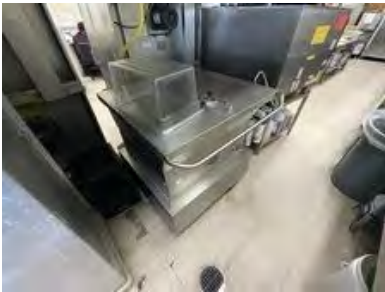
### Foodservice Equipment in Poor condition.

Tilting Skillet  
Main Building G.H. Reid Elementary School  
Kitchen

Tilting skillet is offline and needs to be replaced. - AssetCALC ID: 7524610

Uniformat Code: E1030  
Recommendation: **Replace in 2024**

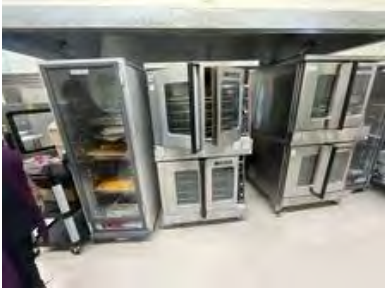
### Foodservice Equipment in Poor condition.

Convection Oven, Double  
Main Building G.H. Reid Elementary School  
Kitchen

Oven is not operating and needs to be replaced. - AssetCALC ID: 7524625

Uniformat Code: E1030  
Recommendation: **Replace in 2024**
