FACILITY CONDITION ASSESSMENT

Richmond Public Schools
301 North Ninth Street
Richmond, VA 23219

Dogwood Middle School
1701 Floyd Avenue
Richmond, VA 23220

September 9, 2024

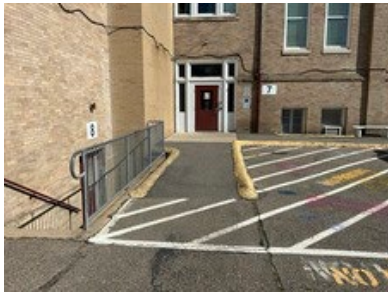
Exterior Walls in Poor condition.

Brick
Dogwood Middle School Main Building Exterior

Deterioration of the exterior brick facade was observed in several areas. - AssetCALC ID: 7718318

Uniformat Code: B2010
Recommendation: **Repair in 2025**

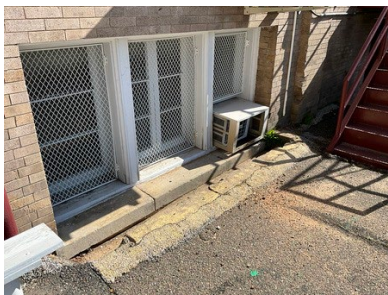
Window in Poor condition.

Vinyl-Clad Double-Glazed, 16-25 SF
Dogwood Middle School Main Building Exterior

Basement windows were noted to be deteriorated. - AssetCALC ID: 7719287

Uniformat Code: B2020
Recommendation: **Replace in 2025**

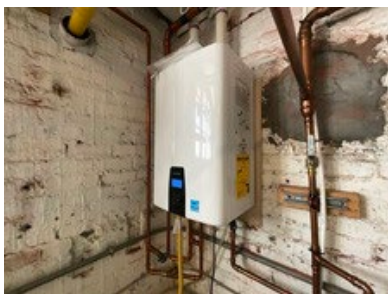
Piping and Valves in Poor condition.

Fiberglass Insulation, Domestic Water
Dogwood Middle School Main Building
Throughout Building

Water piping insulation was noted to be deteriorated. Replacement is recommended in the short term. - AssetCALC ID: 7648991

Uniformat Code: D2010
Recommendation: **Replace in 2025**

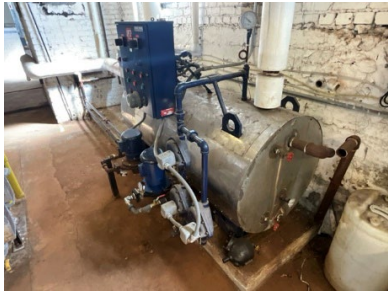
HVAC Steam Components in Poor condition.

Condensate Return Station, 15 GAL
Main Building Dogwood Middle School Main
Building Mechanical Room

Condensate return tank was noted to have several leaks. - AssetCALC ID: 7719257

Uniformat Code: D3050
Recommendation: **Replace in 2025**
