FACILITY CONDITION ASSESSMENT

Richmond Public Schools
301 North Ninth Street
Richmond, VA 23219

Bellevue Elementary School
2301 East Grace Street
Richmond, VA 23223

May 13, 2024

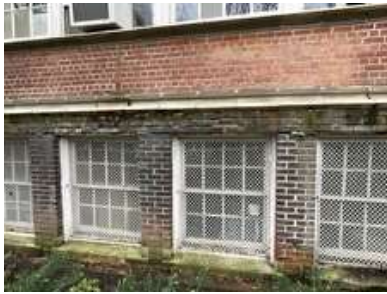
Exterior Walls in Poor condition.

Brick
Main Building Bellevue Elementary School
Building Exterior

Mortar joints can deteriorate over time due to weathering. If the mortar is poor quality, crumbled or open water can seep in and damage the masonry - AssetCALC ID: 7517429

Uniformat Code: B2010
Recommendation: **Repair/Repoint in 2025**

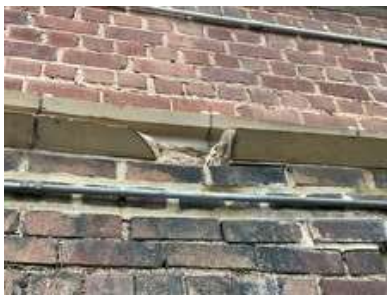
Exterior Walls in Poor condition.

Limestone cornice
Main Building Bellevue Elementary School
Building Exterior

There is a decorative limestone cornice that encircles the building that is cracked and damaged. - AssetCALC ID: 7517461

Uniformat Code: B2010
Recommendation: **Repair in 2025**

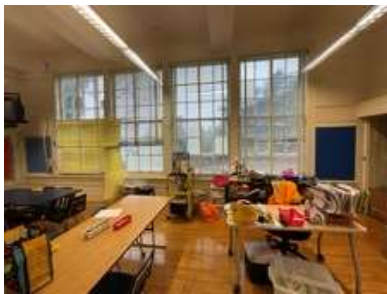
Window in Poor condition.

Wood Historical, up to 15 SF
Main Building Bellevue Elementary School
Building Exterior

The units are single pane with no storms. Units look to be original to the building and highly inefficient. - AssetCALC ID: 7517354

Uniformat Code: B2020
Recommendation: **Replace in 2025**

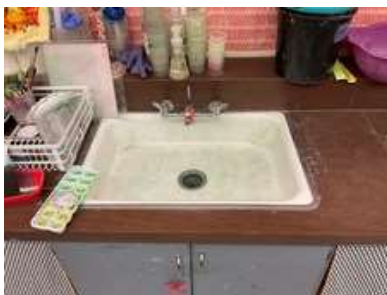
Sink/Lavatory in Poor condition.

Wall-Hung, Enameled Steel
Main Building Bellevue Elementary School 102

The sink and faucet hardware is dated. Modernization is highly recommended. - AssetCALC ID: 7517352

Uniformat Code: D2010
Recommendation: **Replace in 2024**

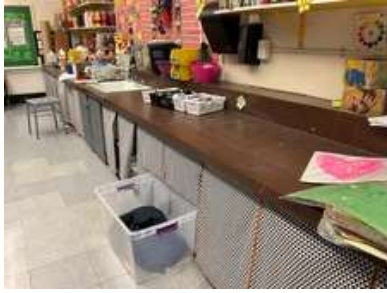
Casework in Poor condition.

The cabinetry is chipped worn and dated. Countertops are not level and chipped. - AssetCALC ID: 7517374

Uniformat Code: E2010
Recommendation: **Replace in 2024**

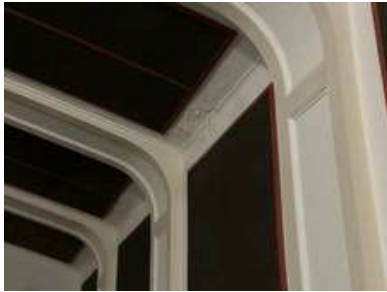
Ceiling Finishes in Poor condition.

Potential leakage from roof. Auditorium right side midway down aisle. Scaffolding will be needed to complete the repair. - AssetCALC ID: 7517379

Uniformat Code: C2050
Recommendation: **Repair in 2024**
