FACILITY CONDITION ASSESSMENT

Richmond Public Schools
301 North Ninth Street
Richmond, VA 23219

Thomas C. Boushall Middle School
3400 Hopkins Road
Richmond, VA 23234

May 11, 2024

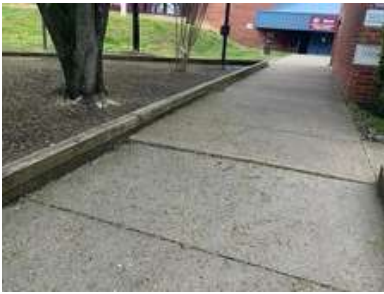
Sidewalk in Poor condition.

Sidewalk is upheaved from tree root and poses a potential trip hazard. There was a report of a teacher tripping incident. - AssetCALC ID: 7526116

Uniformat Code: G2030
Recommendation: **Repair in 2024**

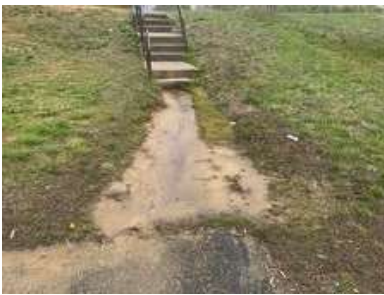
Site Stairs & Ramps in Poor condition.

Stairway is crumbling and handrails bent or missing. Water runoff makes for muddy and slippery conditions. - AssetCALC ID: 7526470

Uniformat Code: G2030
Recommendation: **Replace in 2024**

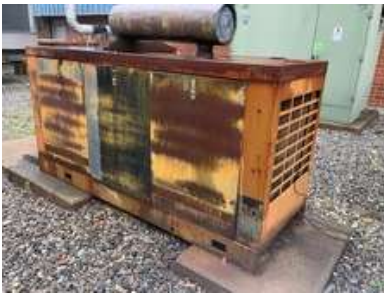
Generator in Poor condition.

Antiquated, rust deteriorated, very loud, leaks, and does not supply much energy. - AssetCALC ID: 7500323

Uniformat Code: D5010
Recommendation: **Replace in 2025**

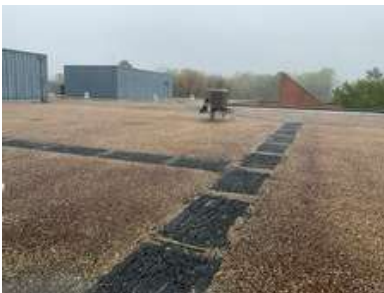
The roof is primarily a built-up system with reported leaks throughout. There are metal roof overhangs throughout the building exterior. A west side exterior wall has a drain that does not connect to any gutters or downspouts and spills out directly down the brick wall resulting in stains and deterioration. It is recommended that the built-up roof be completely replaced and a downspout be added.

Roofing in Poor condition.

Roof leaks reported throughout. - AssetCALC ID: 7526734

Uniformat Code: B3010
Recommendation: **Replace in 2025**

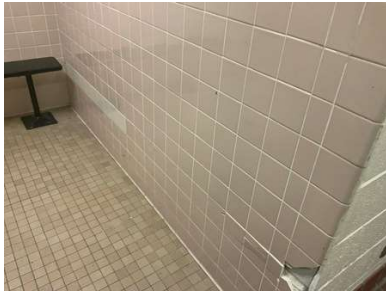
Wall Finishes in Poor condition.

Worn out and cracked at some spots - AssetCALC ID: 7526118

Uniformat Code: C2010
Recommendation: **Replace in 2026**

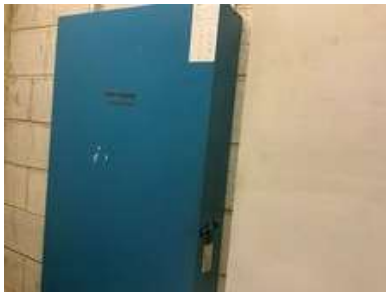
The control panel for the elevator is outdated and replacement parts have become obsolete.

Elevator Controls in Poor condition.

Elevator controls are old and parts are hard to replace - AssetCALC ID: 7500334

Uniformat Code: D1010
Recommendation: **Replace in 2025**

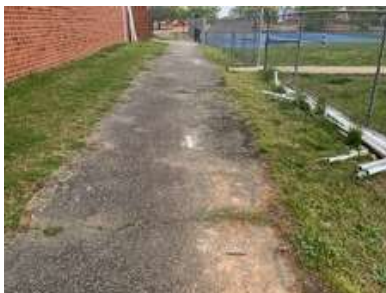
Sidewalk in Poor condition.

Cracks and water runoff damage - AssetCALC ID: 7526472

Uniformat Code: G2030
Recommendation: **Overlay in 2026**

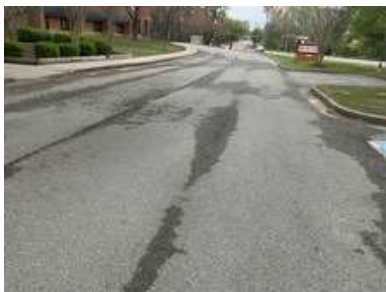
The bus entrance roadway has alligator cracks throughout.

Roadways in Poor condition.

Alligator cracks throughout - AssetCALC ID: 7500406

Uniformat Code: G2010
Recommendation: **Mill & Overlay in 2026**

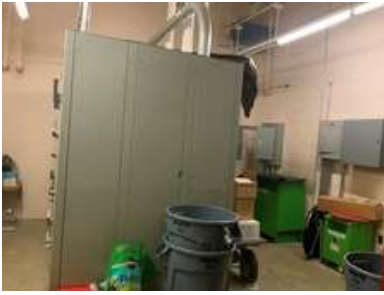
Electrical System in Poor condition.

Outdated panels, switchboards, automatic transfer switch, and issues with not enough outlets - AssetCALC ID: 7526787

Uniformat Code: D5030
Recommendation: **Replace in 2026**

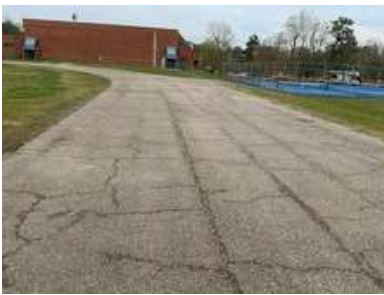
Running Track in Poor condition.

Asphalt track has cracks throughout. - AssetCALC ID: 7500437

Uniformat Code: G2010
Recommendation: **Overlay in 2026**

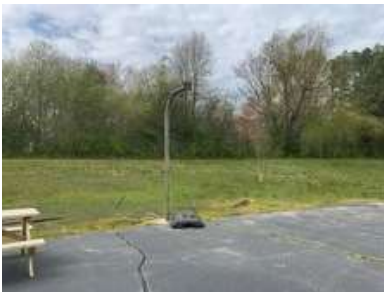
Sports Apparatus in Failed condition.

No hoop or rim - AssetCALC ID: 7500401

Uniformat Code: G2050
Recommendation: **Replace in 2024**

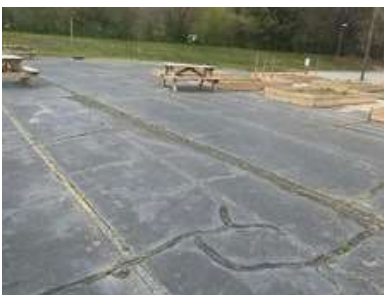
Athletic Surfaces & Courts in Poor condition.

Deep cracks throughout. - AssetCALC ID: 7526473

Uniformat Code: G2050
Recommendation: **Replace in 2025**

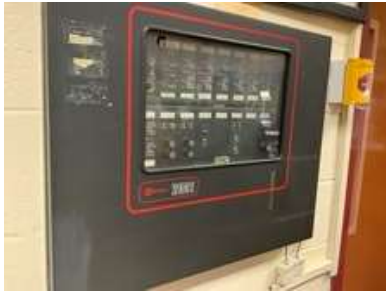
The fire alarm panel located in the main office is outdated. A replacement cost is included.

Fire Alarm Panel in Poor condition.

Outdated - AssetCALC ID: 7500382

Uniformat Code: D7050
Recommendation: **Replace in 2025**

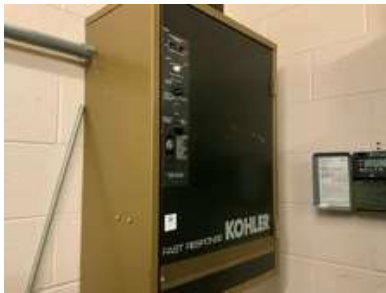
Automatic Transfer Switch in Poor condition.

Very outdated - AssetCALC ID: 7500433

Uniformat Code: D5010
Recommendation: **Replace in 2025**

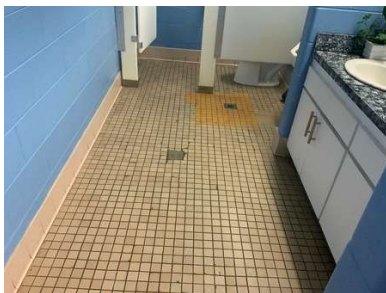
Flooring in Poor condition.

Outdated and worn out - AssetCALC ID: 7526130

Uniformat Code: C2030
Recommendation: **Replace in 2026**

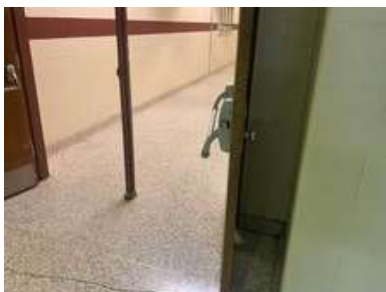
ADA Entrances & Doors in Poor condition.

Most doors are knobs - AssetCALC ID: 7526129

Uniformat Code: Y1030
Recommendation: **Install in 2024**

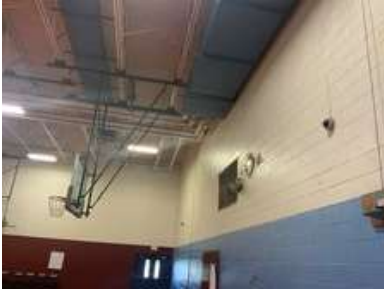
Intercom/PA System in Poor condition.

Uniformat Code: D6060
Recommendation: **Replace in 2025**
