# FACILITY CONDITION ASSESSMENT

**Richmond Public Schools**  
301 North Ninth Street  
Richmond, VA 23219

Southampton Elementary School  
3333 Cheverly Road  
Richmond, VA 23225

*May 15, 2024*

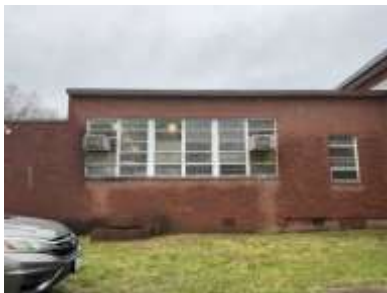
### Glazing in Poor condition.

any type by SF  
Main Building Southampton Elementary School  
Building Exterior

Uniformat Code: B2020  
Recommendation: **Replace in 2025**
