# FACILITY CONDITION ASSESSMENT

**Richmond Public Schools**  
301 North Ninth Street  
Richmond, VA 23219

Open High School  
600 Pine Street  
Richmond, VA 23220

*June 13, 2024*

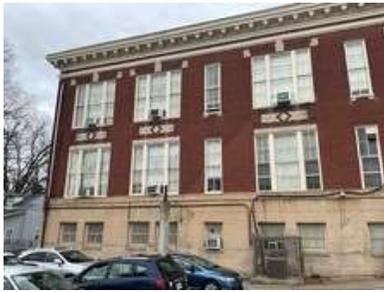
#### Exterior Walls in Poor condition.

Brick  
Main Building Open High School Exterior walls

Clean stained brick and point washed out mortar joints especially under upper floor windows. - AssetCALC ID: 7675209

Uniformat Code: B2010  
Recommendation: **Repair in 2025**

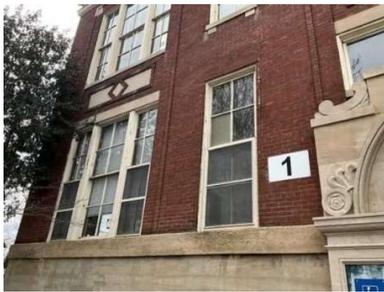
#### Exterior Walls in Poor condition.

any painted surface  
Main Building Open High School Building Exterior

The painted sections of the exterior facade were observed to be in poor condition with areas of damage and deterioration. - AssetCALC ID: 7412387

Uniformat Code: B2010  
Recommendation: **Prep & Paint in 2026**

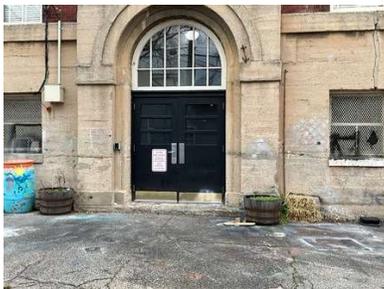
#### Exterior Walls in Poor condition.

Concrete  
Main Building Open High School Exterior concrete walls

Repair cracks in concrete walls around building perimeter. - AssetCALC ID: 7675207

Uniformat Code: B2010  
Recommendation: **Repair in 2025**

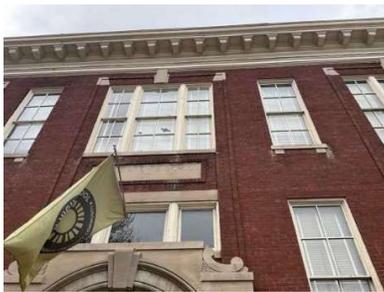
#### Glazing in Poor condition.

any type, by SF  
Main Building Open High School Building Exterior

Damage and deterioration were observed at the window frames and glazing. - AssetCALC ID: 7412383

Uniformat Code: B2020  
Recommendation: **Replace in 2025**

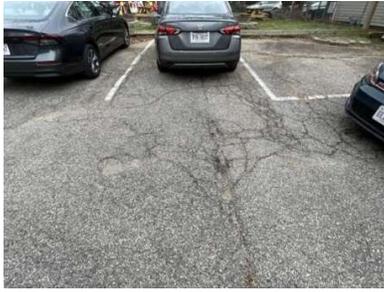
### Parking Lots in Poor condition.

Pavement, Asphalt  
Site Open High School Site

Alligator cracking and deterioration were observed at various sections of the parking areas. - AssetCALC ID: 7412394

Uniformat Code: G2020  
Recommendation: **Cut & Patch in 2025**

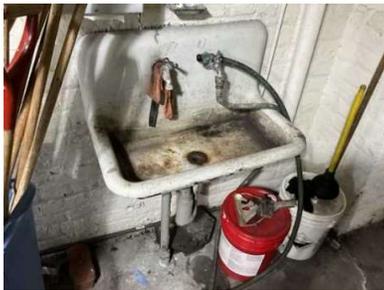
### Sink/Lavatory in Poor condition.

Service Sink, Wall-Hung  
Main Building Open High School Mechanical room

Damage and deterioration were observed at the custodial sinks. - AssetCALC ID: 7412404

Uniformat Code: D2010  
Recommendation: **Replace in 2026**

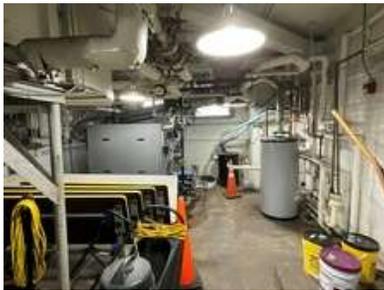
### Piping & Valves in Poor condition.

Fiberglass Insulation, Domestic Water  
Main Building Open High School Throughout

Water piping insulation was noted to be deteriorated. Replacement is recommended in the short term. - AssetCALC ID: 7649049

Uniformat Code: D2010  
Recommendation: **Replace in 2025**

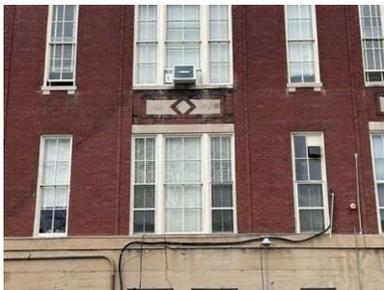
### Recommended Follow-up Study: Building Envelope, Façade

Building Envelope, Façade  
Main Building Open High School Throughout building

Architectural study for building facade due to age and surface cracks in basement level concrete walls. - AssetCALC ID: 7412403

Uniformat Code: P2030  
Recommendation: **Evaluate/Report in 2024**

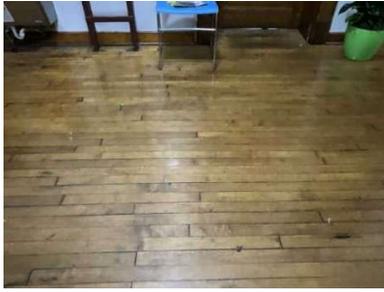
### Flooring in Poor condition.

Wood, Strip  
Main Building Open High School Throughout building

Damage and deterioration was observed at the interior wood flooring. - AssetCALC ID: 7412388

Uniformat Code: C2030  
Recommendation: **Replace in 2026**

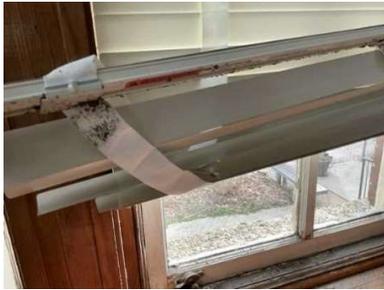
### Recommended Follow-up Study: Environmental, Remediation of Suspect Fungal Growth

Environmental, Remediation of Suspect Fungal Growth  
Main Building Open High School Throughout Building

Uniformat Code: P2030  
Recommendation: **Remove in 2024**

Environmental remediation of microbial growth. - AssetCALC ID: 7412415

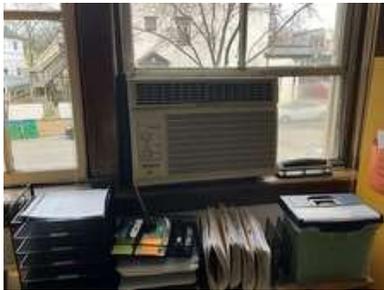
### HVAC System

Full System Renovation/Upgrade, Medium Complexity  
Main Building Open High School Throughout building

Uniformat Code: D3050  
Recommendation: **Replace in 2026**

Renovate HVAC system to correct humidity and unconditioned spaces. - AssetCALC ID: 7675146
