FACILITY CONDITION ASSESSMENT

Richmond Public Schools
301 North Ninth Street
Richmond, VA 23219

Oak Grove-Bellemeade Elementary School
2409 Webber Avenue
Richmond, Virginia, 23224

October 9, 2024

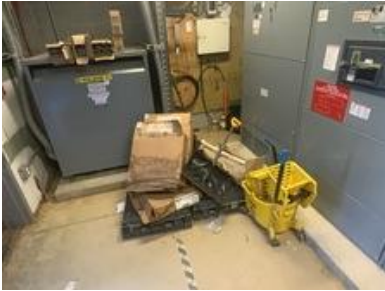
Electrical System in Failed condition.

any type, Repairs per Man-Day
Main Building Oak Grove-Bellemeade
Elementary School Electrical room

Combustibles stored next to electrical equipment . - AssetCALC ID: 7543094

Uniformat Code: D5020
Recommendation: **Repair in 2024**

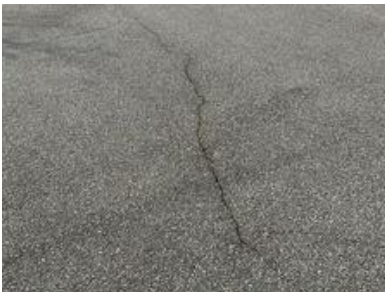
Parking Lots in Poor condition.

Pavement, Asphalt
Site Oak Grove-Bellemeade Elementary
School Site

Longitudinal and transverse cracking observed - AssetCALC ID: 7542568

Uniformat Code: G2020
Recommendation: **Cut & Patch in 2024**

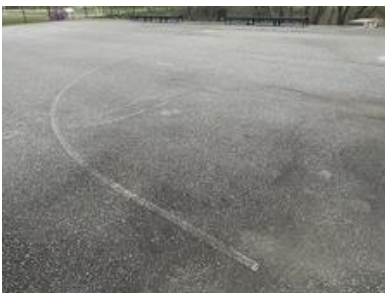
Athletic Surfaces & Courts in Poor condition.

Basketball/General, Asphalt Pavement
Site Oak Grove-Bellemeade Elementary
School Site

Court lines are extremely faded. - AssetCALC ID: 7542573

Uniformat Code: G2050
Recommendation: **Seal & Stripe in 2025**

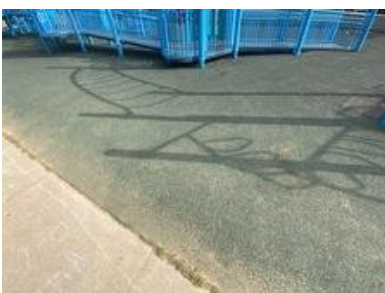
The asphalt parking lots are observed to be adequate overall for the short term with recent sealing and striping. The concrete sidewalks and concrete paving system are not anticipated to need replacement within the reserve term. Site lighting is with LED pole-mounted fixtures and appears to be adequate for the site. The play structure on the east side did not exhibit any deficiencies but the rubber play surface was torn and will require repair or replacement in the near term

Playfield Surfaces in Poor condition.

Artificial Play Turf
Site Oak Grove-Bellemeade Elementary
School Site

Several tears and missing material observed - AssetCALC ID: 7542594

Uniformat Code: G2050
Recommendation: **Replace in 2026**

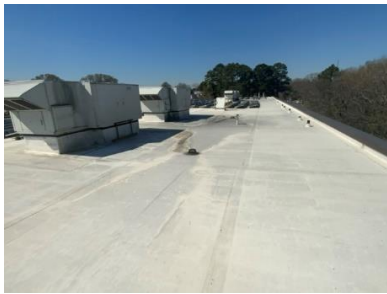
**Recommended Follow-up Study:
Mechanical, HVAC Controls /
Rebalance**

Mechanical, HVAC Controls / Rebalance
Main Building Oak Grove-Bellemeade
Elementary School Rooftop units

Significant temperature variations between floors. - AssetCALC ID: 7543979

Uniformat Code: P2030
Recommendation: **Evaluate/Report in 2024**

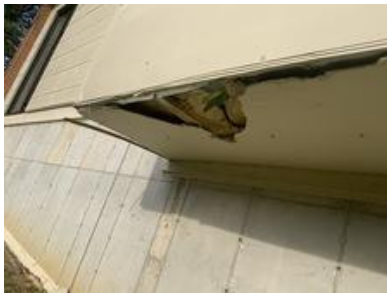
A small portion of soffit material under a west side window bay on the west side is damaged and a cost for repair is provided.

Soffit/Fascia in Poor condition.

Wood Fiber
Main Building Oak Grove-Bellemeade
Elementary School Building exterior - west side

Finish system damaged - AssetCALC ID: 7543136

Uniformat Code: B3080
Recommendation: **Replace in 2024**

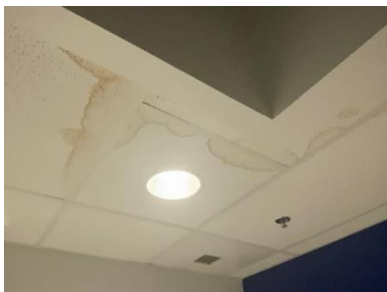
**Suspended Ceilings in Poor
condition.**

Acoustical Tile (ACT)
Main Building Oak Grove-Bellemeade
Elementary School 2nd Floor bathroom

Ceiling tiles stained - AssetCALC ID: 7543925

Uniformat Code: C1070
Recommendation: **Replace in 2025**

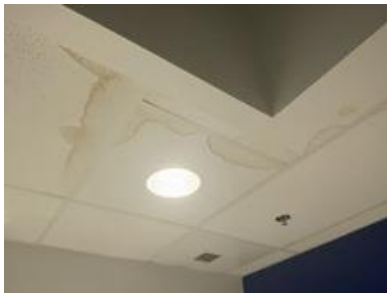
**Recommended Follow-up Study:
Environmental, Analysis of
Suspect Fungal Growth**

Environmental, Analysis of Suspect Fungal
Growth
Main Building Oak Grove-Bellemeade
Elementary School 2nd Floor restroom

Ceiling tiles in restroom are stained from moisture penetration - AssetCALC ID: 7543277

Uniformat Code: P2030
Recommendation: **Evaluate/Report in 2024**
