# FACILITY CONDITION ASSESSMENT

**Richmond Public Schools**  
301 North Ninth Street  
Richmond, VA 23219

Amelia Street School  
1821 Amelia Street  
Richmond, VA 23220

*July 2, 2024*

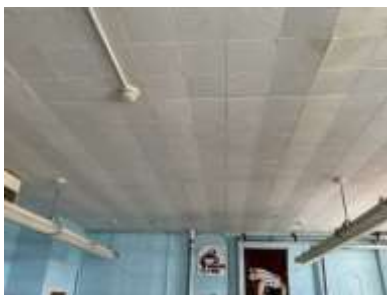
### Suspended Ceilings in Poor condition.

Hard Tile, Replacement w/ ACT  
Main Building Amelia Street School Building  
Interior

Tiles are sagging and stained. - AssetCALC ID: 7421067

Uniformat Code: C1070  
Recommendation: **Replace in 2025**
