# FACILITY CONDITION ASSESSMENT

**Richmond Public Schools**  
301 North Ninth Street  
Richmond, VA 23219

Amelia Street School  
1821 Amelia Street  
Richmond, VA 23220

*July 2, 2024*

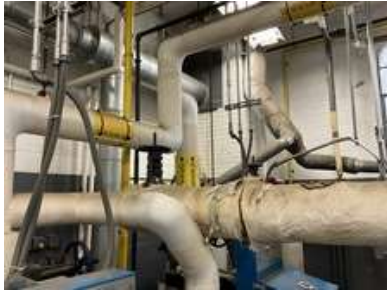
### Piping & Valves in Poor condition.

Insulation missing and damaged from cold water pipes creates condensation leaks. - AssetCALC ID: 7649116

Uniformat Code: D2010  
Recommendation: **Replace in 2025**

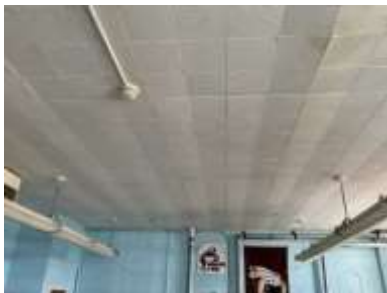
### Suspended Ceilings in Poor condition.

Hard Tile, Replacement w/ ACT  
Main Building Amelia Street School Building  
Interior

Tiles are sagging and stained. - AssetCALC ID: 7421067

Uniformat Code: C1070  
Recommendation: **Replace in 2025**
