# FACILITY CONDITION ASSESSMENT

**Richmond Public Schools**  
301 North Ninth Street  
Richmond, VA 23219

Thomas H. Henderson Middle School  
4319 Old Brook Road  
Richmond, VA 23227

*May 24, 2024*

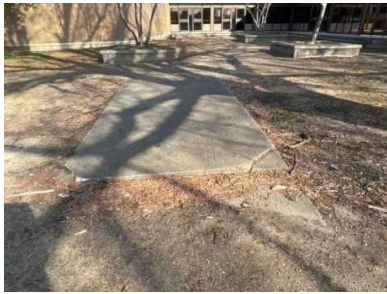
#### Sidewalk in Poor condition.

Multiple large cracks that present trip hazards throughout the concrete walking paths - AssetCALC ID: 7448603

Uniformat Code: G2030  
Recommendation: **Repair in 2024**

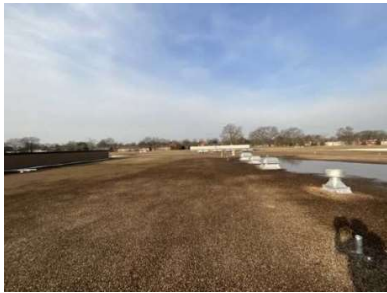
#### Roofing in Poor condition.

There is numerous roof leaks, as well as inadequate drainage with large areas of standing water present - AssetCALC ID: 7448595

Uniformat Code: B3010  
Recommendation: **Replace in 2025**

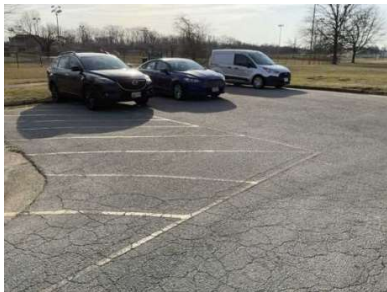
#### Parking Lots in Poor condition.

Striping is poorly visible throughout the lot - AssetCALC ID: 7448525

Uniformat Code: G2020  
Recommendation: **Seal & Stripe in 2025**

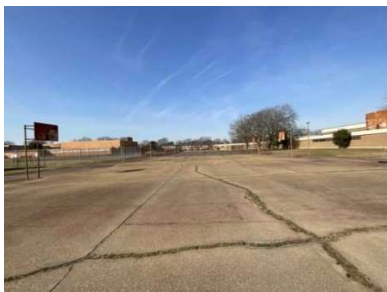
#### Athletic Surfaces & Courts in Poor condition.

Faded lines and cracking - AssetCALC ID: 7448672

Uniformat Code: G2050  
Recommendation: **Seal & Stripe in 2025**

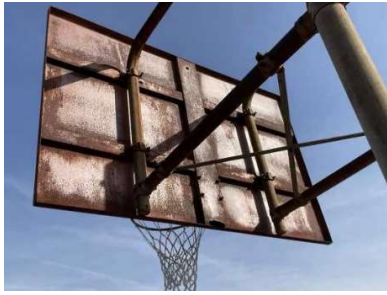
### Sports Apparatus in Poor condition.

Structure has surface rust throughout and surrounding foundation has major cracking - AssetCALC ID: 7448687

Uniformat Code: G2050  
Recommendation: **Replace in 2025**

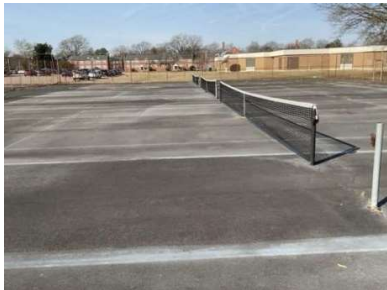
### Athletic Surfaces & Courts in Poor condition.

Cracking present throughout - AssetCALC ID: 7448656

Uniformat Code: G2050  
Recommendation: **Mill & Overlay in 2025**

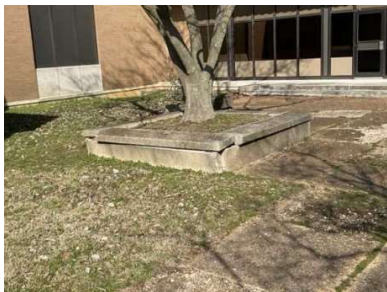
### Planter Boxes in Poor condition.

Concrete planters throughout site have cracks and complete broken off sections. Many are not salvageable. - AssetCALC ID: 7448638

Uniformat Code: G2080  
Recommendation: **Replace in 2025**

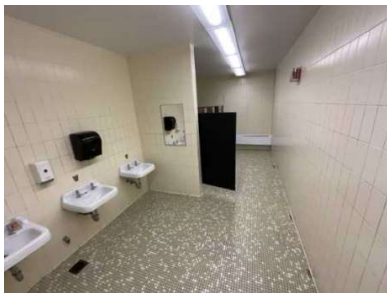
### ADA Restrooms

Pipe insulation needed for compliance - AssetCALC ID: 7448546

Uniformat Code: Y1050  
Recommendation: **Install in 2024**

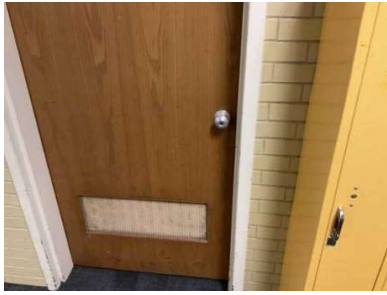
### ADA Entrances & Doors

Most door handles are not ADA compliant. - AssetCALC ID: 7448599

Uniformat Code: Y1030  
Recommendation: **Install in 2024**

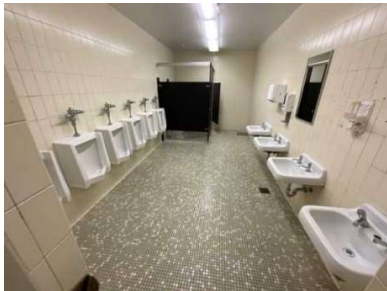
### ADA Restrooms

No lower urinal present. - AssetCALC ID: 7448640

Uniformat Code: Y1050  
Recommendation: **Modify in 2024**

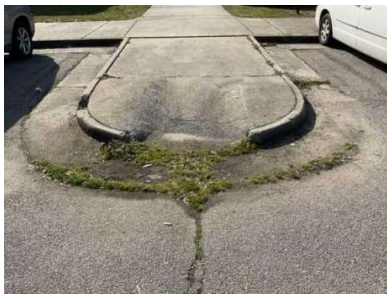
### ADA Paths of Travel

Walkways, Curb Cut Ramp  
Site Thomas H. Henderson Middle School Parking lot

Uniformat Code: Y1020  
Recommendation: **Install in 2024**

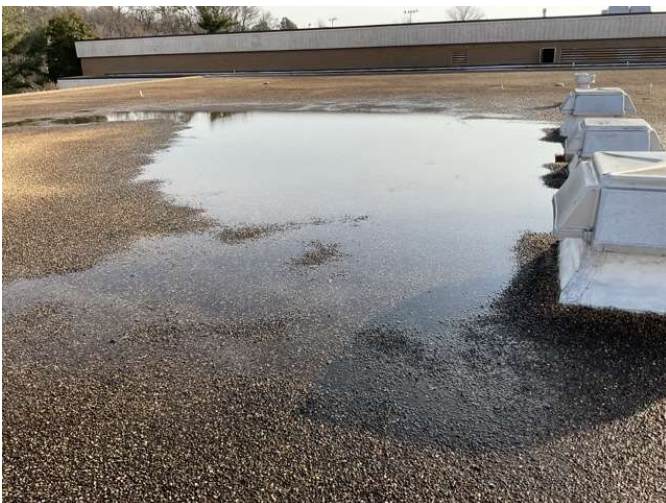
5 - STANDING WATER PRESENT ON ROOF

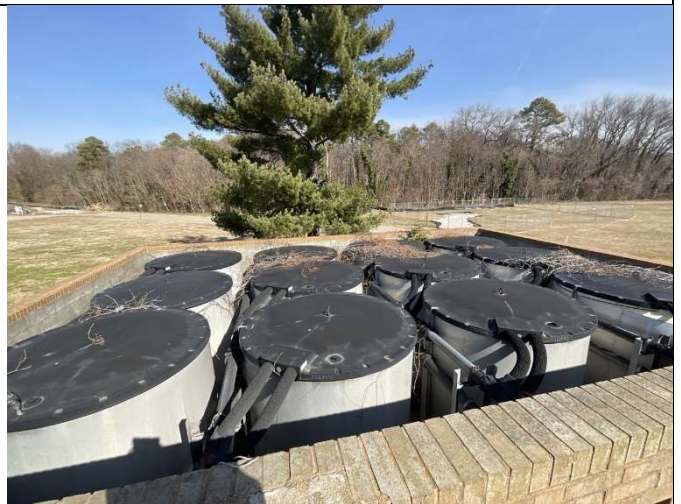
18 – ABANDONED HVAC THERMAL ICE STORAGE
