FACILITY CONDITION ASSESSMENT

Richmond Public Schools
301 North Ninth Street
Richmond, VA 23219

Richmond Technical Center North
2015 Westwood Avenue
Richmond, VA 23230

April 11, 2024

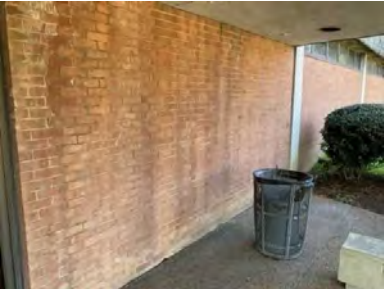
Exterior Walls in Poor condition. Priority Score: **89.8**

Paint has significantly deteriorated - AssetCALC ID: 7425005

Uniformat Code: B2010
Recommendation: **Prep & Paint in 2024**

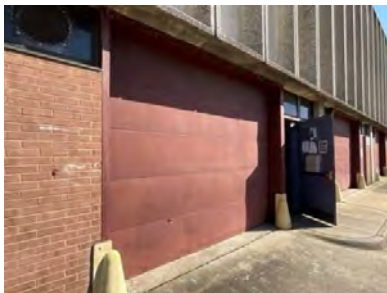
Exterior Door in Poor condition.

Reported that the exterior doors and frames are problematic - AssetCALC ID: 7425064

Uniformat Code: B2050
Recommendation: **Replace in 2025**
