# FACILITY CONDITION ASSESSMENT

**Richmond Public Schools**  
301 North Ninth Street  
Richmond, VA 23219

Richmond Success Academy  
119 West Leigh Street  
Richmond, VA 23220

*October 11, 2024*

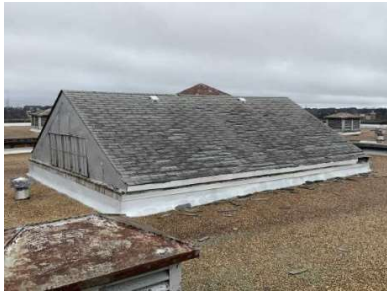
### Roofing in Poor condition.

Asphalt Shingle, 20-Year Standard  
Main Building Richmond Success Academy  
Roof

The field of the roofs have damaged and missing shingles. The entire roof requires replacement. - AssetCALC  
ID: 7419236

Uniformat Code: B3010  
Recommendation: **Replace in 2024**
